**STRUCTURAL INSPECTION OF  
THE BARN, WARBAGE LANE  
BELBROUGHTON, WORCESTERSHIRE**

Date	<b>23/04/2021</b>
Client	<b>Mrs Evans</b>
Property Address	<b>The Barn, Warbage Lane, Belbroughton Worcestershire</b>
Shire Ref number (our ref)	<b>S-21-188</b>
Report prepared by	<b>Richard Hartshorne – 07976 691472</b>

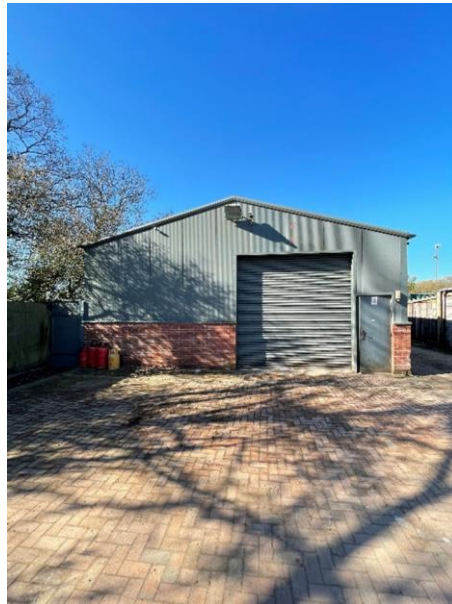
- 3.1 The roof cladding is in good condition with no defects noted.
- 3.2 The North East (Front) elevation of the building contains a roller shutter door and personnel door. All of the cladding and low-level masonry are in good condition

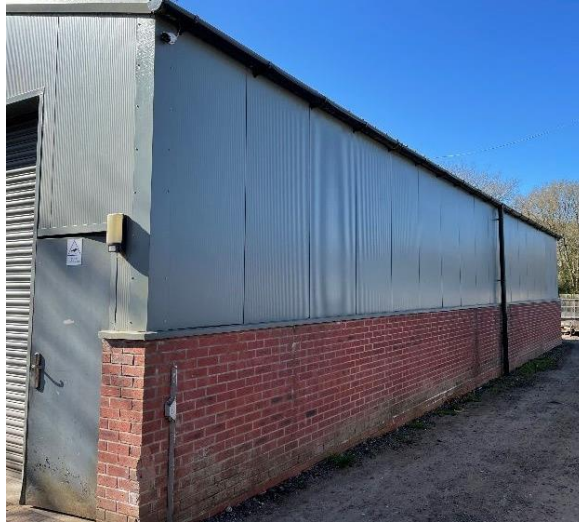
- 33 The South East elevation of the building is in good condition with only some minor damage to low level brickwork adjacent to the personnel door

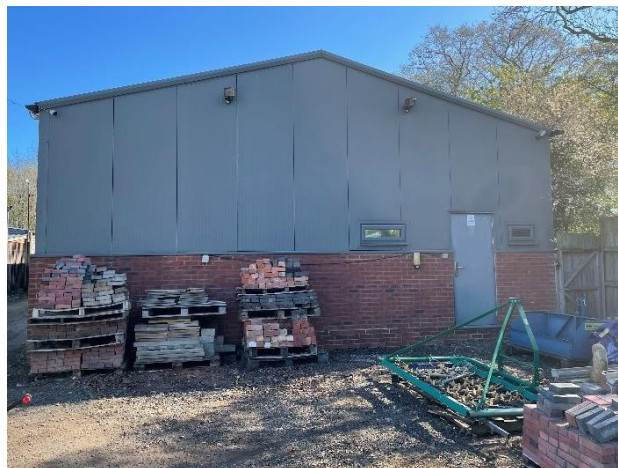
- 34 The South West elevation of the building is in good condition with no defects noted

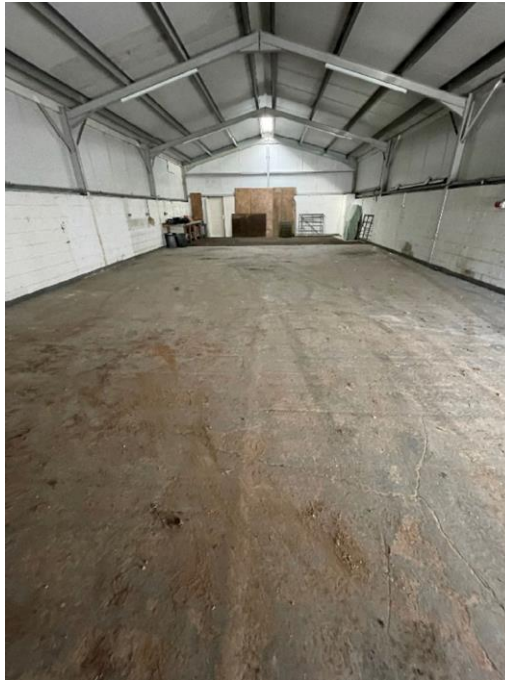
4.1. The steel frame comprises hot rolled steel portal frame with galvanized cold rolled sleeved system purlins and butt system side rails. The steelwork is in good condition with no corrosion noted

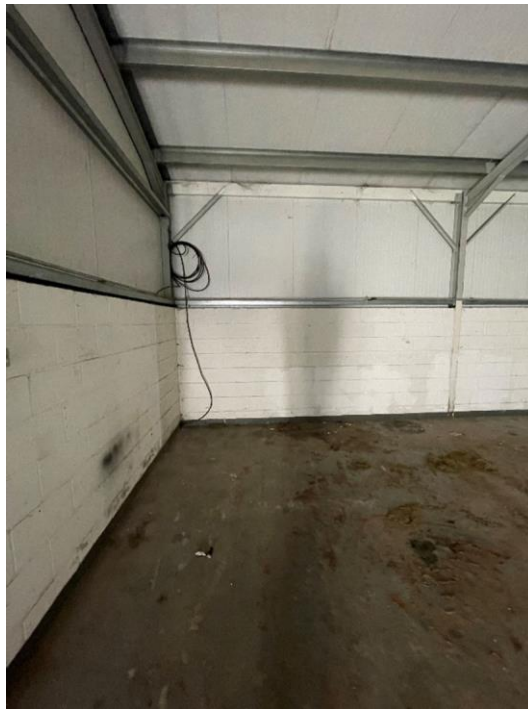
4.2. The ground floor slab is of in-situ concrete construction and is in good condition. It is suitable to be retained in the conversion and receive insulation and finishes on top.
