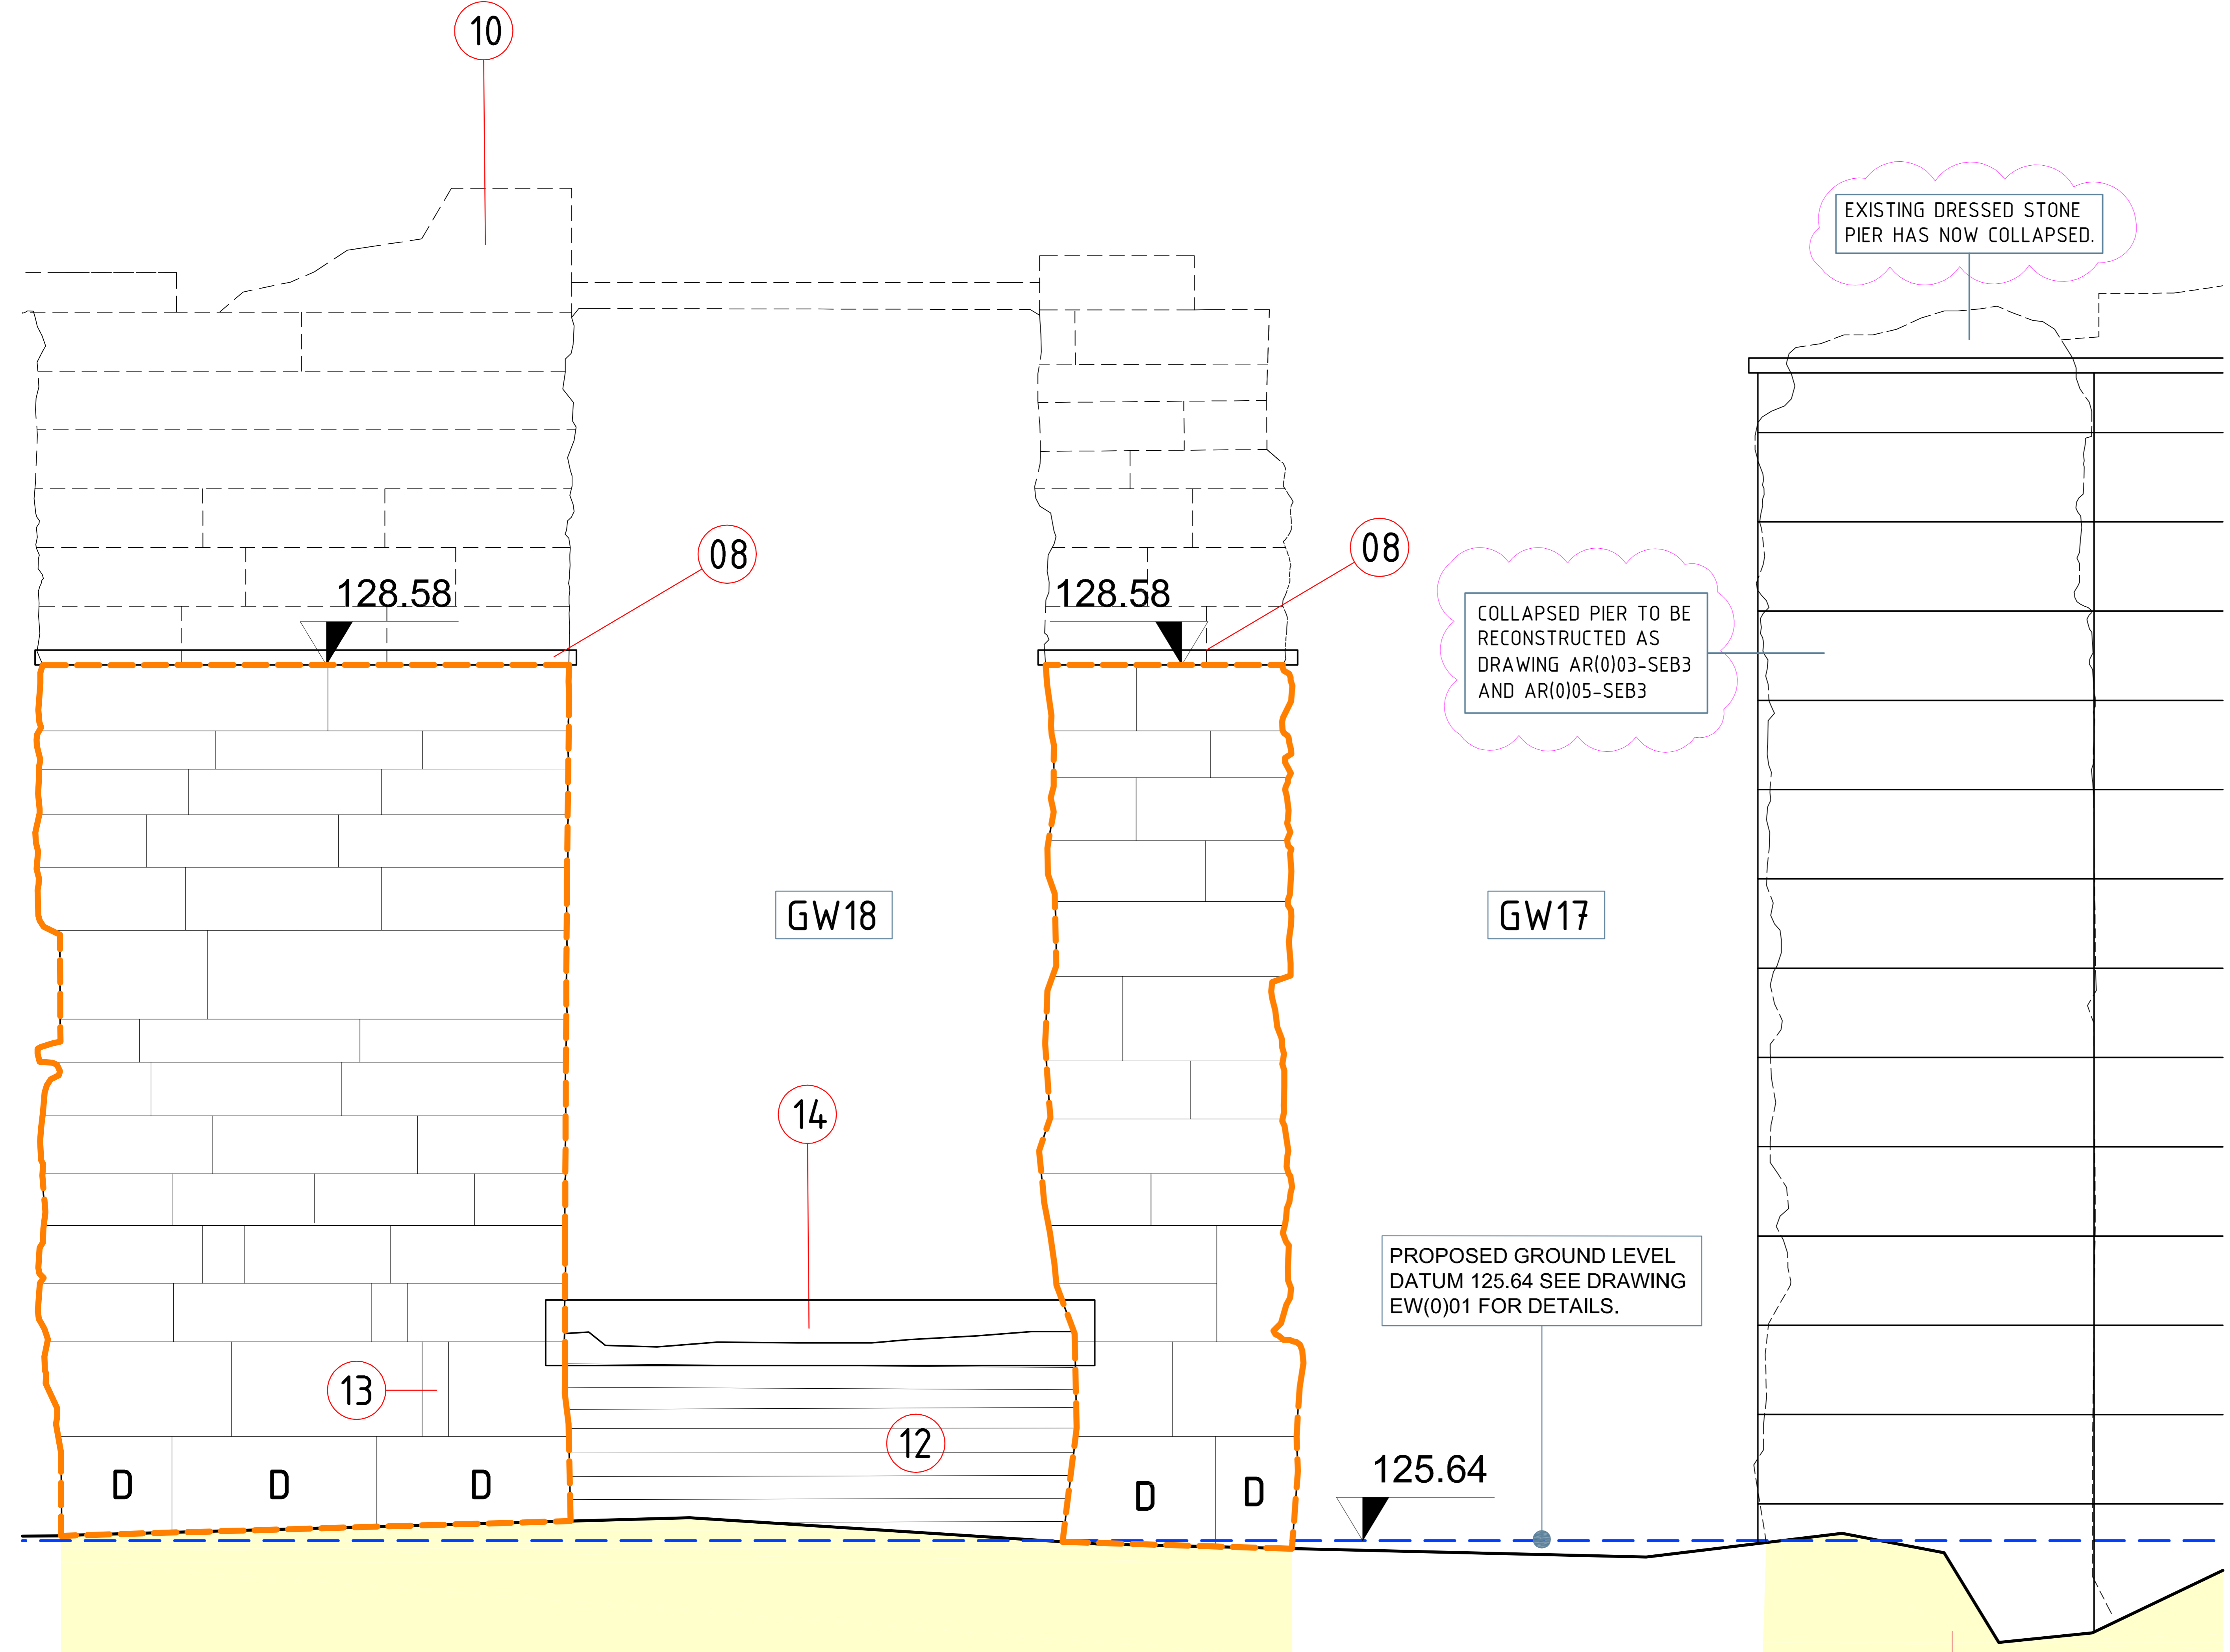
THIS FAÇADE HAS SUFFERED FROM EXTENSIVE UNCONTROLLED COLLAPSE OVER THE YEARS AND THE STRUCTURAL INTEGRITY OF THE REMAINING ELEMENTS IS SIGNIFICANTLY COMPROMISED. ON THE BASIS THAT REPRESENTATIVE SAMPLES OF THE VARIOUS BUILDING ELEMENTS ARE PRESERVED ELSEWHERE IT IS PROPOSED THAT MISSING OR COLLAPSED SECTIONS ARE NOT REINSTATED AND UNSTABLE REMNANTS ARE REMOVED. THE EXISTING MASONRY WILL BE REDUCED IN HEIGHT TO A LOGICAL POINT WHERE IT IS MORE STRUCTURALLY VIABLE AND CAN BE WEATHERED EFFECTIVELY IN ORDER THAT DECAY AND FURTHER COLLAPSE CAN BE ARRESTED AND THE RUIN CONSOLIDATED. STONES TAKEN DOWN WILL BE LEFT ON SITE ADJACENT TO WHERE THEY CAME FROM. A PHOTOGRAPHIC RECORD IS TO BE MADE OF THE STRUCTURE AS IT CURRENTLY STANDS PRIOR TO DISMANTLING.

- SEB4 INTERNAL WORKS:**
- 01 GENERALLY REMOVE ALL REMNANTS OF VEGETATION.
 - 02 AREA OBSCURED BY REMAINING VEGETATION AND SCAFFOLD PLANKS. ASSUME CATEGORY B REPAIR REQUIRED.

BASE OF WALL EXPOSED, PATCH REPAIRED AND UNDERPINNED ONLY WHERE UNDERMINED BY IVY / ROOT BALLS (ON REAR FACE AS NECESSARY - IN 900MM SECTION LENGTHS. EXTENT TO BE AGREED ON SITE UPON INSPECTION).

- 03 CARRY OUT CATEGORY B REPAIRS - LIGHTLY DRESS EXISTING STONES IN-SITU
 - 04 CARRY OUT CATEGORY C REPAIRS - REPAIR DAMAGED OR HEAVILY ERODED STONES USING REINFORCED STONE REPAIR SYSTEM AS REQUIRED, SEE NBS.

- 05 CARRY OUT CATEGORY D REPAIRS - CUT OUT STONES CONSIDERED TO BE TOO BADLY DAMAGED OR ERODED FOR REPAIR AND REPLACE WITH NEW TO ORIGINAL PROFILE. REPLACE MISSING STONES WITH NEW TO MATCH ORIGINAL PROFILE.

- 06 GENERALLY REPOINT ELEVATION WITH LIME MORTAR.
 - 07 CAREFULLY REMOVE AND REINSTATE AFTER A LIGHT DRESSING ORIGINAL WINDOW SURROUND STONES. EMPLOY STAINLESS STEEL CRAMPS , DOWELS AND HELICAL FIXINGS TO SECURE STONES IN PLACE.

- 08 NEW CAPPING OF LEAD CLAD PAVING SLABS INSTALLED IN ACCORDANCE WITH DRAWING AR(0)08 SEB4
 - 09 HOLES IN STONE ASSUMED TO HAVE BEEN WHERE RAINWATER GOODS WERE FIXED FILLED.

- 10 STONES REMOVED PERMANENTLY.
 - 11 IRONWORK REMNANTS TO BE REMOVED.
 - 12 BRICK INFILL CHECKED FOR SOUNDNESS. ANY HEAVILY ERODED OR DISINTEGRATING BRICKS CUT OUT AND REPLACED. UNDAAGED AND LIGHTLY DAMAGED BRICKS DRESSED AND REPOINTED AS REQUIRED.

- 13 BRICK PATCHES REPLACED WITH NEW STONEMWORK TO MATCH EXISTING PROFILES.
 - 14 NEW STONE CILL INSTALLED TO MATCH EXISTING. ENSURE TOP OF WALL BELOW IS FULLY PROTECTED FROM MOISTURE PENETRATION.

- 15 BRICKWORK IN VERY POOR CONDITION REMOVED. BRICKWORK BELOW CILL REBUILT IN NEW APPROVED BRICK TO LEVEL SUITABLE FOR SUPPORTING CILL.
 - 16 GENERALLY REMOVE ALL REDUNDANT IRONWORK AND FILL HOLES LEFT WITH LIME MORTAR FOR SMALL HOLES. DISCUSS REPAIR METHOD FOR LARGER AREAS OF DAMAGE WITH ARCHITECT.

ALL STONES TO BE NUMBERED AND CATALOGUED PRIOR TO PIER BEING CAREFULLY TAKEN DOWN TO GROUND LEVEL. PIER TO BE RECONSTRUCTED TO DATUM SHOWN USING SALVAGED STONES DEEMED ACCEPTABLE FOR RE-USE (WITH RE-DRESSING) IN ORIGINAL UN-DISPLACED POSITIONS. STONES CONSIDERED TO BE TOO BADLY DAMAGED OR ERODED FOR REPAIR REPLACED WITH NEW TO ORIGINAL PROFILE.
