Project Name: Mount House (maidstone)

Project Date: 31/08/2021

Inspection Standard: MSCC4 Sewers & Drainage GB (SRM4 Scoring)

Section Inspection - 31/08/2021 - R/EX

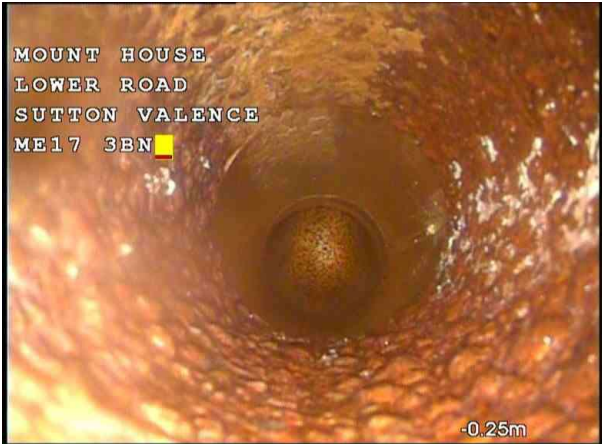
R_EX_7fe73e08-065a-4425-8ffd-112ce194063e_20210831_1
13323_197.jpg, 00:00:10, 0.00 m
Water level, 0% of the vertical dimension, Looking down stack pipe

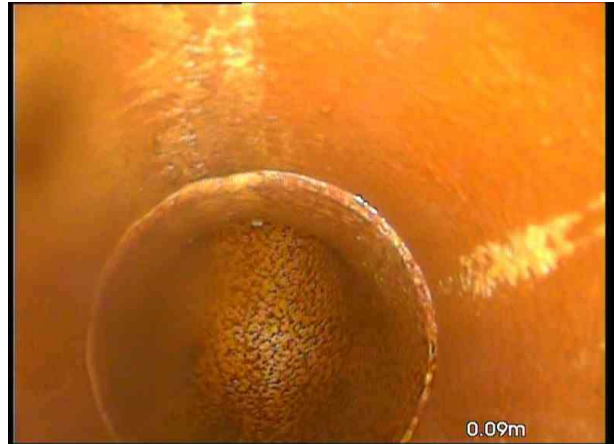
R_EX_411f8351-be1d-440f-8bb5-4e2ef0718ce6_20210831_1
13429_403.jpg, 00:00:27, 0.09 m
Material changes to vitrified clay, Rest Bend

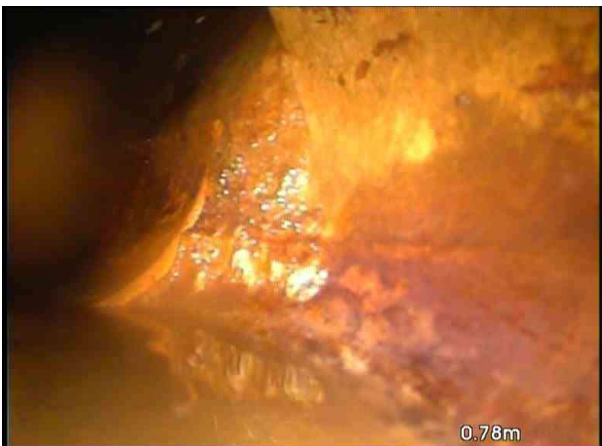
R_EX_46738934-6b8e-42d2-a93a-416dd35a5a63_20210831_1
113531_487.jpg, 00:00:44, 0.78 m
Water level, 5% of the vertical dimension

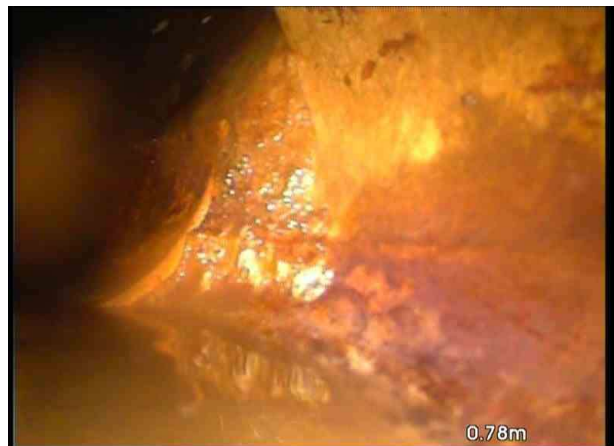
R_EX_0fbfca10-2847-4e03-bc53-ae3ceaf1fe58_20210831_11
3545_414.jpg, 00:00:44, 0.78 m
Line deviates left

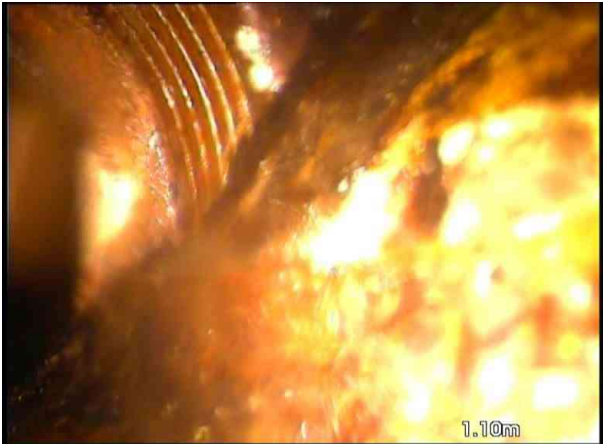
R_EX_da87cf2a-4cd9-4542-adf4-8fe13c085c4c_20210831_113647_577.jpg, 00:00:52, 1.10 m
General photograph taken at this point, Buried manhole with connection

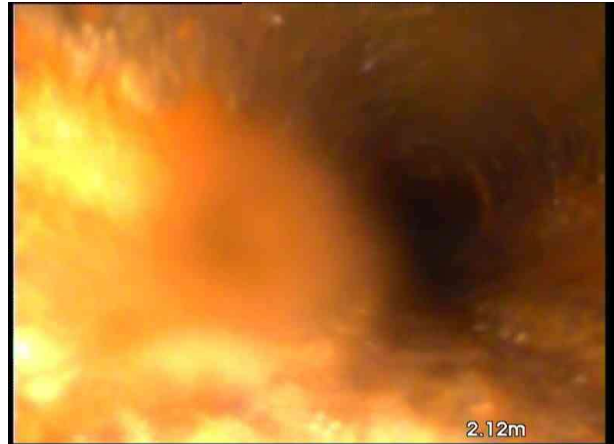
R_EX_3d1fb0c9-901e-4baa-a7d7-1f2d8dffaa0b_20210831_113742_561.jpg, 00:01:45, 2.12 m
Water level, 0% of the vertical dimension

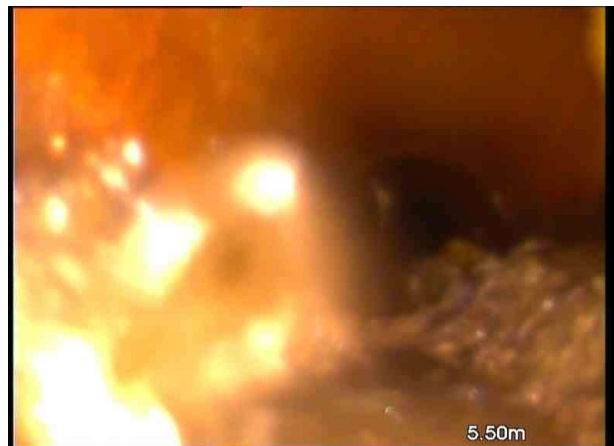
5.50	RM	Roots, mass, 45% cross-sectional area loss	00:02:42	R_EX_d1903cee-7226-4cd5-aa	5
		6.79	WL	Water level, 0% of the vertical dimension	00:03:02	R_EX_8cf3df74-3e40-4ce9-9a

R_EX_d1903cee-7226-4cd5-aa22-3e67f3164058_20210831_113935_789.jpg, 00:02:42, 5.50 m
Roots, mass, 45% cross-sectional area loss

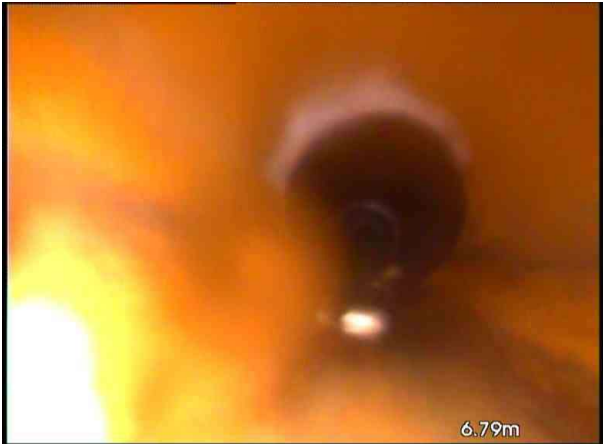
R_EX_8cf3df74-3e40-4ce9-9a4b-f97c9653ee7b_20210831_14018_637.jpg, 00:03:02, 6.79 m
Water level, 0% of the vertical dimension

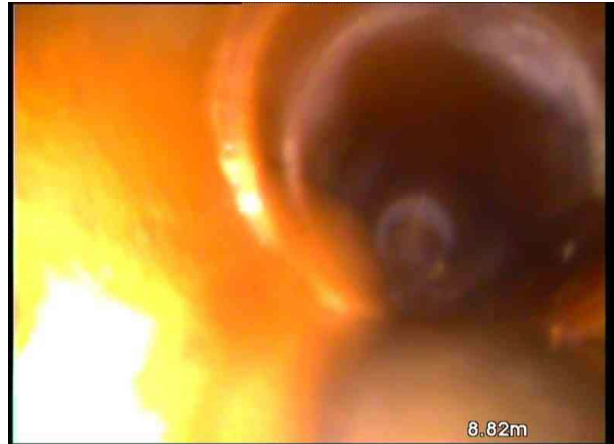
8.82	CCJ	Crack, circumferential at joint from 12 o'clock to 12 o'clock	00:03:31	R_EX_6c2bc7a6-4ca9-4381-b2	2
		9.69	MHF	Finish node type, manhole, reference number: Main run: Back drop	00:03:44	R_EX_d25a7815-0dd3-4ef0-888	
				Main run			
				Depth: m

R_EX_6c2bc7a6-4ca9-4381-b2d8-ce4bed2d4871_20210831_114126_080.jpg, 00:03:31, 8.82 m
Crack, circumferential at joint from 12 o'clock to 12 o'clock
