## **OLD GRANARY, NORTON**

**REPORT OF STRUCTURAL SURVEY  
FOR  
PLANNING PERMISSION**

**ROGER WATKINS**

25 June 2020

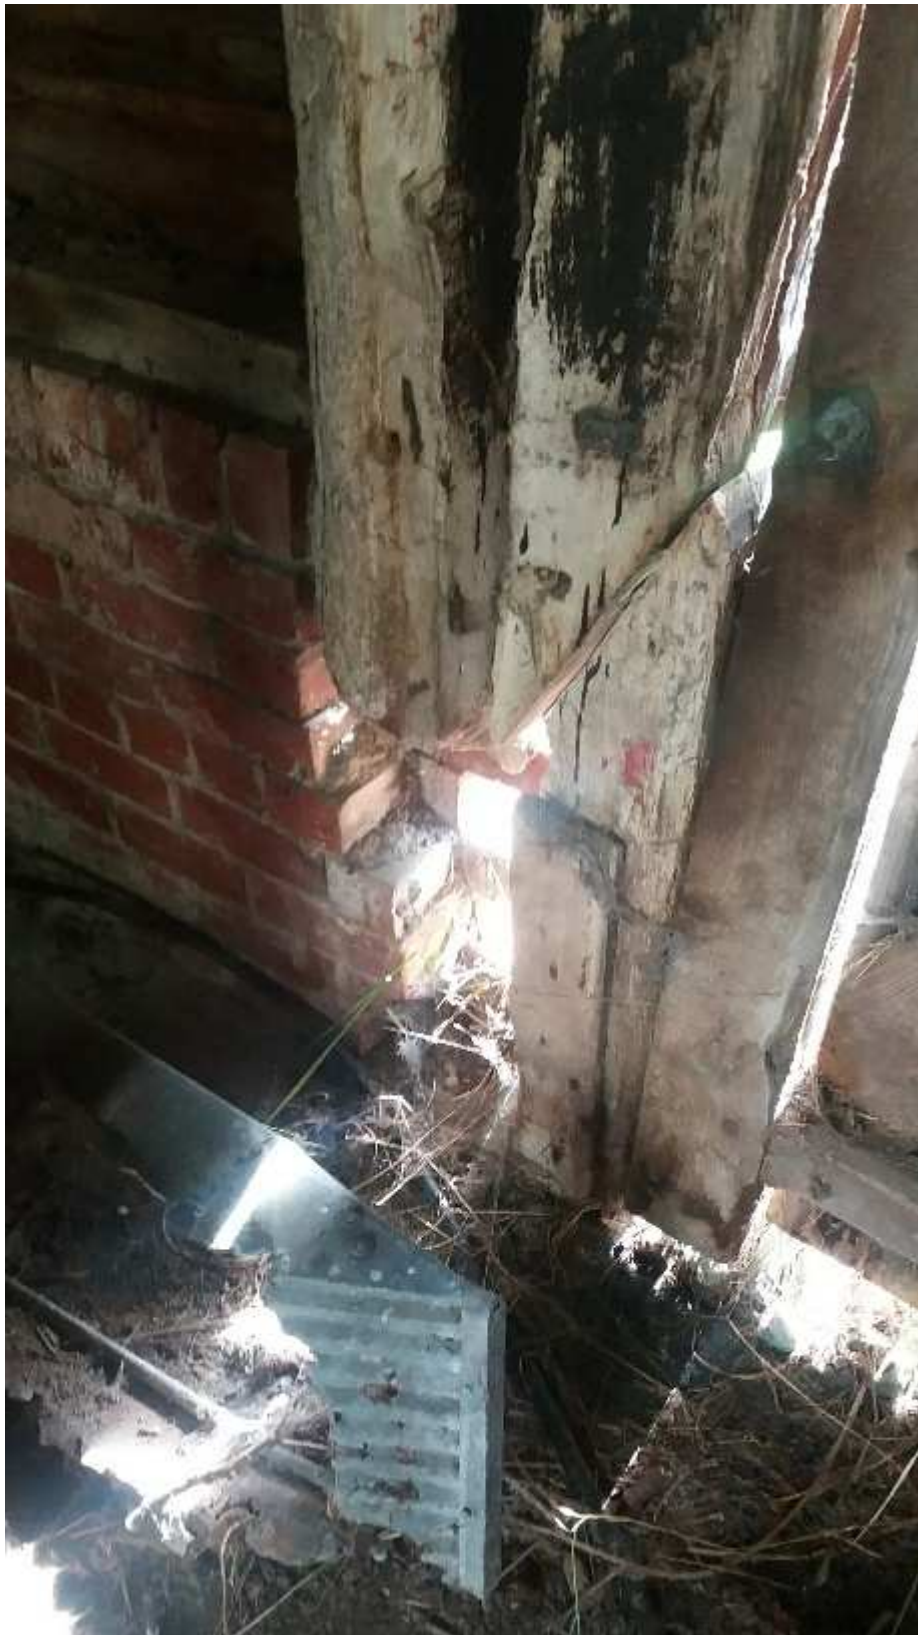
The walls are timber framed with 200 mm square posts supporting the trusses and 200x100 mm posts in between with timber board external cladding. The posts all sit on a stone or brick dwarf walls and thus the bases of all of the posts are kept relatively dry. There are a few posts where there is no support at the base and this is supposed to be due to the masonry support being lost. It is a simple case for this to be built up again.

**TYPICAL PHOTO WHERE SUPPORT LOST AT POST BASE**

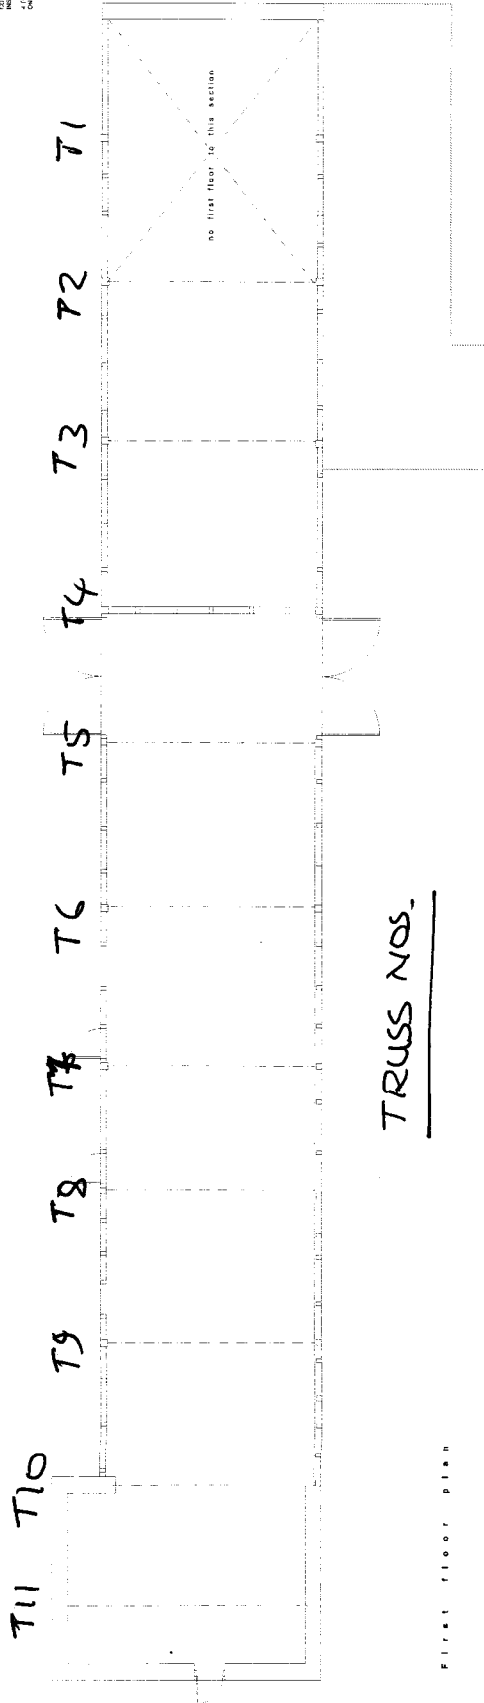
FIRST FLOOR PLAN

The timber roof is standard and consists of common rafters which are supported mid span by two timber purlins per slope and the purlins are supported in turn by timber trusses of which there are two types. A strutted A frame and a Queen post type frame. I have attached to this report the position of the two types of trusses and two trusses where members are missing. The trusses are supported by 200 mm square posts at each end.

The timbers all appear to be in a good condition from the first-floor level inspection, truss T11 could not be inspected closely. Some of the purlins between these two trusses appear to be undersize and will need to be strengthened by the addition of timbers.

TRUSS NOS.

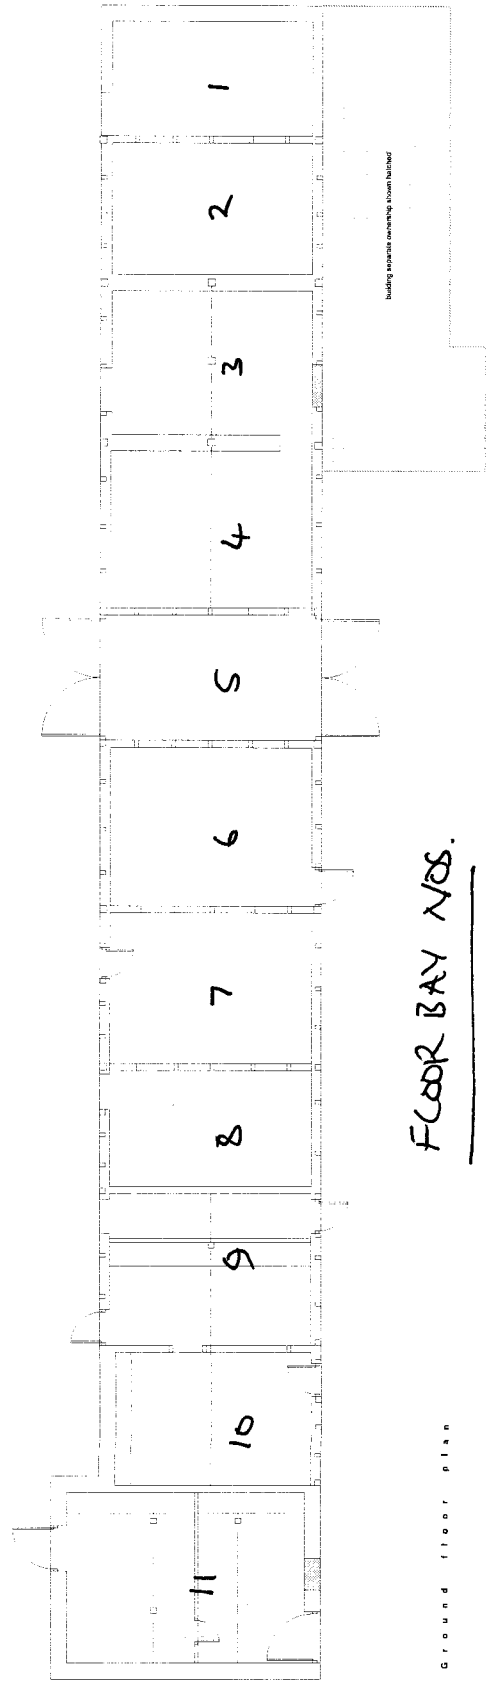
GROUND FLOOR PLAN

- 6.1 The ground floor will need to be replaced with a concrete floor to meet current thermal and moisture requirements.
- 6.2 The existing first floor has a combination of different support and spans. The attached marked up survey plan shows the floor bays marked nos 1 to 11. Bays 1,2 and 5 have no floor and new timbers will need to be installed. Bays 3 and 4 have suitable timber joists and support beams as long as the steel beam in bay 4 has a mid span lateral restraint (this can be achieved by a positive connection from two floor joists to the top flange at mid span). In bays 6 to 9, 150x112 floor joists span across the bays but in bays 6,7 and 9 the span is too great for the joists and they will need to be strengthened by additional joists or replaced. The joists and supporting beams in bays 10 and 11 are adequate.

FLOOR BAY NOS.

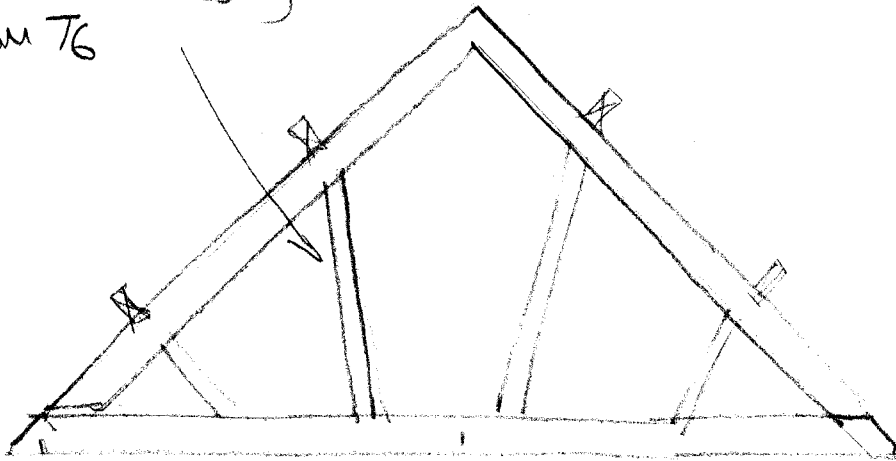
TRUSSES T1,3,4,5,6,9

this member missing  
from T6

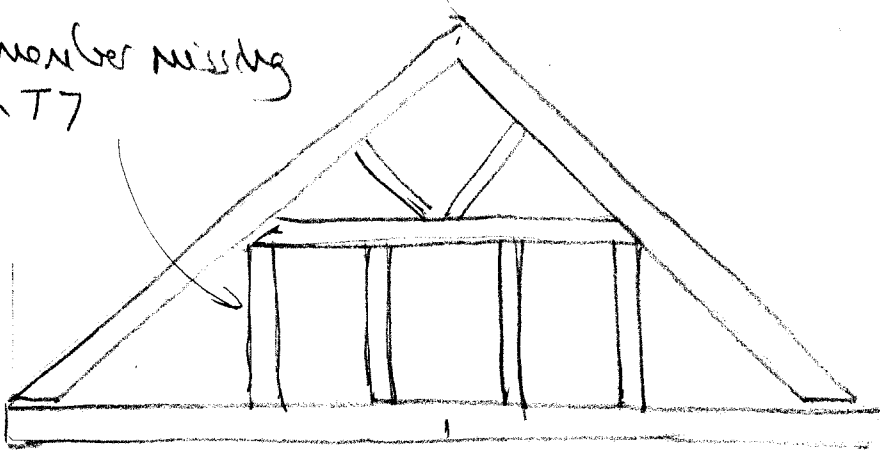
TRUSSES T2,7,8,10

this member missing  
from T7
