Bridge Name	Fignon Cycle Bridge
Bridge Number	6222
Location	Marston Cycle Path, University Parks, Oxford Grid reference: SP 52139 07090 W3W: ///rich.nerve.cards
Inspection date	22/06/2021
Inspection type	General inspection with special inspection of concrete deck
Inspected by	Ben Dodds
Bridge type	Foot/cycle bridge
Structure description	Single span, post tensioned concrete portal frame/arch. Bespoke aluminium parapets. Reinforced concrete deck. Resin bound gravel finish
Span(s)	13.7m
Overall width	2.68m
Width between parapets	2.46m
Inspectors Comments	<p>Bridge is generally in good condition, but with significant defects to load carrying elements.</p> <p>Main beams appear to be in sound condition but have widespread surface algae growth.</p> <p>The reinforced concrete decking appears to be a Hy-Rib deck spanning between the main beams. There is wide delamination of the soffit which was hollow sounding when tapped with a hammer. A large area of the soffit concrete cover was missing and additional areas spalled off following light tapping with a hammer. The Hy-Rib reinforcement is exposed and is corroded to its full exposed extent. Corrosion appears to be shallow, but it is not possi

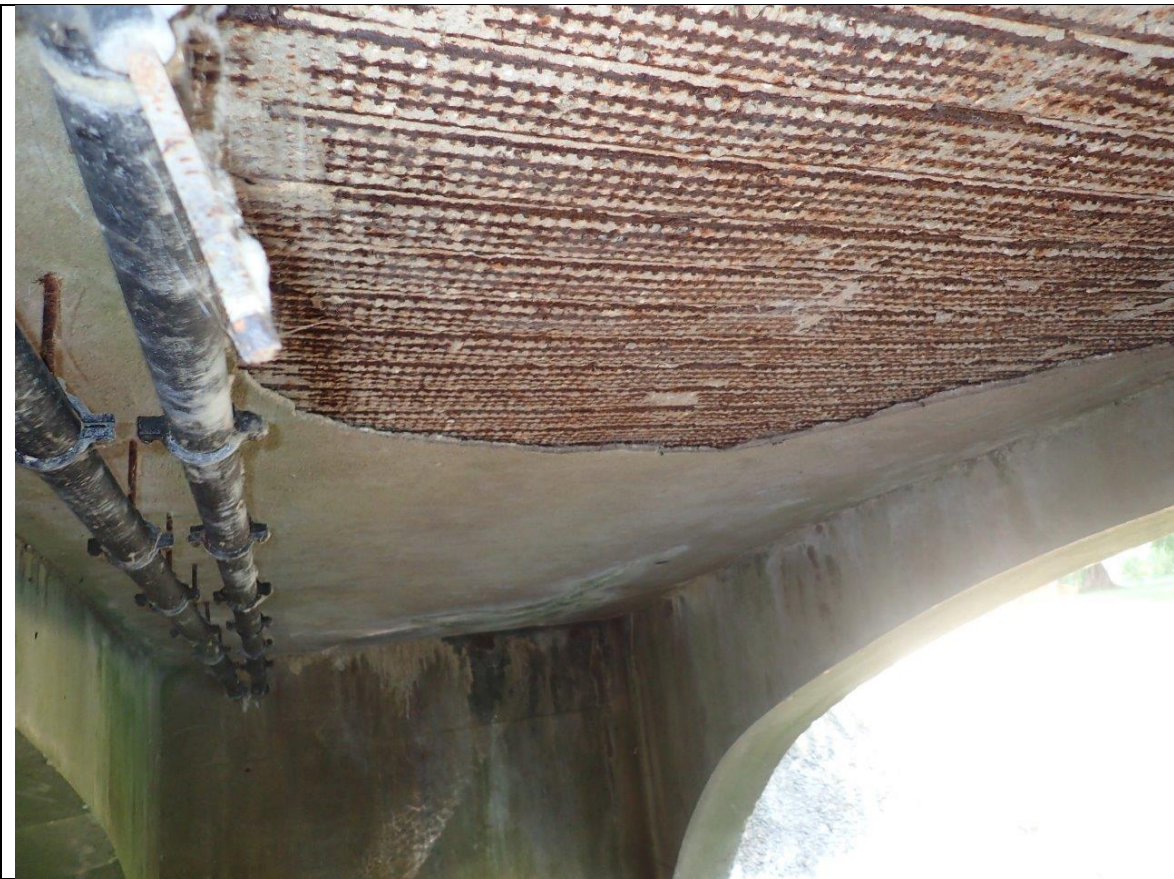
Large spall to reinforced concrete deck soffit

Inspectors recommendations	<p>The existing deck should be assessed for structural capacity, and consideration given to replacement. The river is open to public and delaminated concrete is posing a risk.</p> <p>The parapet should be risk assessed and consideration given to replacement.</p> <p>Consider cleaning concrete elements.</p>

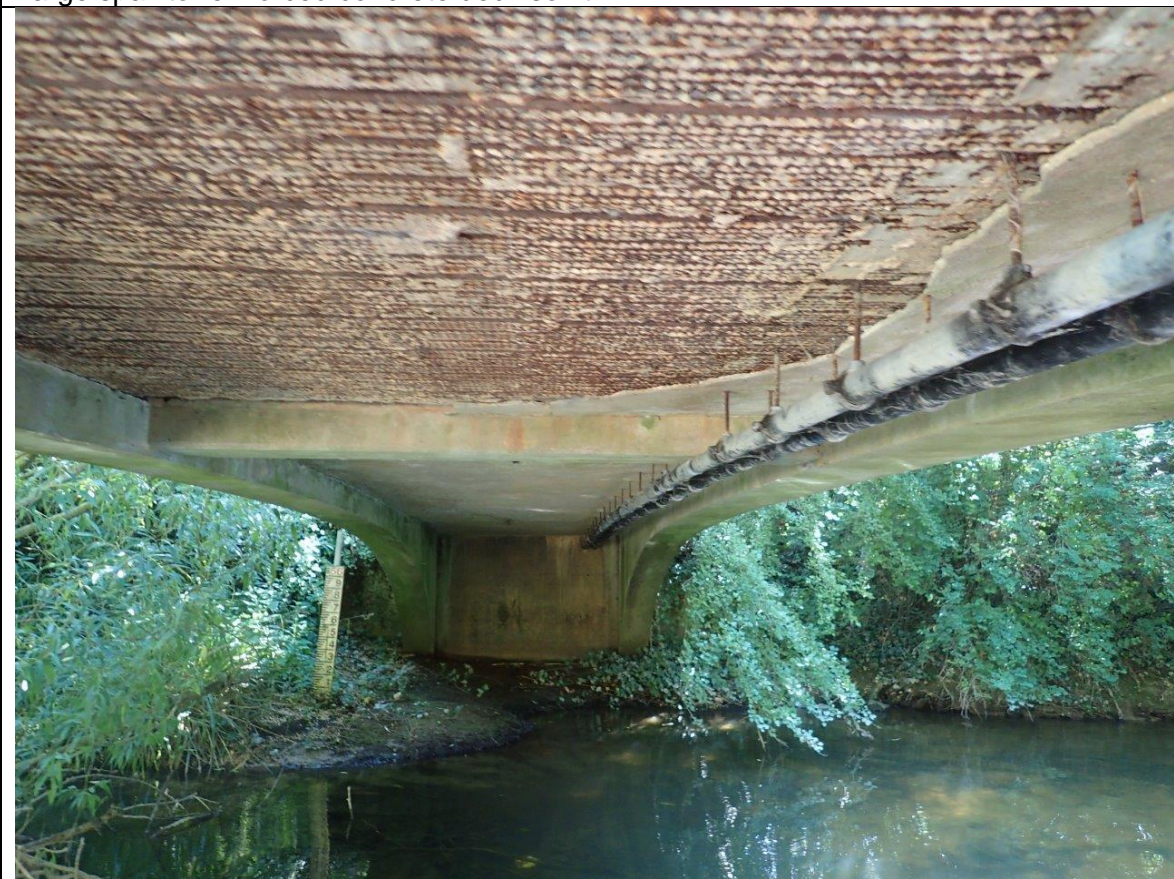
Large spall to reinforced concrete deck soffit

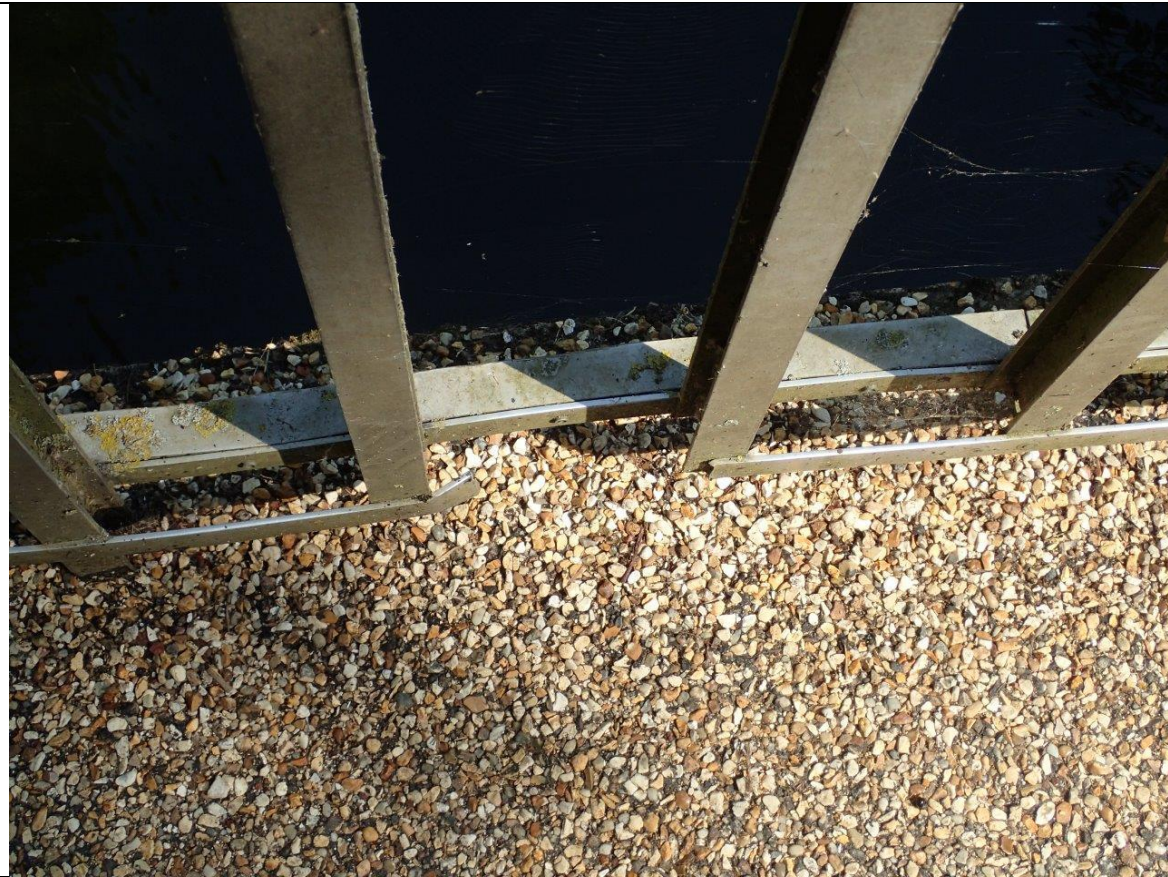
Localised parapet damage and resin bound gravel surfacing
