PRIORY FARM, PRIORY GREEN, SUFFOLK
PARISHES OF EDWARDSTONE AND LITTLE WALDINGFIELD
HISTORIC BUILDING APPRAISAL

LEE PROSSER

JULY 2020

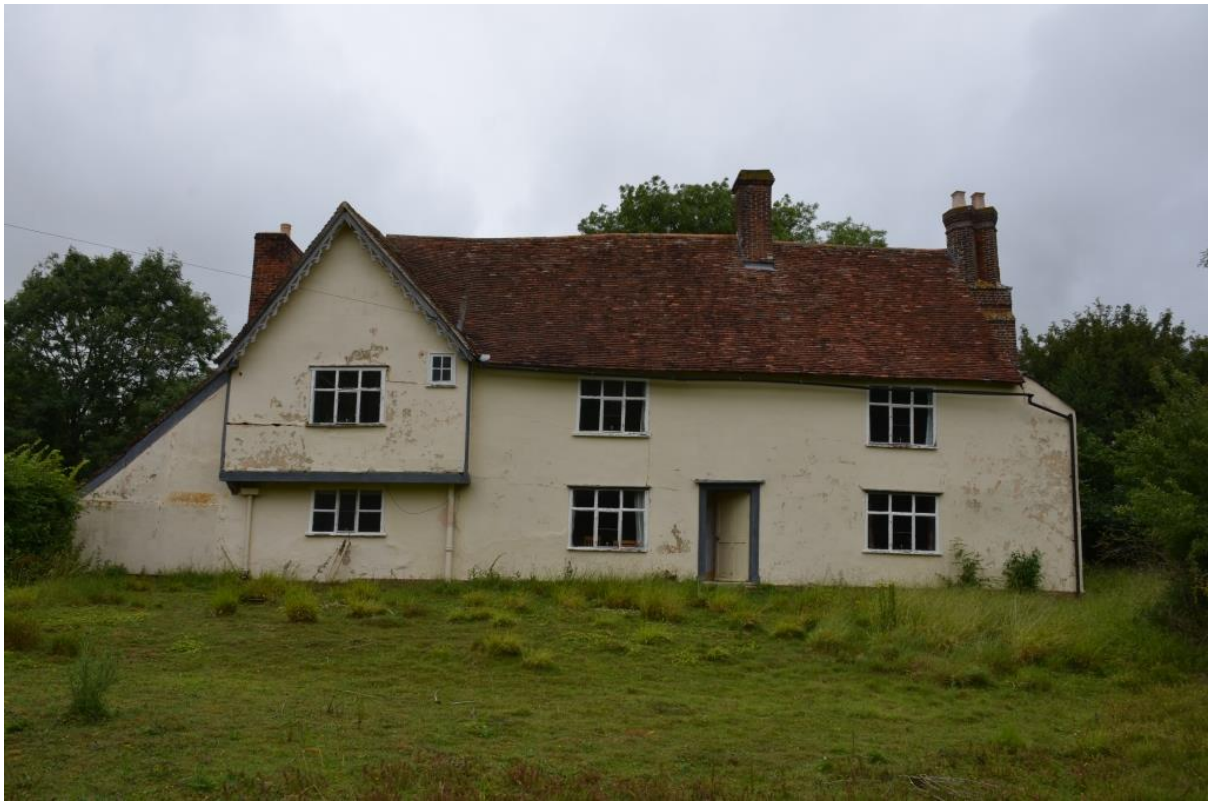
Figure 2: View of the south elevation: East is to the right. Small outshuts have been pushed out on either side; that to the west with a steep cat-slide roof, while a smaller addition to the east created internal closets on ground and first floor.

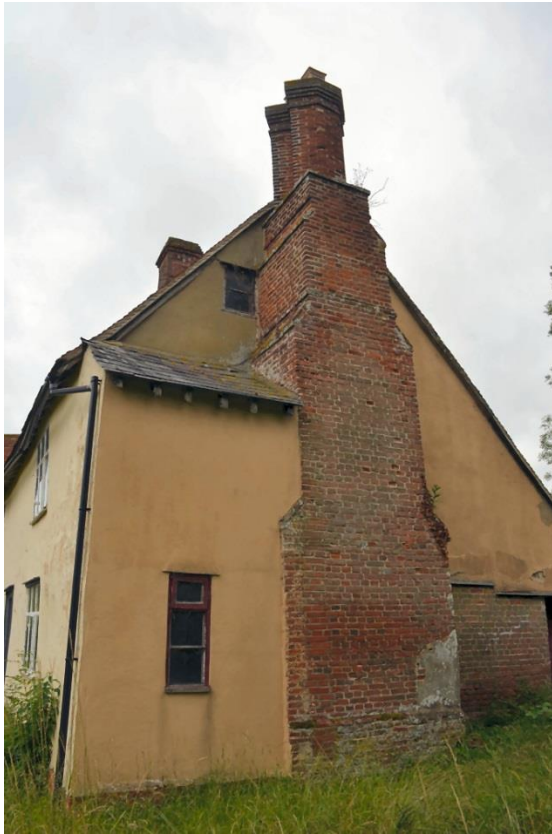
Figure 3: East end of the house showing the shouldered stack and closet outshut.

The east gable end is dominated by a large stack, square on plan, which is constructed of small, thin bricks of homogenous orange colour, laid in English bond and typical of 16th century fabric (Fig 3). Some repointing and careful replacement with matching bricks has occurred, but the stack has been little altered otherwise. It has a low off-set to the east and diminishes with three shoulders to an upper course before terminating in two clasped stacks of hexagonal profile. It retains square yellow terracotta pots of 19th century date. The upper gable is rendered and contains a tiny single-light window providing some light to the attic. To the south of the stack, the small pushed-out pent-roofed extension is slated, and has rough rafter-ends visible. The render appears fairly new. It is lit on the ground floor by a three-light window of 1920s or '30s date. To the north, the main range continues to an outshut with a cat-slide roof. To the north of the stack we see the lower area constructed of 18th to 19th century orange brick laid in English bond, to a height of approximately two metres, stepping down within the later cat-slide extension. The upper area is all rendered – clearly mostly modern. A small boarded door gives access to the outshut, noted below.

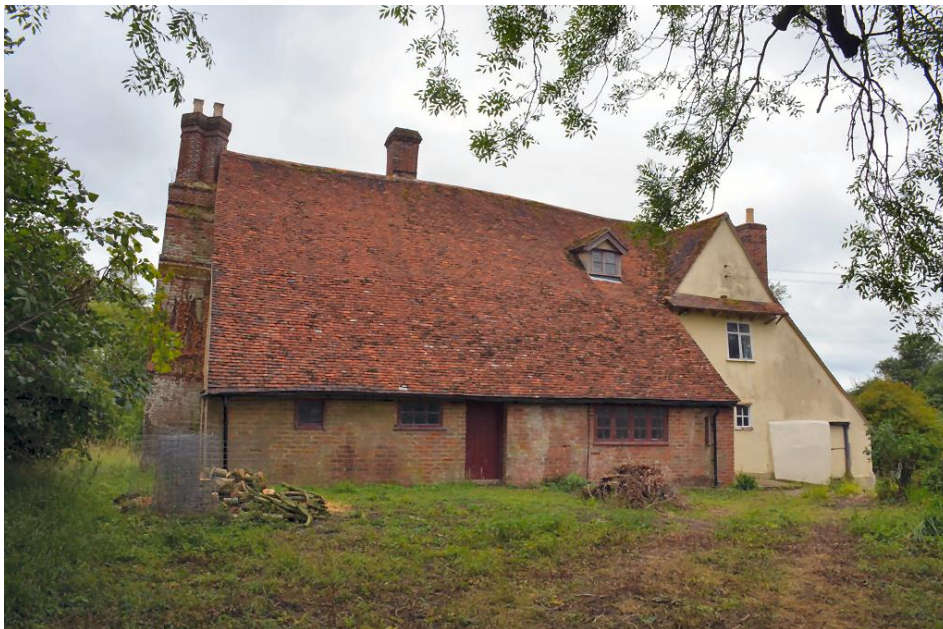
Figure 4: North elevation with cross-wing to the right.

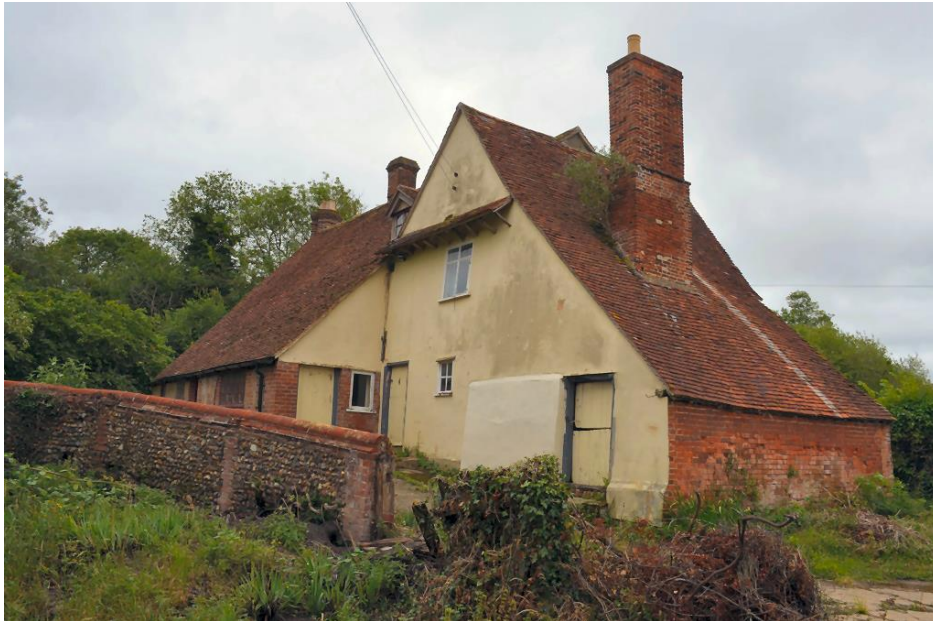
Figure 5: East elevation seen from the north-west, with outshuts to north (left), and west (right).

Originally, the eastern stack was attached to the northern bay of the cross-wing, but was then subsumed within an outshut, producing a cat-slide roof on this side also (Fig 5). The lower outer walling, now in poor condition with some signs of structural failure is of 19th century mass-produced brick, laid in Flemish bond and rises from an off-set of moulded bricks. The stack rises to a flat stage before continuing as a more slender shaft, but conforming in brick type and fabric to its companions. The outshut, latterly used as a coal store is entered from the north by a split door (Fig 6).

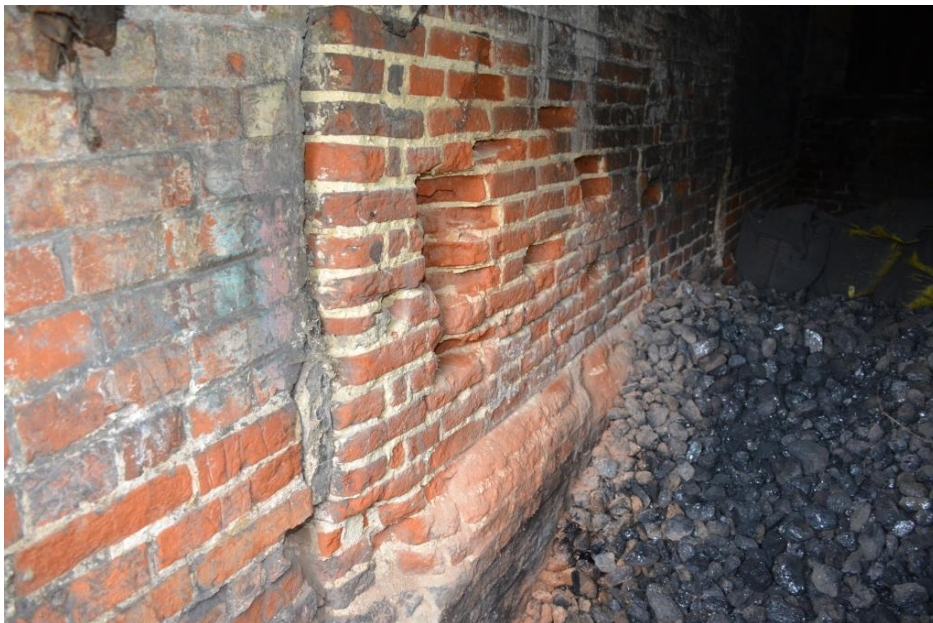
Figure 6: Rear of the west chimney stack within the outshut, latterly used as a coal shed. The chimney has an off-set at the base, as we see on the eastern stack. The left hand brickwork is later in date.

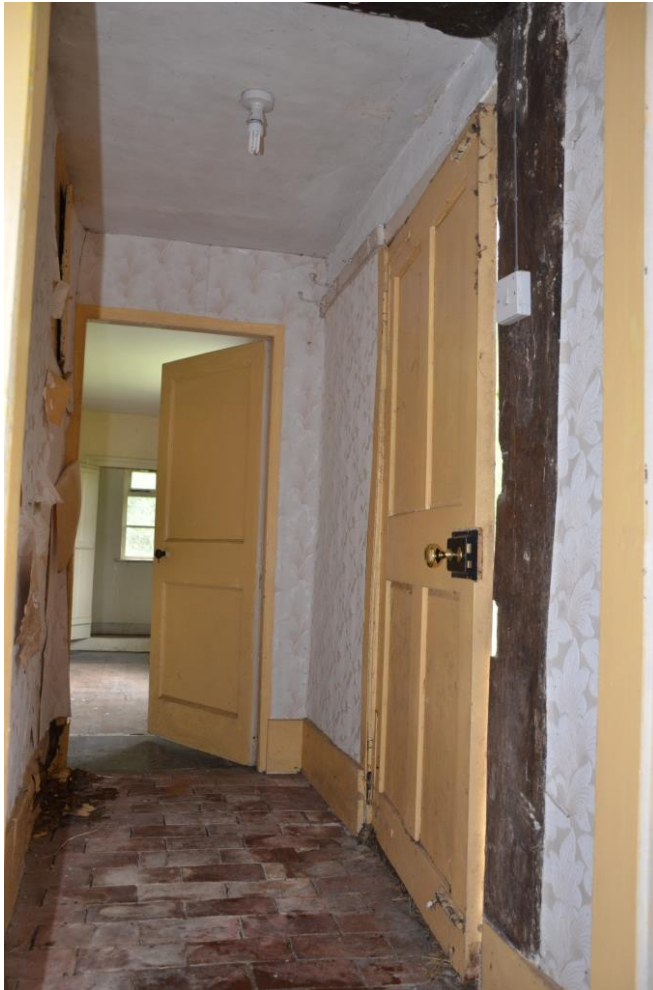
Figure 7: Main entrance lobby with Sitting Room beyond. Visible adjoining the door are post and principal joist.

3.6.2 Visible elements of the timber-frame include a principal post, which serves as the west jamb for the door. This supports a principal binding joist, which extends through the adjoining western room and beyond into the stair hall to terminate at a second post at the base of the stairs. This measures 12 inches in width with wide, two-inch chamfers on either side and wavy chamfer stops (Fig 8). The post is nine inches wide with adze or side-axe marking to the lower area, suggesting it has been hacked back slightly. It retains small slots for the ledges of the earlier door.

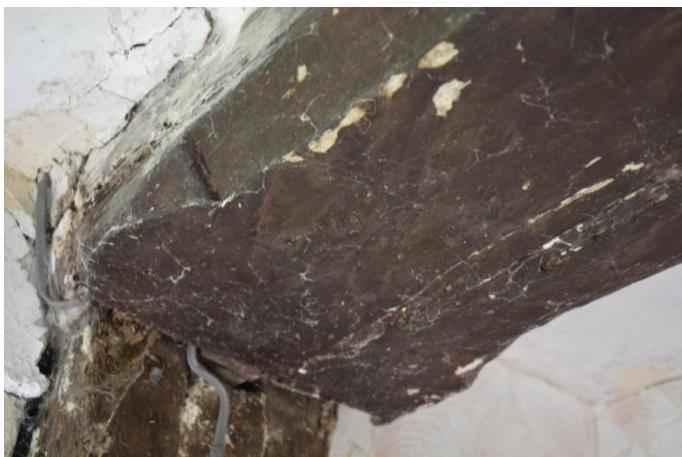
Figure 8: Detail of chamfer stop on door lobby joist.

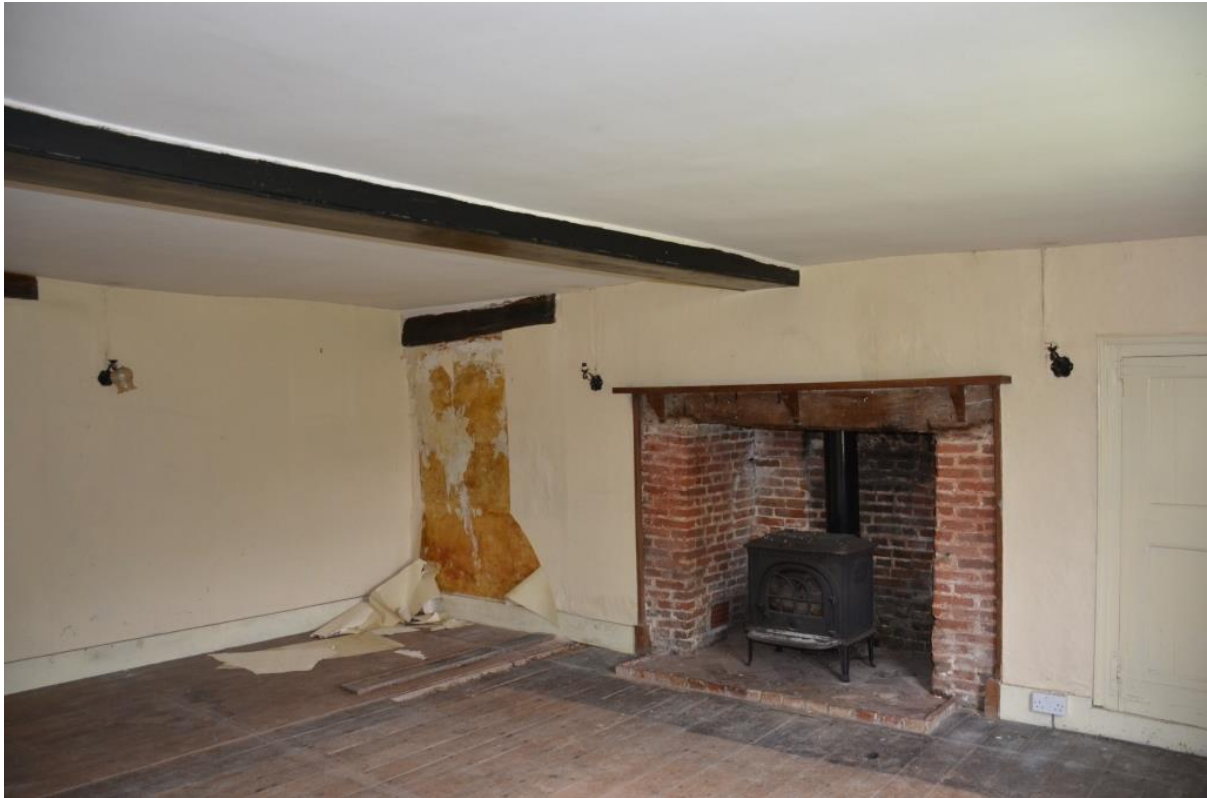
Figure 9: Sitting Room from the south-west, showing fireplace and closet door adjoining to the south. The main joist is boxed in, but fragments of the mid-rail of the timber-frame survive to the east and north.

3.7.5 To the south of the fireplace, a small cupboard or closet occupies the push-out adjoining the chimney stack noted above. This has a little two-panelled door of late 17th century date with a spring latch and one surviving so-called 'Hampton Court' hinge, characterised by its small finials, which reinforce the date. The rear face has three crude ledges. It originally had a large rim lock, now lost. Inside, the closet is fitted with modern shelves and a modern window with typical geometric 1920s or '30s stay-bar. Nothing else of interest is visible.

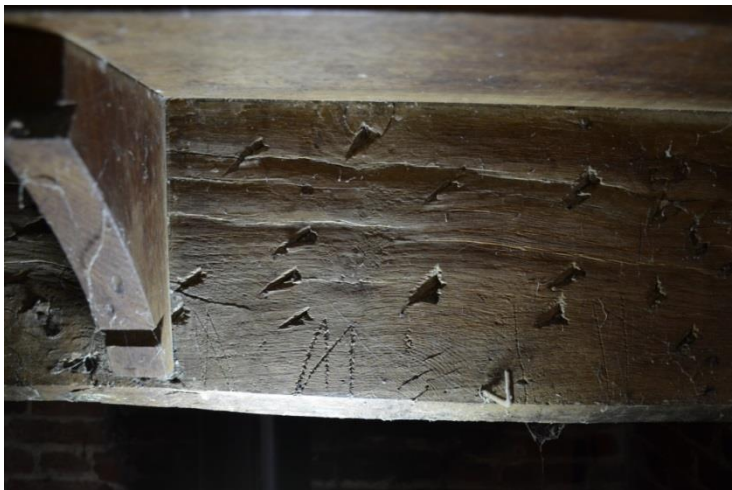
Figure 10: Detail of fireplace lintel showing scribed 17th century apotropaic or protective marks, including Ms. Off image to the left are several taper burns, deliberately applied. The timber is keyed, suggesting that it was formerly plastered over.

3.7.4 The fireplace aperture is of old bricks contemporary with the stack, though the hearth with a small upstand are of probable 19th or 20th century date. The jambs have a residual chamfer, while the back has a low off-set and recessed panel. Prominent remains of ruddled or colour-washed mortar can also be seen. The lintel now has a modern applied oak shelf with brackets, but the timber preserves many ritual protection marks, typically applied in the later 16th or early 17th century (Fig 10). These include taper burns, which it is now suggested are not random but deliberately applied for protection, as well as scribed M marks¹¹. The lintel sits on small timber pads. The likelihood is that both brick jambs and lintel were plastered originally.

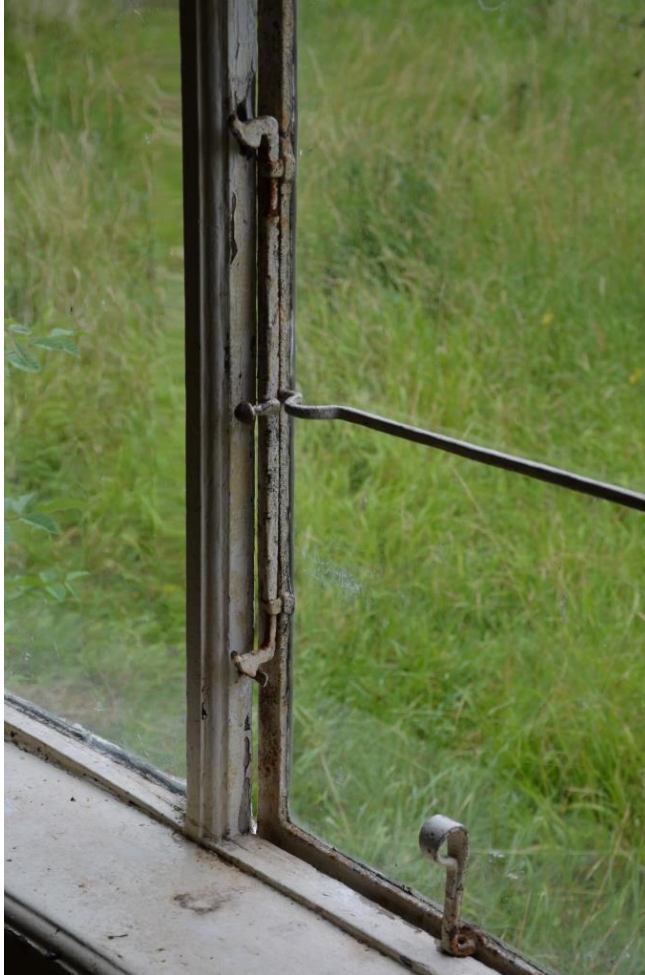
Figure 11: Window detail, showing the heavy glazing bar profile, scrolled tulip-leaf handle, catch and saddle-bar.

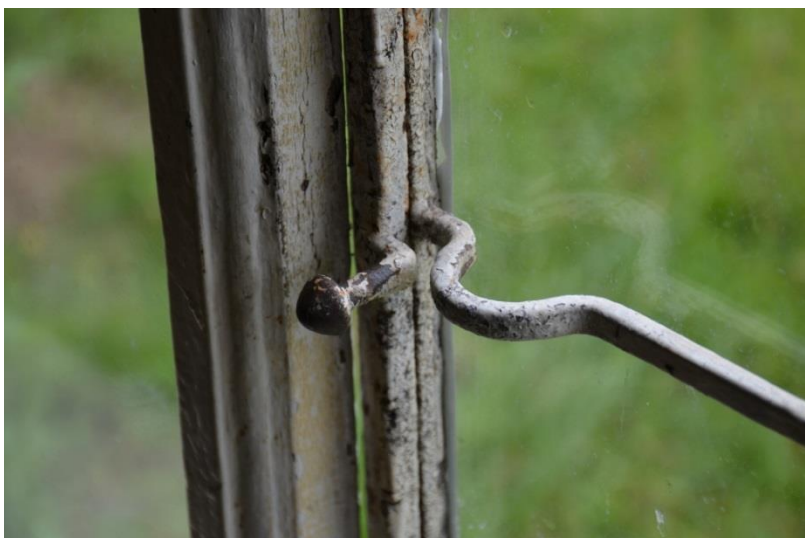
Figure 12: Window details including knob on catch-bar and finger-loop on saddle-bar.

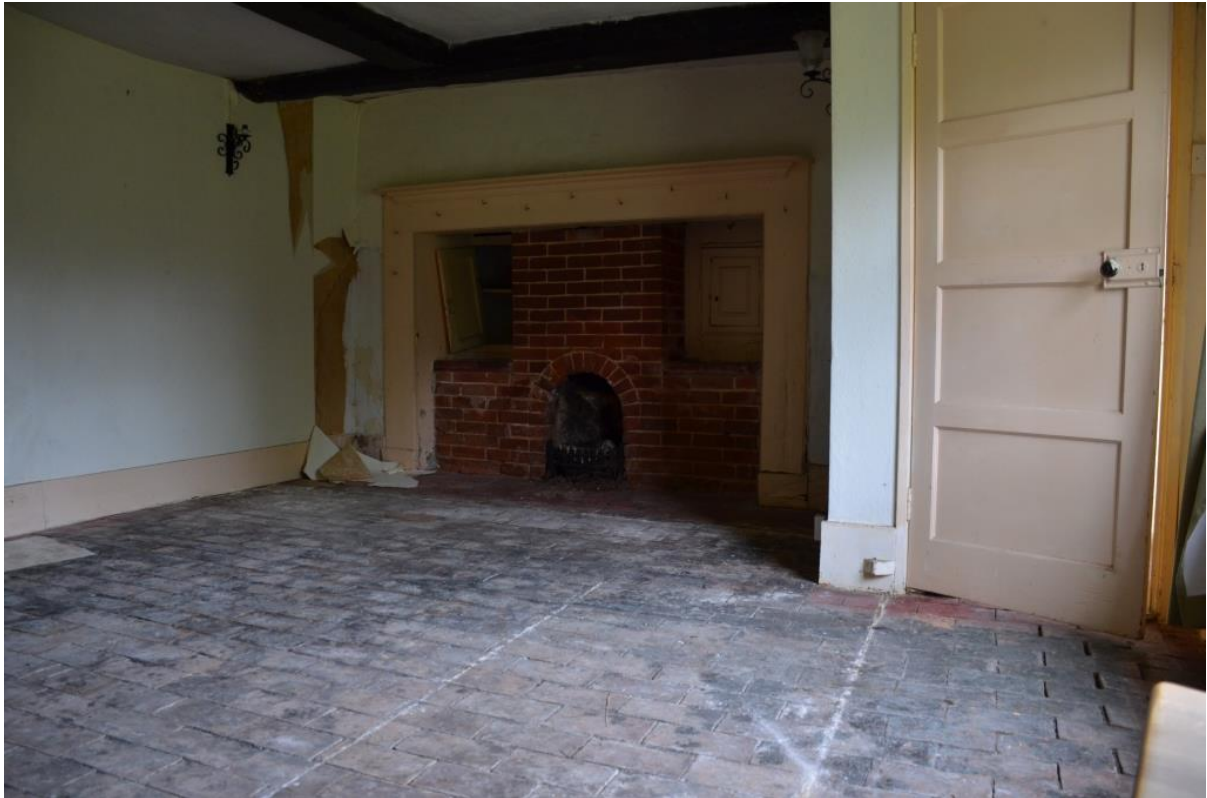
Figure 13: The Dining Room with 18th century fireplace surround, with 1940s door to right.
Figure 14 (below): late 17th or early 18th century door, and below right, **Figure 15**, fragment of early window sill or lintel preserved above existing window.

3.9.4 The principal feature of the room is a large fireplace on the east wall, serving the central stack. This has a thin 18th century board-like surround and probably a later shelf. Within the aperture, much has been filled with 20th century brickwork, creating a smaller arched aperture, but leaving high side-shelves which frame deeply-recessed cupboards. The whole thing appears to be cobbled together, but preserves elements of an earlier inglenook.

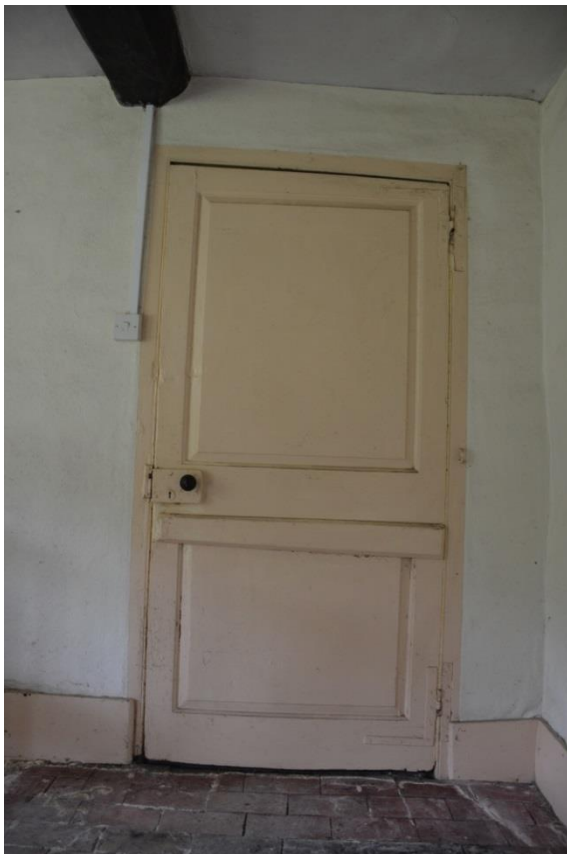
3.9.1 This room, entered to the left from the entrance lobby, continues the utilitarian form of the flooring with brick pavers (Fig 13). It is entered via a four panelled door of 1940s date with modern frame and bakelite knobs. A second door to the rear hall is of typical later 17th to 18th century form, being wide, and having two panels, those to this side being raised and fielded. It retains H-L hinges and bakelite handle and knob. A crude ledge has been nailed over the lower panel as a repair (Fig 14).

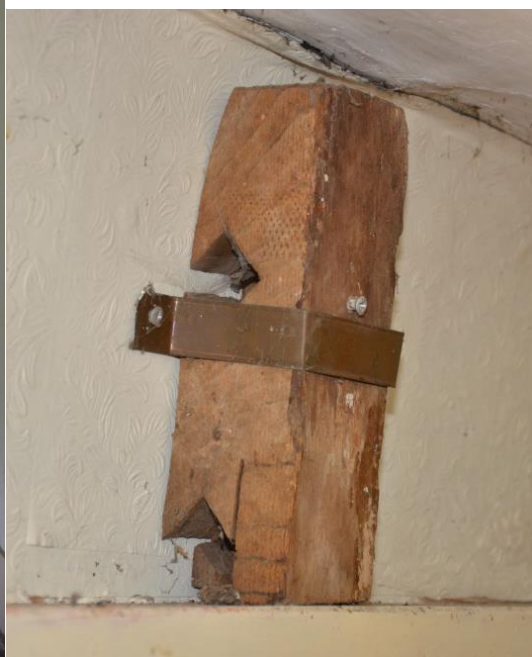
3.9.2 The window is of the standard form and fully intact. Above the window, a small section of window lintel has been bolted to the wall as a relic – presumably a discovery made during repairs. It retains diamond-shaped mortices for the earlier, medieval-style window mullions (Fig 15).

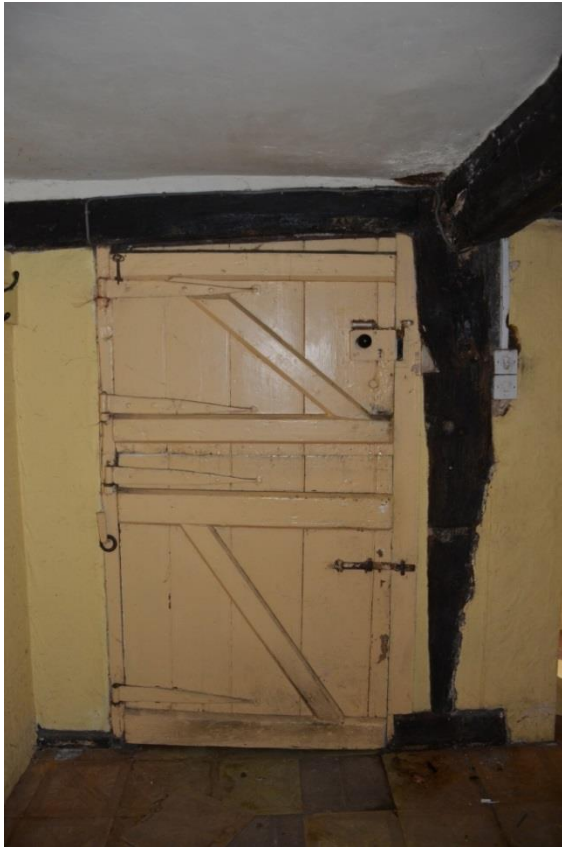
Figure 16: Rear door with ledges and braces. Probably 17th or 18th century in date with contemporary hinges and lower bolt. The door abuts a principal upright of the frame.

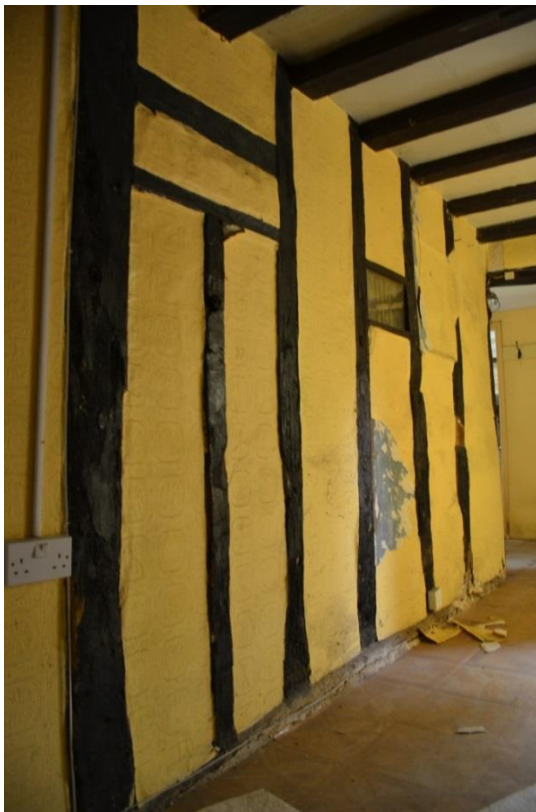
Figure 17: Partition wall between the Stair Hall and Dining Room with blocked doorway to left and small wattle panel exposed behind glass to the right. Note that the studwork of the partition is independent of the ceiling joists.

3.10.4 The internal partition wall to the dining room preserves six visible studs with, at the east end, a section of hard-board or similar modern fabric applied over earlier fabric. The studs are fairly thick, five inches in places and incorporate the remains of a blocked door. Several large peg-holes survive in discrete lines which might suggest the presence of shelves at one time. A small section of the internal wattle is exposed behind glass, presumably left as a point of interest after a modern repair.

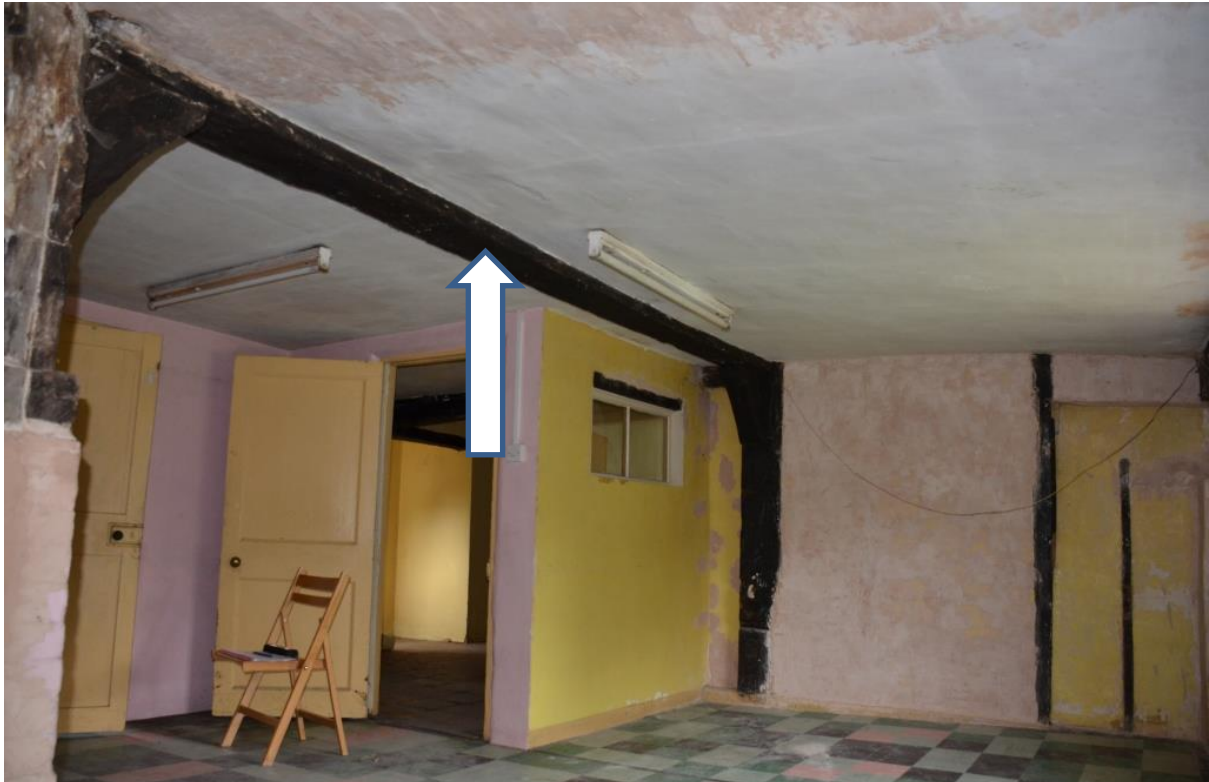
Figure 18: Kitchen viewed from the south-west showing the primary elements of the frame. The arrow denotes the position of the protective mark shown in Figure 21, below.

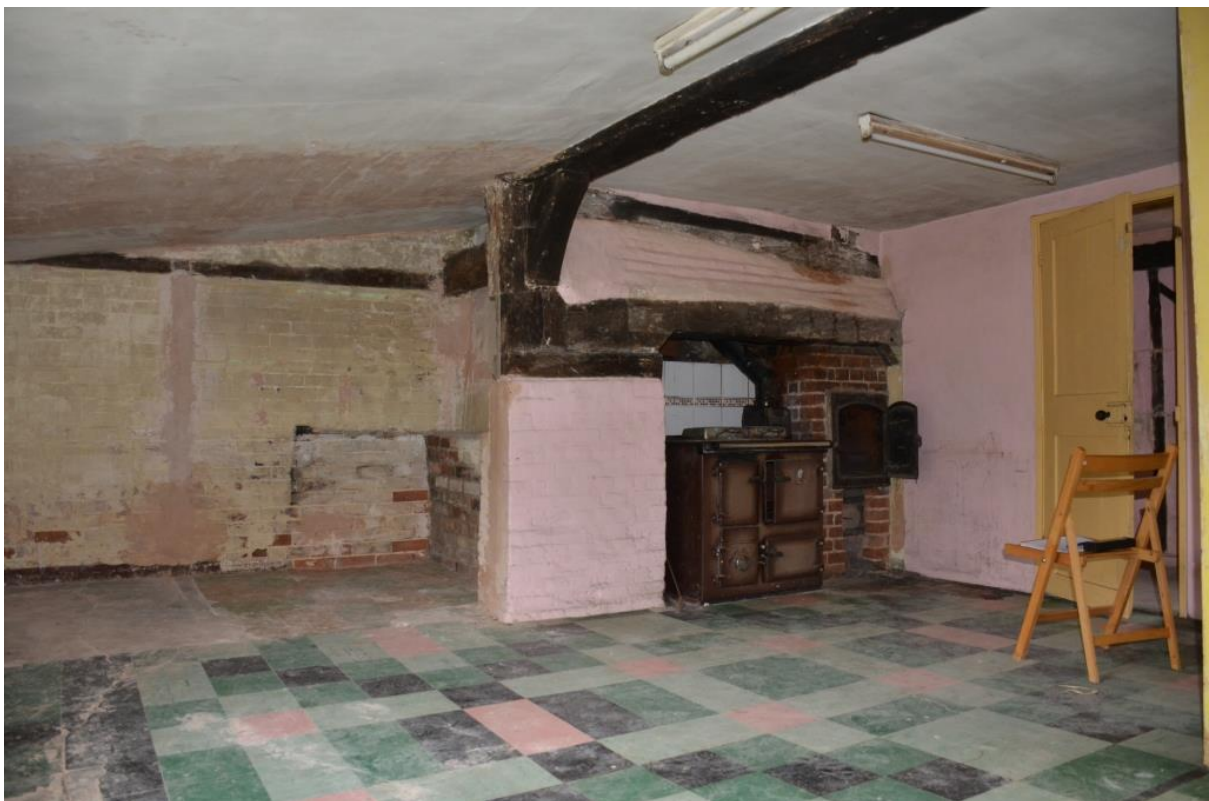
Figure 19: Kitchen from the south-east with the truncated principal, now supported by brickwork.

3.11.5 The fireplace occupies most of the north-western corner. It shows much piecemeal modification. The principal bay-division post has been underpinned as noted above, while a large lintel is accompanied by a second upper lintel, infilled with brick and stepped to form a hood. The lintel preserves taper marks and large peg-holes for an earlier shelf.

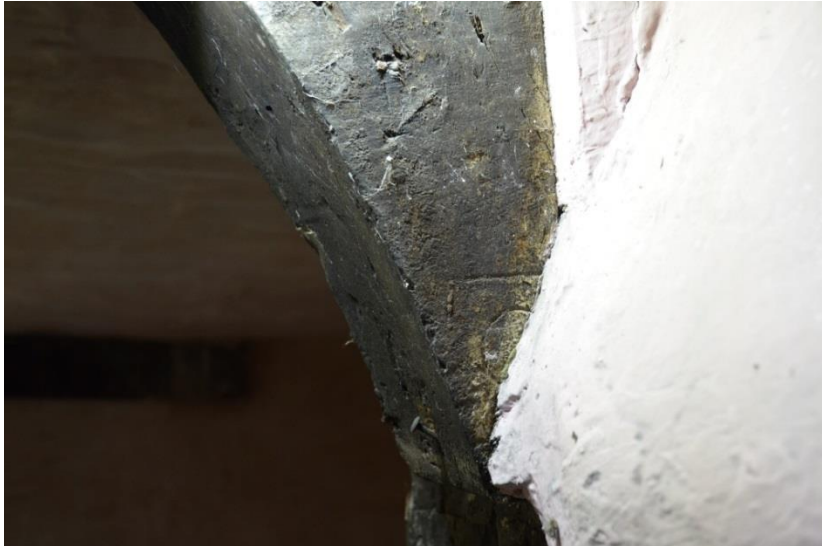
Figure 20: Detail of the western brace, north face adjoining the fireplace, showing the carpenter's assembly mark at bottom.

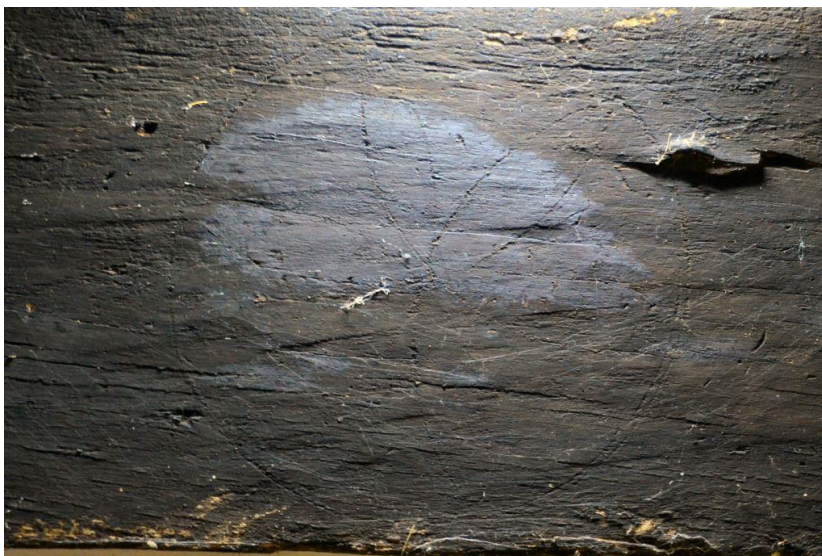
3.11.6 The large posts, including the truncated example noted above and its eastern companion are of most historic interest. They are both large, (7 x 10 inches) and are braced to the principal joist by short, shaped braces of square section and preserve, on their northern faces, carpentry assembly marks. These form circles with long, scribed Roman numerals (Fig 20). The underside of the joist is 10½ inches, with regularly-spaced pegs of 5/8 inch diameter to upper floor joisting – but only on the south side of the joist and not on the north. The pegs are two feet apart. The underside preserves a faintly scribed hexafoil or so-called 'daisy wheel' representing a typical protective mark applied in the early 17th century (Fig 21).

Figure 21: Detail of the protective mark forming a lightly scribed hexafoil within a circle on the soffit of the principal joist.

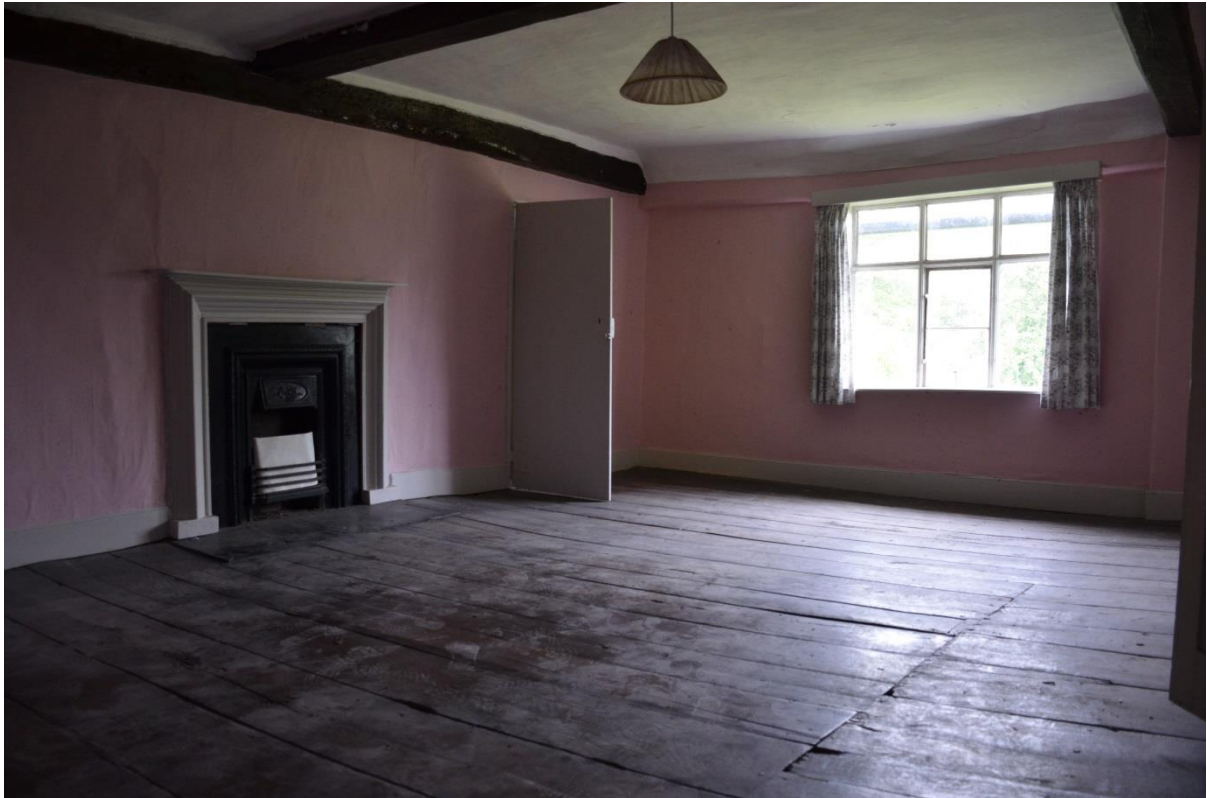
Figure 22: Bedroom 1 from the north-west, showing fireplace and closet door adjoining to the south.

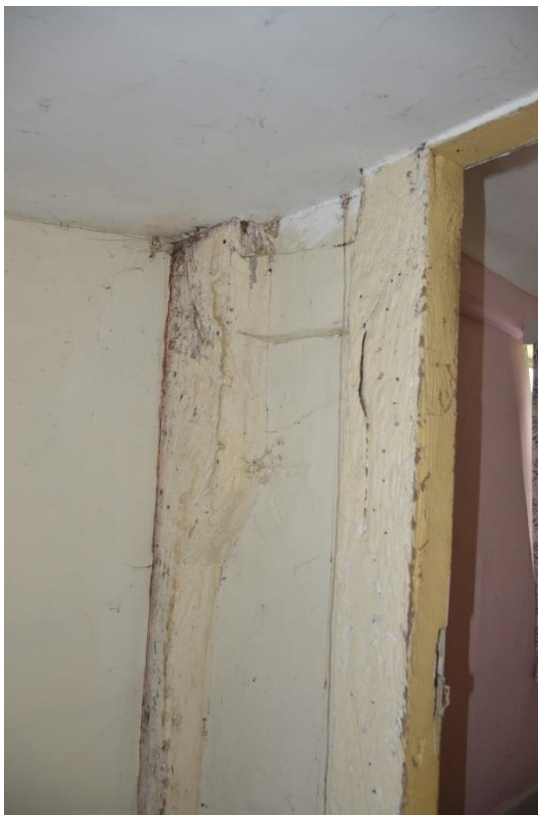
Figure 23: Formerly external frame elements seen from inside the closet. They include the south-eastern corner post and a stud.

3.13.5 The interior of the closet preserves visible elements of the external framing (Fig 23). When the closet was added to the building, the original external cladding or infill was clearly removed, together with a single stud to create the doorway. The corner post is splay-cut and two studs survive, with the door replacing a third, noted by the presence of a peg-hole. This demonstrates the form of the original studwork, with 16 inches between each stud, and these of 5 to 5½ inches in width. Slots and notches survive for original wattle and daub infill. Further pegs for studs are expressed on the eastern wall-plate, including to the north of the fireplace, where two are visible. This part of the beam also houses a continuous slot in the soffit for a shutter groove, which must indicate the presence of a window in the central part, latterly superseded by the fireplace.

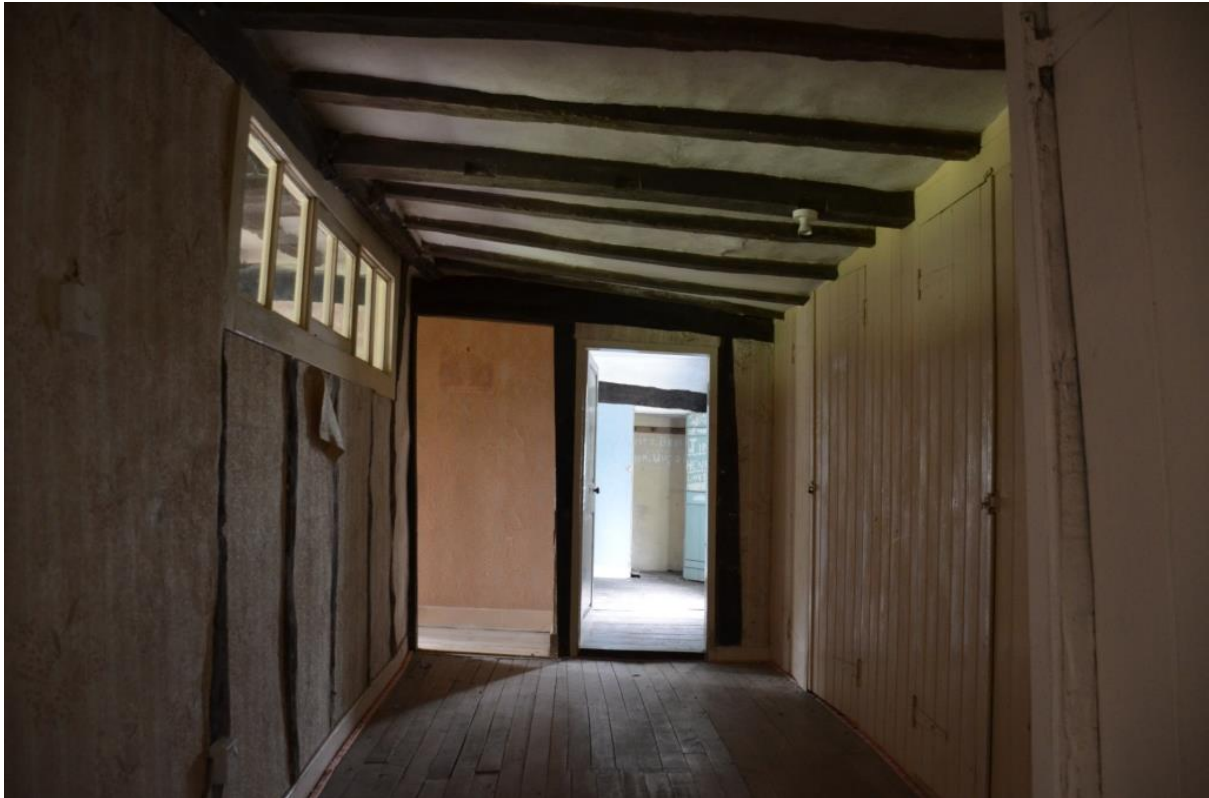
Figure 24: View of the upper landing from the east with cupboards to the right. The door jams into Bedroom 3 are medieval studs from the cross-wing frame.

3.14.1 The upper landing is necessarily wide to accommodate the enclosed stair to the attic floor (Fig 24). The elm floor seen in the east chamber continues for a short distance in the eastern area of the landing before being replaced by 20th century narrow oak boards elsewhere. They do not, however extend into a series of modern double-doored storage cupboards against the north wall, where a few wide boards survive. Opposite the stair head, the shouldered chimney is exposed. On the ceiling we see the joists from the north wall, where they rest on the wall-plate, extending to the partition wall to Bedroom 2. These are fairly thin and waney, of around 3½ inches in width. A single middle joist is more substantial at 5 inches and has notches for a former studded partition, though it may not relate to this position. At the end of the corridor we see the wall-plate of the cross-wing, together with two early studs framing the doorway into Bedroom 3, one of which retains a filled notch for a large tension brace as a companion to the example preserved in Bedroom 2.

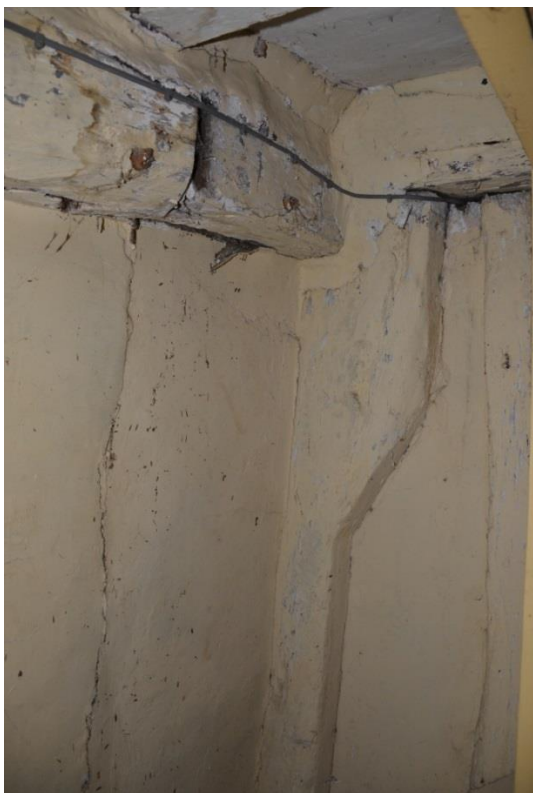
Figure 25: Wall-plate with scarf joint, and inserted, secondary principal post within the landing cupboard.

3.14.2 Within the cupboards, the wall plate of the building is visible and preserves a series of holes – some conventional peg-holes and so structural (at 20 inches apart), and others clearly snapped-off coat pegs. To the east, part of a post with a splay-cut jowl carries the ceiling joist but is secondary, and springs off the mid-rail on the floor below (Fig 25). Nearby, a scarf joint in the primary frame is of simple bladed form.

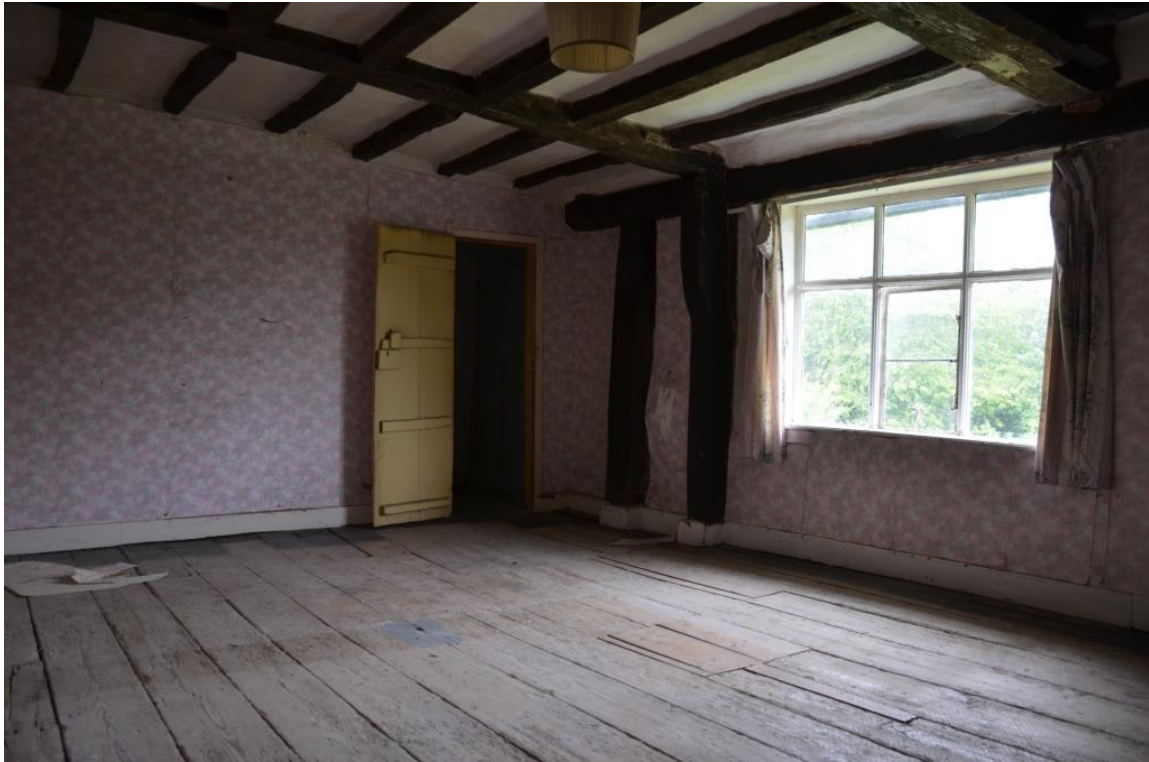
Figure 26: Bedroom 2 viewed from the north-west, showing the two principals adjoining one another. The left hand post is original, while its companion is inserted.

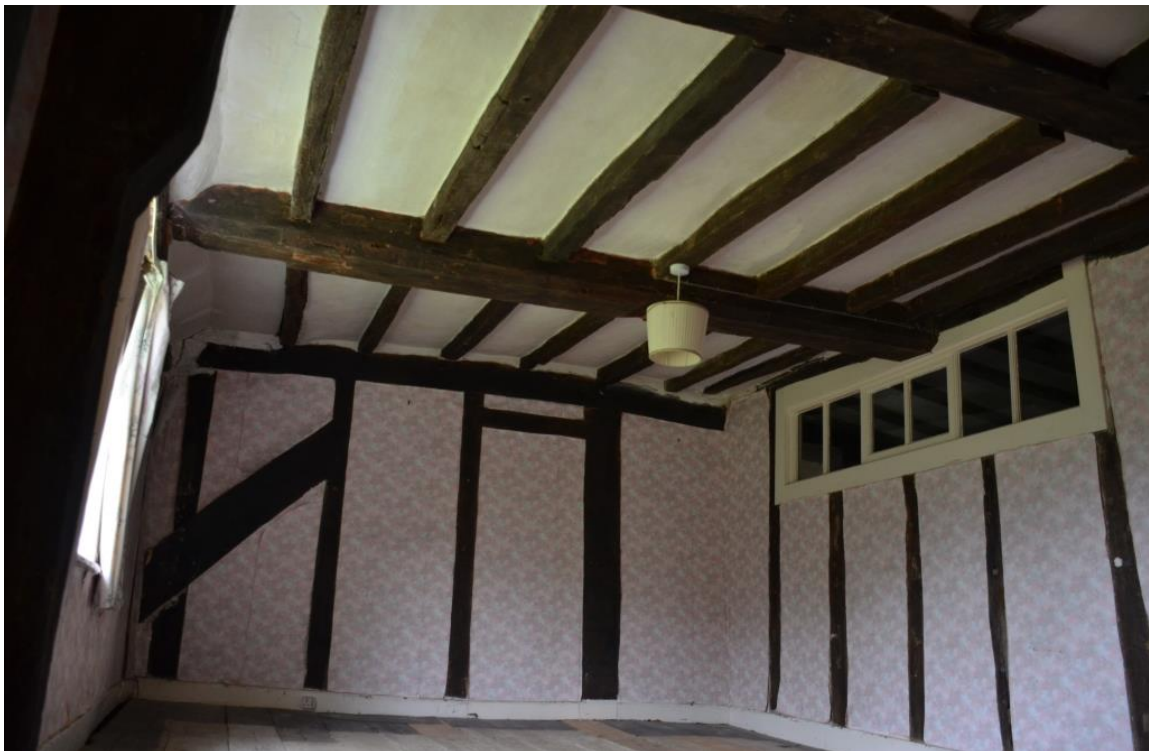
Figure 27: Bedroom 2 viewed from the east. The end wall is structurally part of the cross-wing, and preserves a partially truncated sweeping brace and blocked door. The ceiling joists change direction to the north, suggesting that the partition wall is contemporary.

3.15.8 The west wall has no weathering on the timber, so has always been enclosed. The widest stud forms the bay-division post, noted also below and is 10 inches wide, while the brace is 10½ inches wide. It is now truncated, but the pegs survive where it was once jointed to the wall-plate. A doorway was latterly inserted between studs, and subsequently blocked.

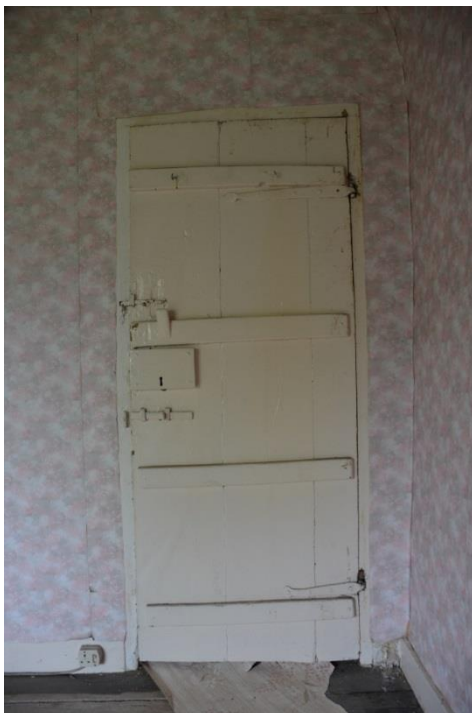
3.15.1 The western chamber is partitioned from the landing by a stud wall, now pierced with a modern internal window, and is entered via an old boarded door with latch and bolt (Fig 28). This is very thin and crudely finished but preserves a typical early 17th century pull (Fig 29). The room is floored in old, wide pine boards, some of which are 10 inches in width, with some repair near the cupboard in the south-east corner. This is effectively the lobby cupboard over the lower entrance.

Figure 28: Door into the room, with strap-hinges, latch, bolt and rim-lock.

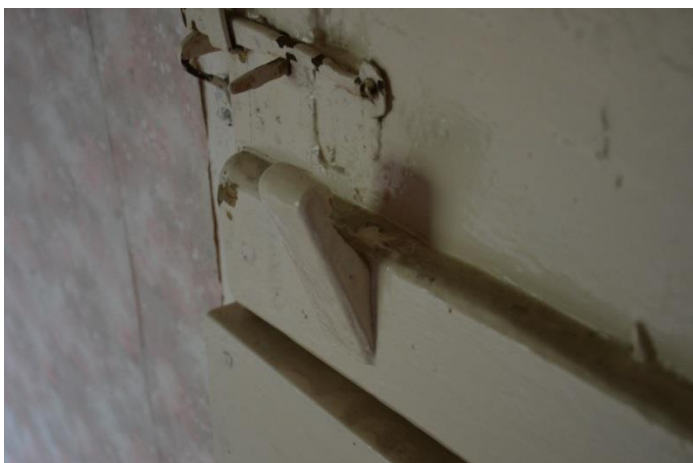
Figure 29: Detail of the pull, of late 16th or 17th century type, to rear of door.

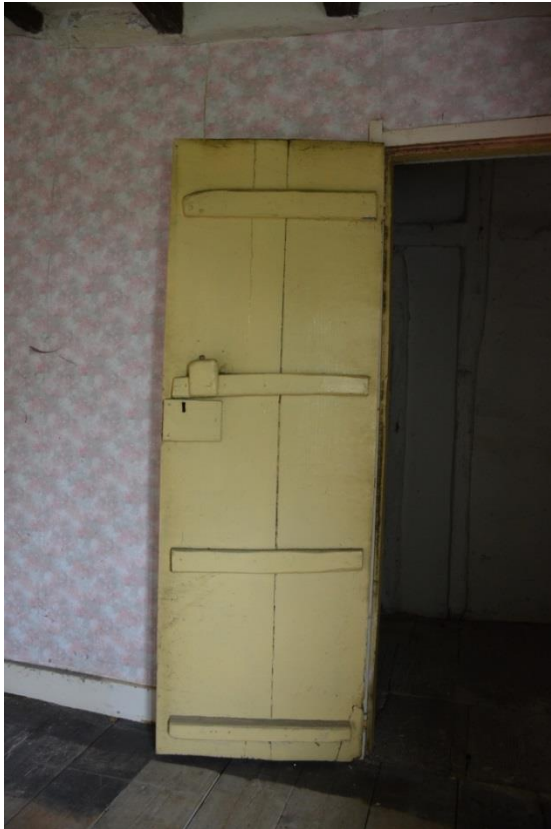
Figure 30: Door to lobby over entrance. This is of supreme vernacular type and simple construction. Late 16th or 17th century.

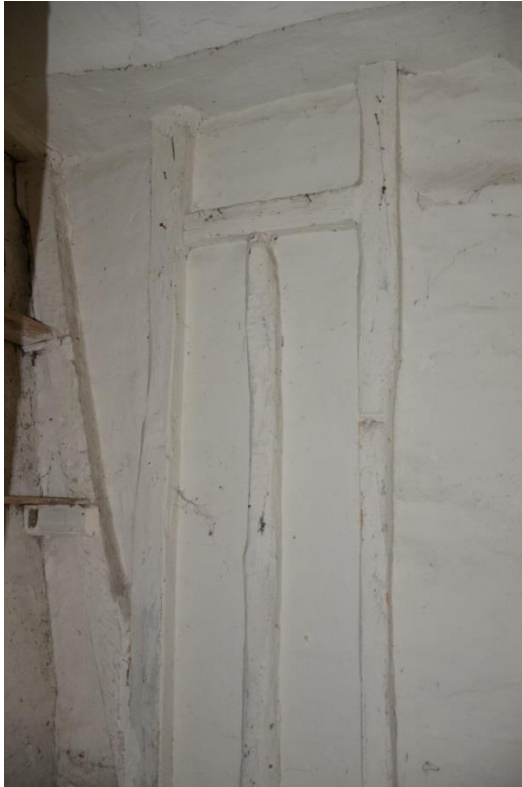
3.15.10 Within the closet adjoining the stack, we see a possible small blocked window, and a blocked door from Bedroom 1(Fig 31).

Figure 31: Detail of external wall within the lobby, with possible small blocked window at top.
