PRIORY FARM, PRIORY GREEN, SUFFOLK
PARISHES OF EDWARDSTONE AND LITTLE WALDINGFIELD
HISTORIC BUILDING APPRAISAL

LEE PROSSER

JULY 2020

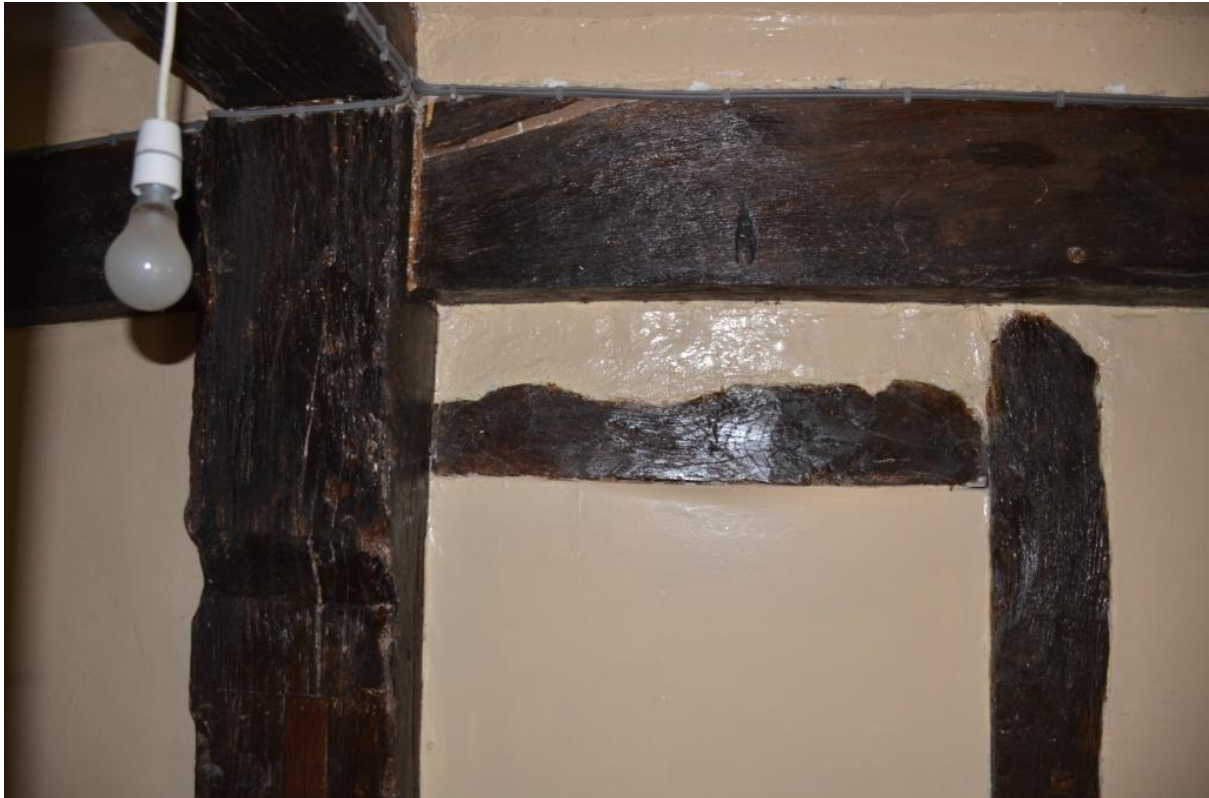
Figure 32: Rear of the 17th century inserted/blocked doorway visible from Bedroom 2, seen here from the rear, in the bathroom corridor. Note the taper burn on the wall-plate above.

3.16.2 Much timber-framing is visible in the corridor, including the bay-division post, which is splay-cut, and preserves an empty mortices for a brace, which survives in the opposing closet, showing its original form (Fig 32). Some stapling of the tie-beam has occurred, probably in the 17th century. Above the blocked door on this side we also see a single, deliberately-placed taper burn. Within the room, the wall-plates are exposed to the south and west, as well as the principal joist and common joists.

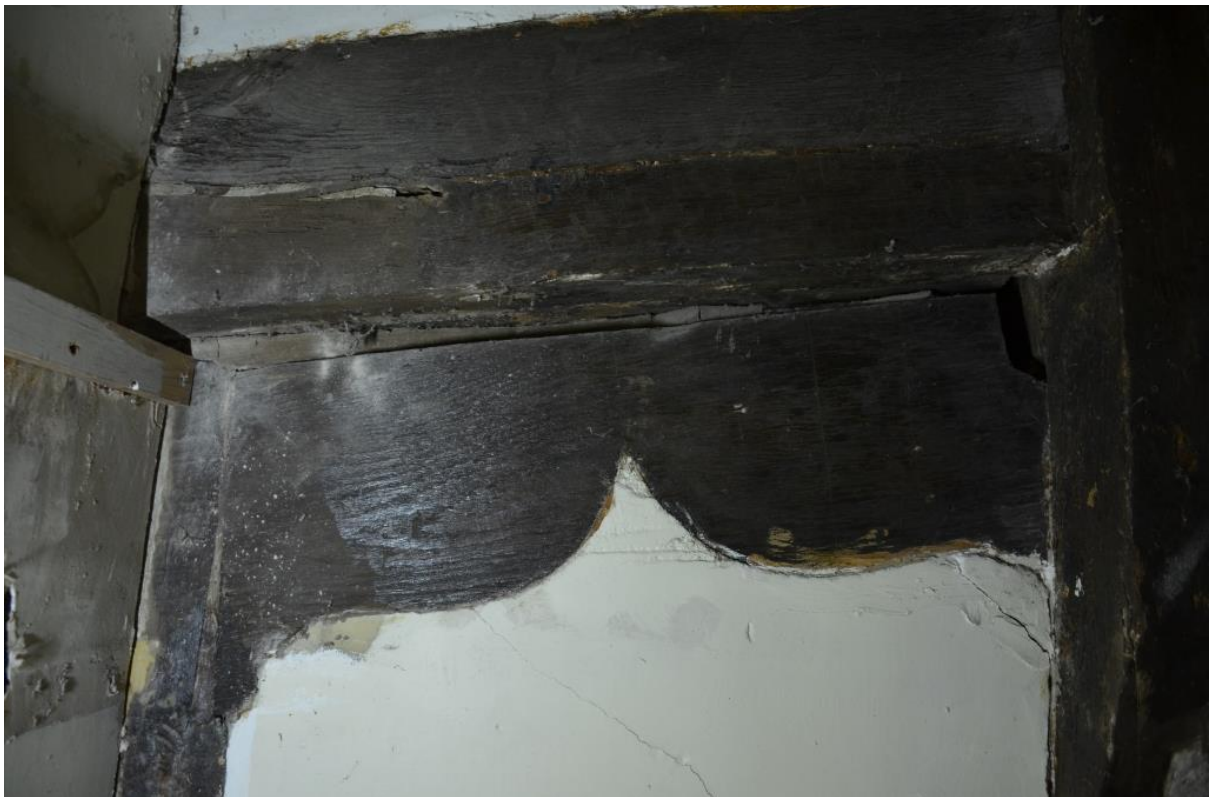
Figure 33: Bathroom closet: ogee-headed door lintel adjoining the bay-division post.

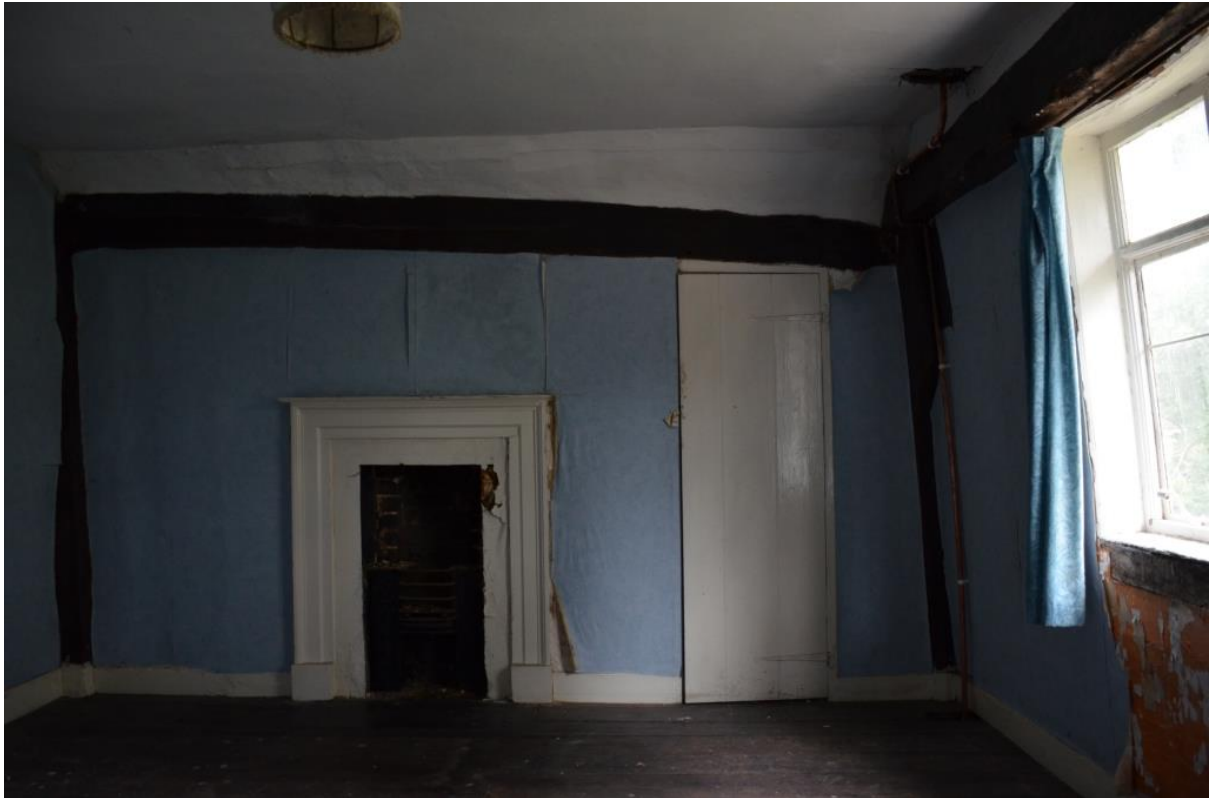
Figure 34: Bedroom 3 viewed from the east, with original corner post and wall-plate.

3.17.1 Bedroom 3 occupies the northern part of the cross-wing. It is floored with stained, 19th century pine boards and preserves a simple 18th century fire surround with a decorative cast-iron grate of mid-19th century date (Fig 34).

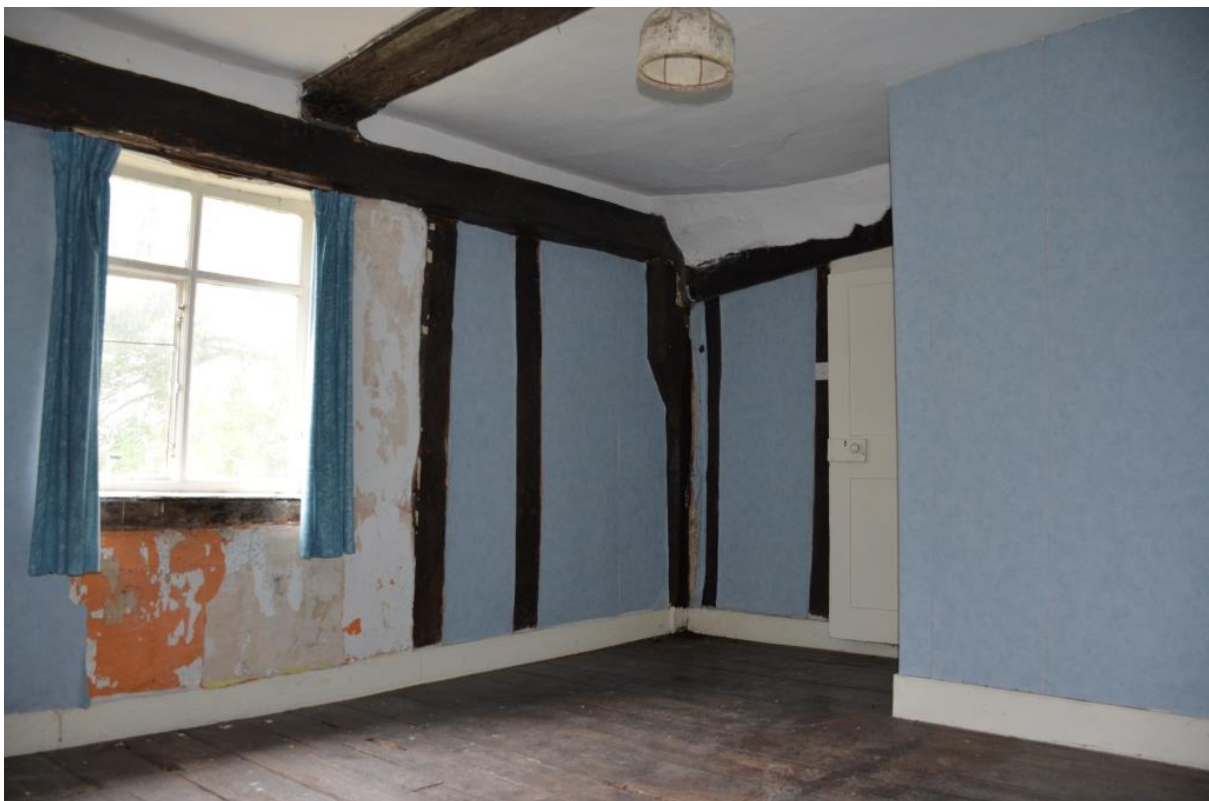
Figure 35: Bedroom 3 viewed from the south-west, showing corner post, studs and standard-type window.

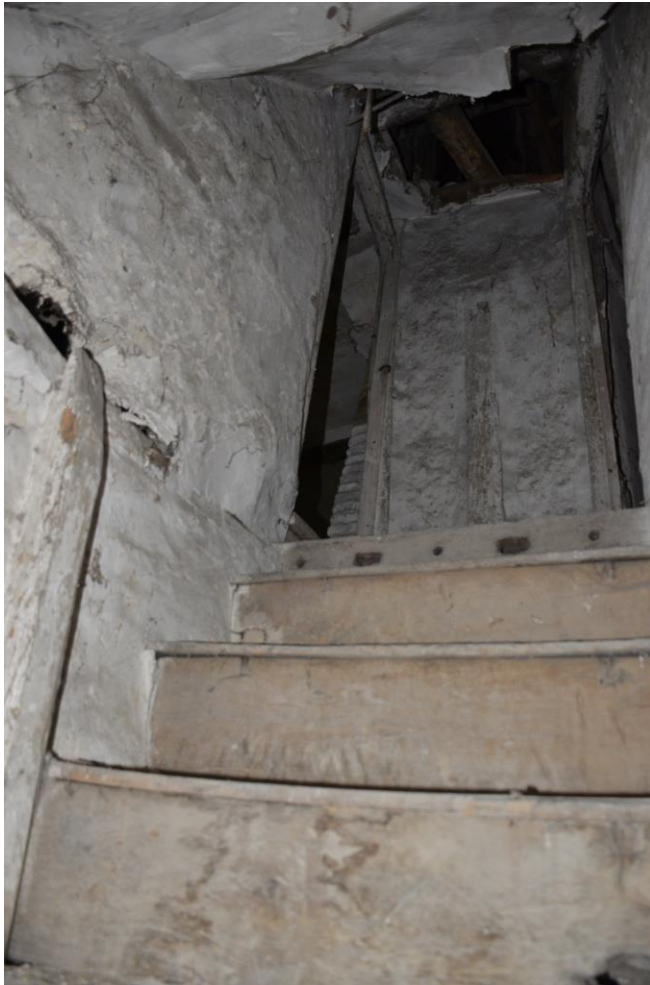
Figure 35: Top of attic stair seen from below. The top threshold appears to be a reused window lintel or sill.

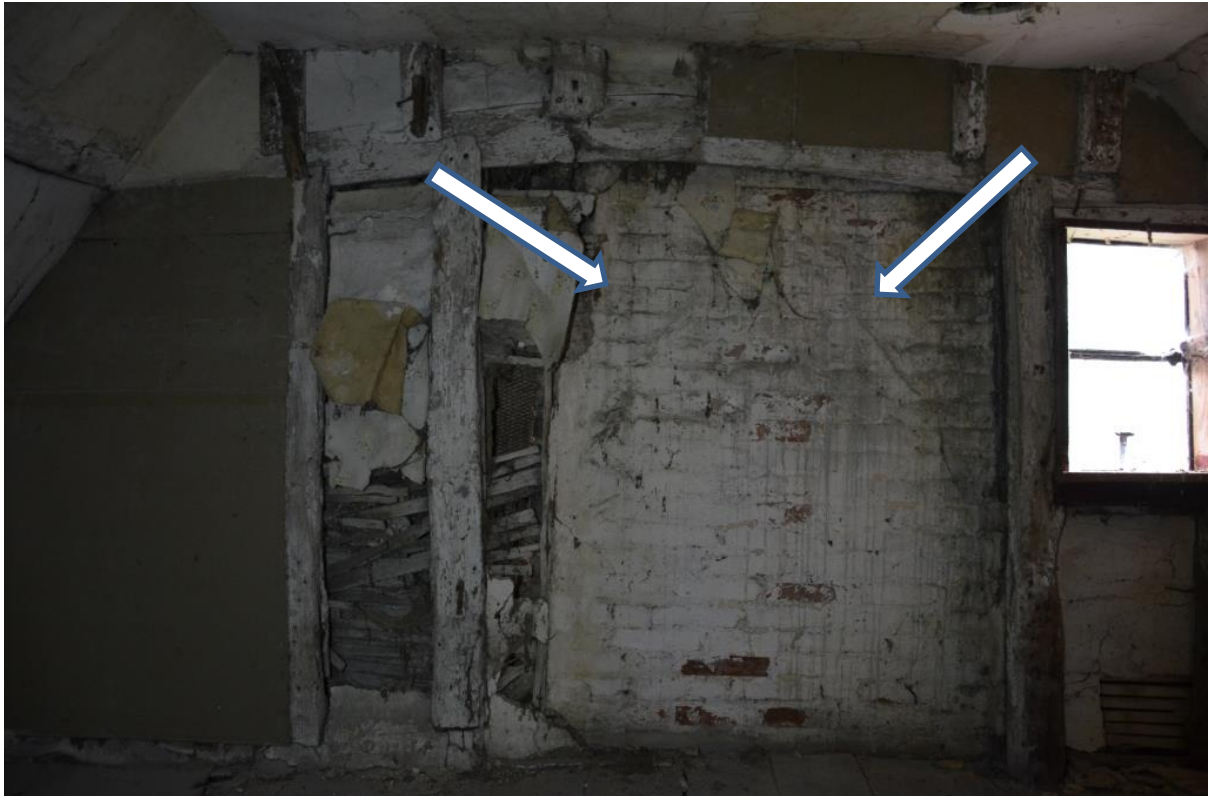
Figure 36: Eastern gable end of the building. The stack preserves impressions of a former saddle or 'cricket' which linked it to an earlier hipped pitch at this end (noted with arrows).

3.19.1 This eastern attic is framed on either side by the two stacks – the tapering central stack (Fig 37) and the flush stack on the east gable (Fig 36). The room was formerly entered via a door from the stair, now missing, though pintles remain in the surviving jambs. The room is ceiled above collar level, and plastered to the eaves at low level. The main visible structural elements include a series of collars, mostly bird-mouthed into a slender purlin on each side. These are small and of square-section.

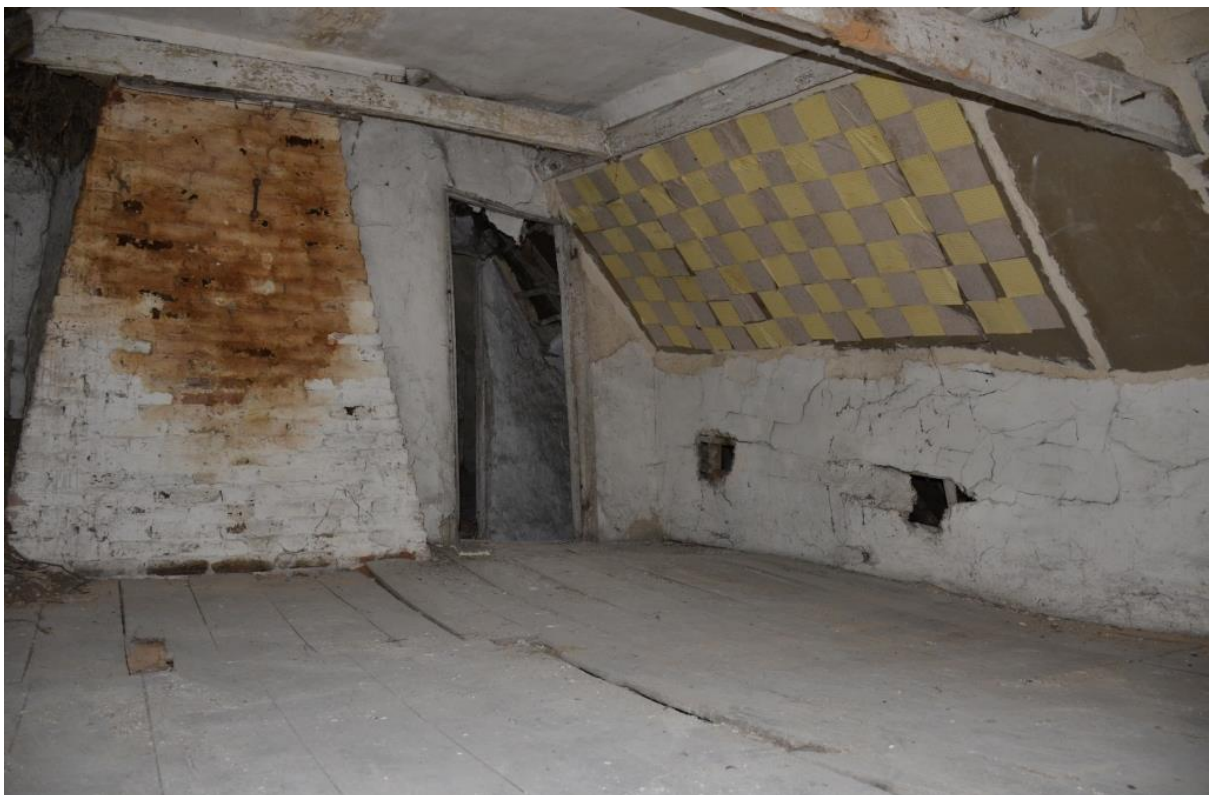
Figure 37: Eastern attic room viewed from the east, with central stack and door from stairs.

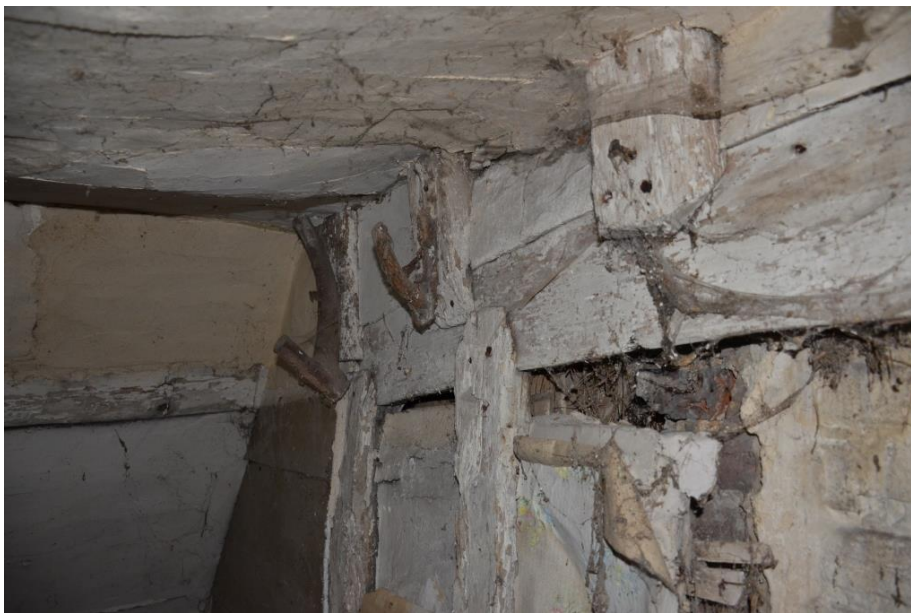
Figure 38: Detail of the eastern gable end, showing rudimentary nailing of studs, and crooked branches used as clothes hooks .

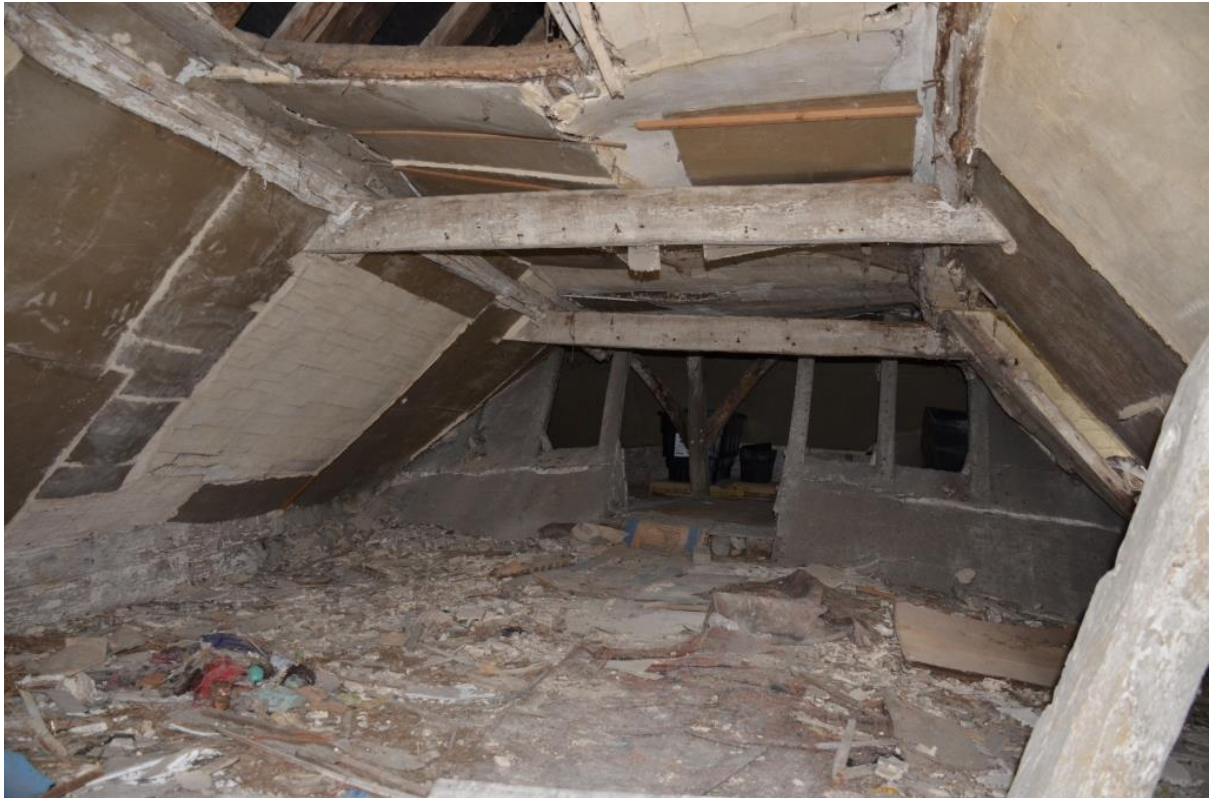
Figure 39: Central attic viewed from the east, showing aperture into the cross-wing roof beyond.

3.19.1 The central attic was once enclosed by a boarded door, which currently lies *ex-situ* as a duckboard near the doorway. The eaves have been boarded at low level, and the whole area ceiled with lime plaster below the collars (Fig 39). One or two areas of failure give a limited view into the upper roof structure, which we can see comprises smoke-blackened rafter-couples, each with mortices for a removed collar (Fig 41). This is proof that the roof was once open and perhaps supported a crown-post. The roof now has three plank-like collars claspings a fairly modest purlin in each pitch, square in section as elsewhere. A rudimentary queen post on the north pitch seems to have no structural purpose, but nonetheless has been stiffened with a rudimentary brace (Fig 40).

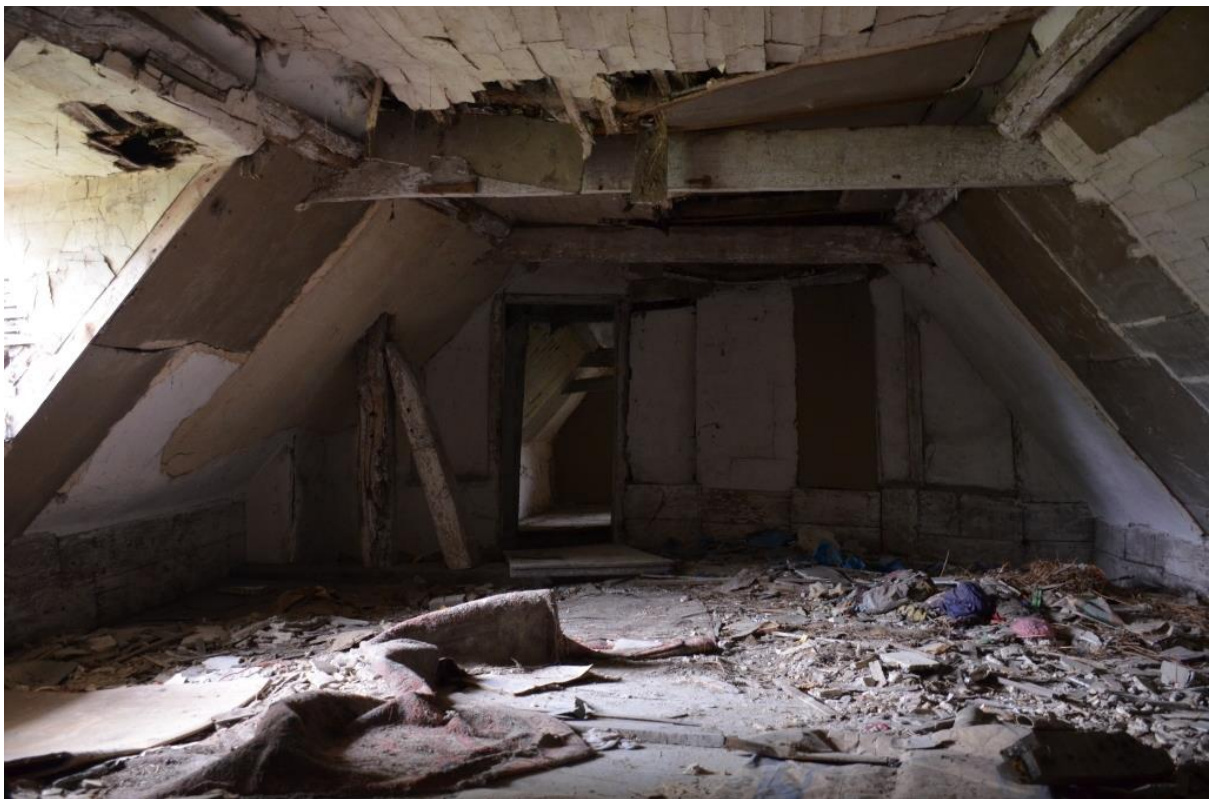
Figure 40: Central attic viewed from the cross-wing back towards the staircase.

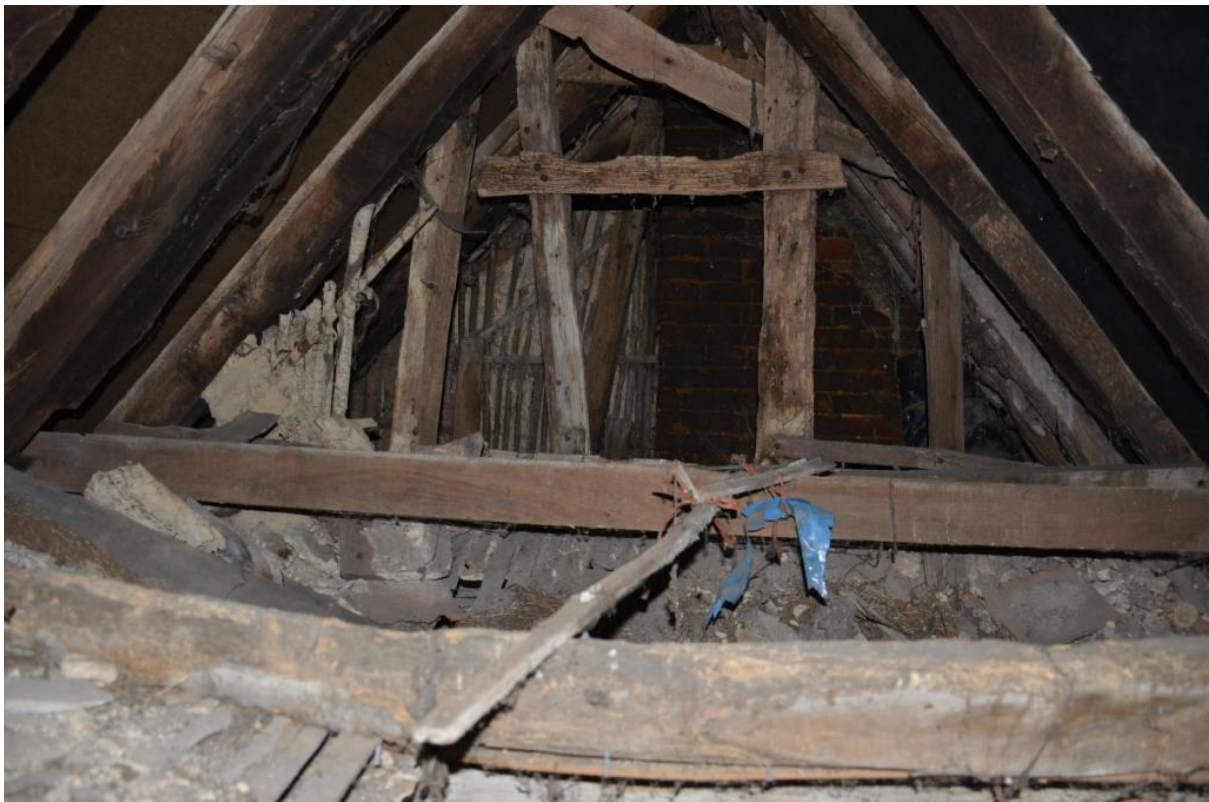
Figure 41: View into collar void above the central ceiling showing smoke-blackened timbers.

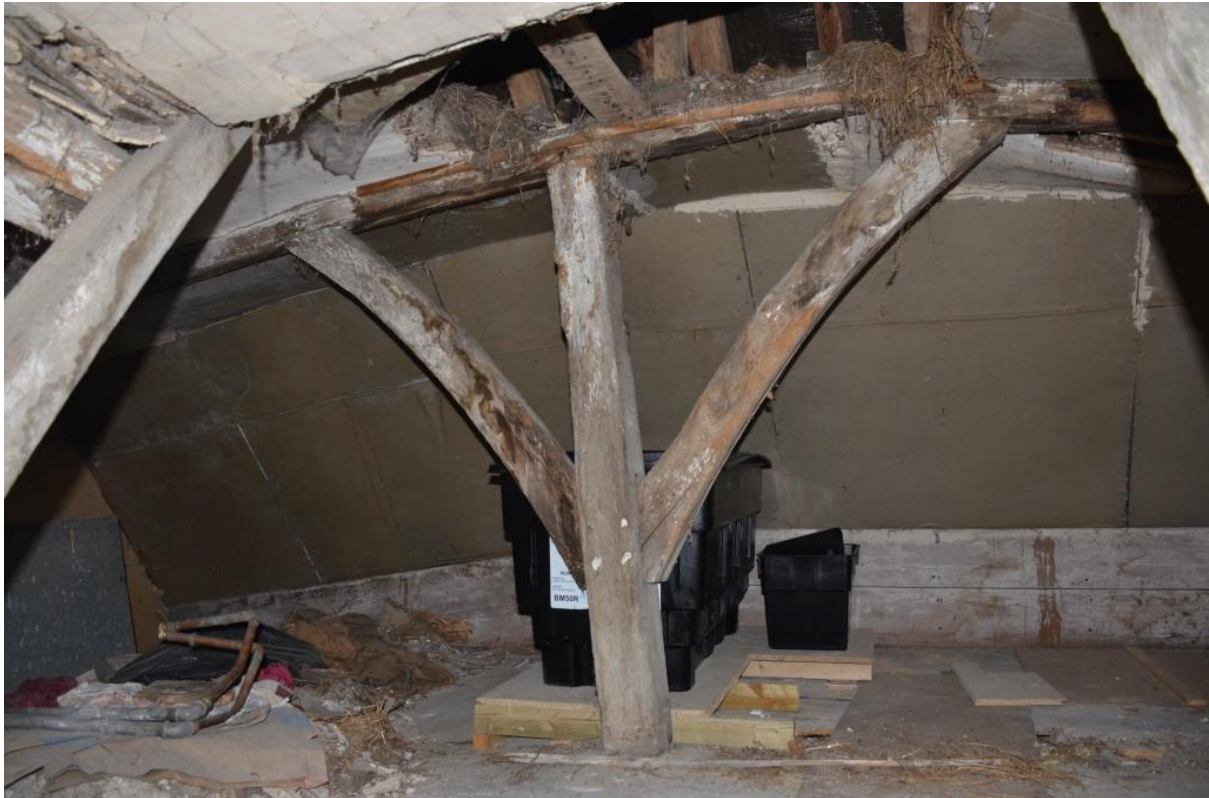
Figure 42: Crown post roof in the cross-wing roof. View from the east.

The cross-wing is of two bays, preserving a simple, unadorned crown-post roof with long, upswept braces to north and south. The stress of the subsiding south-western corner has caused the collar or crown-purlin to fracture and the crown-post itself to rack, though this movement appears to be ancient. The crown-post measures 5 x 4½ inches with 5 x 4 inch braces. The common rafters are all crudely under-boarded in modern materials and so not visible, though the gable end studwork is exposed.

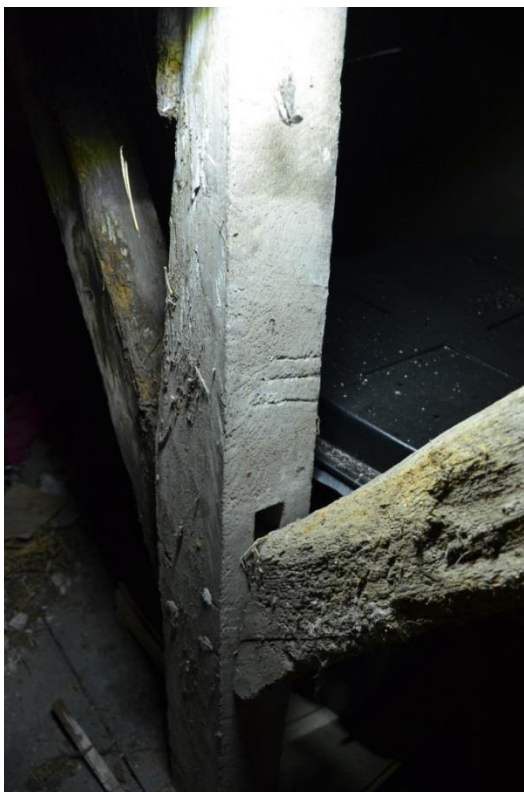
Figure 43: Carpentry marking visible on the north face of the crown-post.

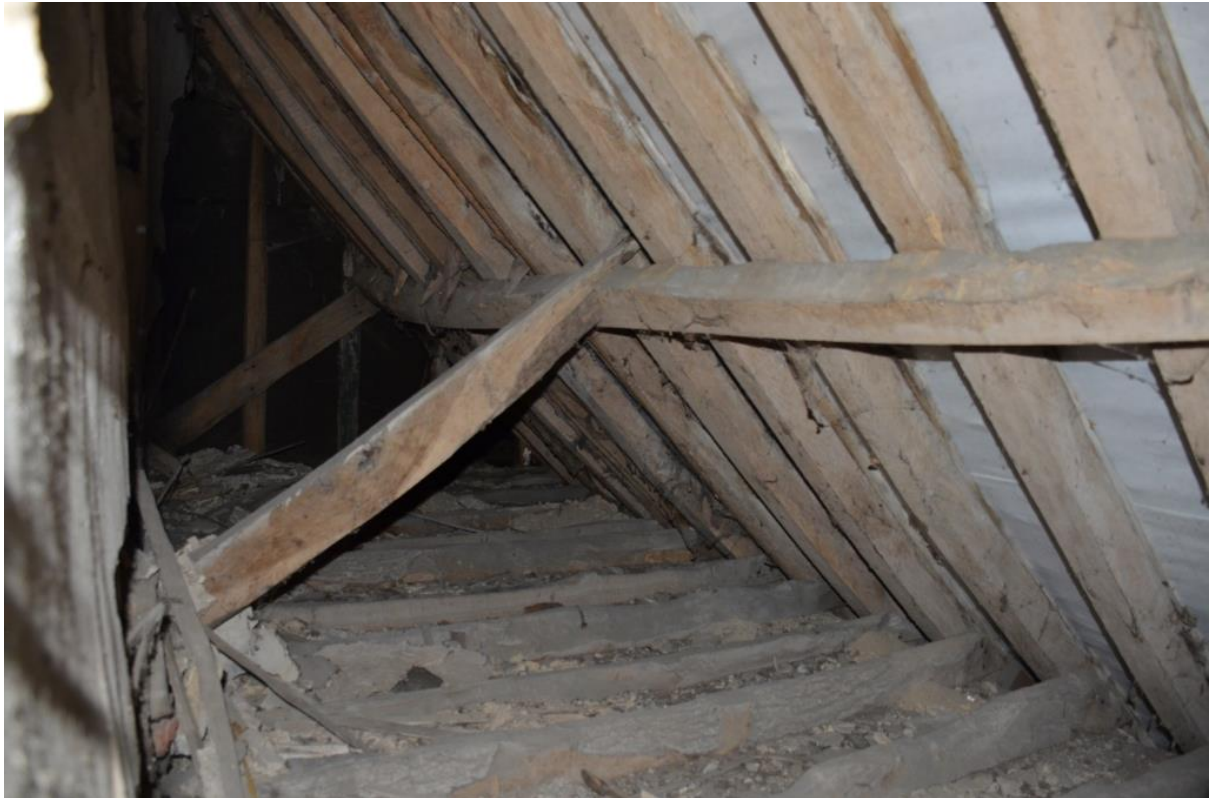
Figure 44: View into the outshut roof above ceiling level.

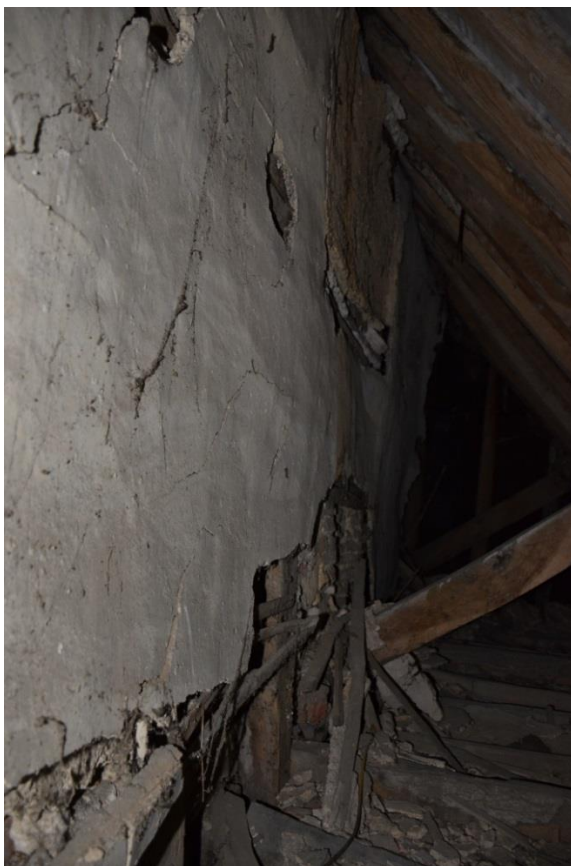
Figure 45: View into the outshut roof showing external face of the north wall.

3.21.2 The rear, north outshut is divided into three areas, but united above ceiling level under a continuous roof. This is visible through small apertures broken through the north wall of the upper floor of the house, and reveals a good series of regular oak rafters supported on a purlin of similar dimensions and stabilised with several raking ties springing off the mid-rail, all bird-mouthed to the purlin (Fig 44). The rear wall of the main range is covered with plain lath and plaster, with evidence in places of original blocked windows, though these were not investigated closely (Fig 45) due to physical constraints.

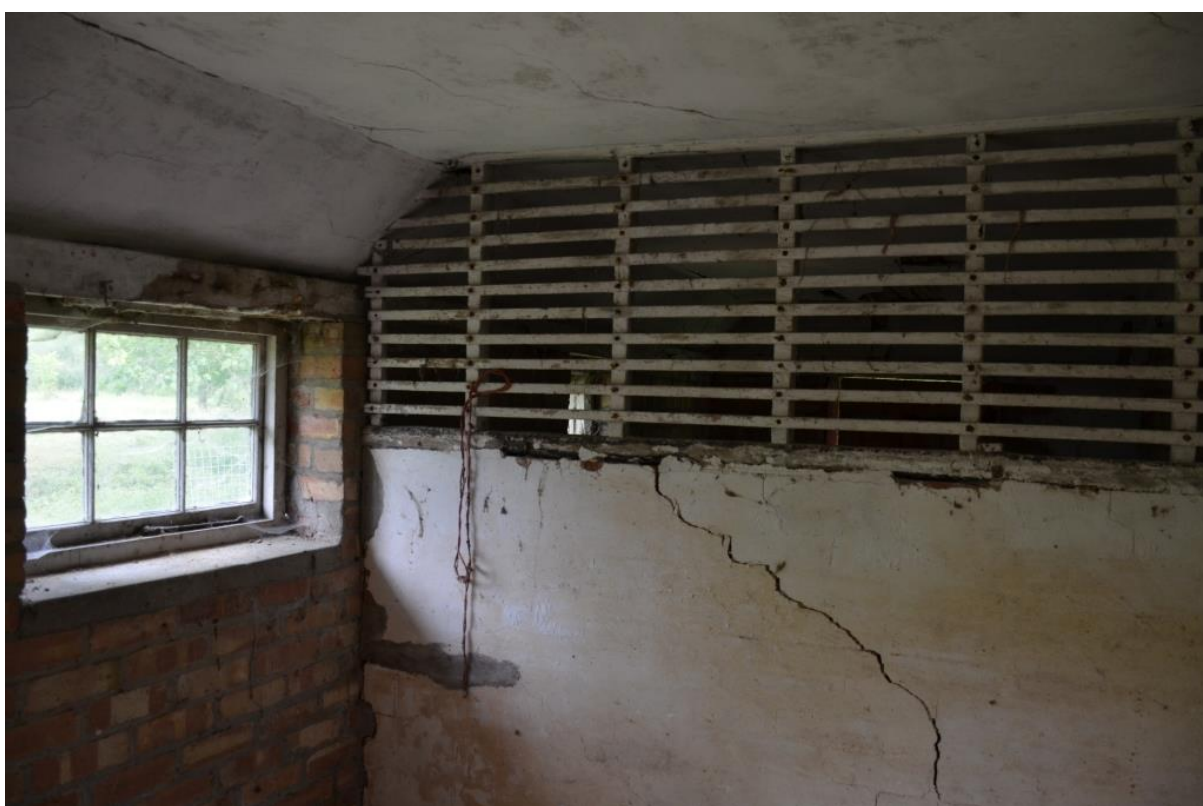
Figure 47: Central outshut with latticed wall to the east.

3.21.4 The middle outshut is may have formed a small dairy (Fig 47) and has been extensively modernised, with the exception of the dividing wall to the east, which has an open lattice at upper level. At low level, the original sill beam for the central range is visible, extending further to the west into the adjoining area. A small hatch survives at low level, giving access directly into the staircase. This may have been used to pass produce from the room into the house without needing to go outside.

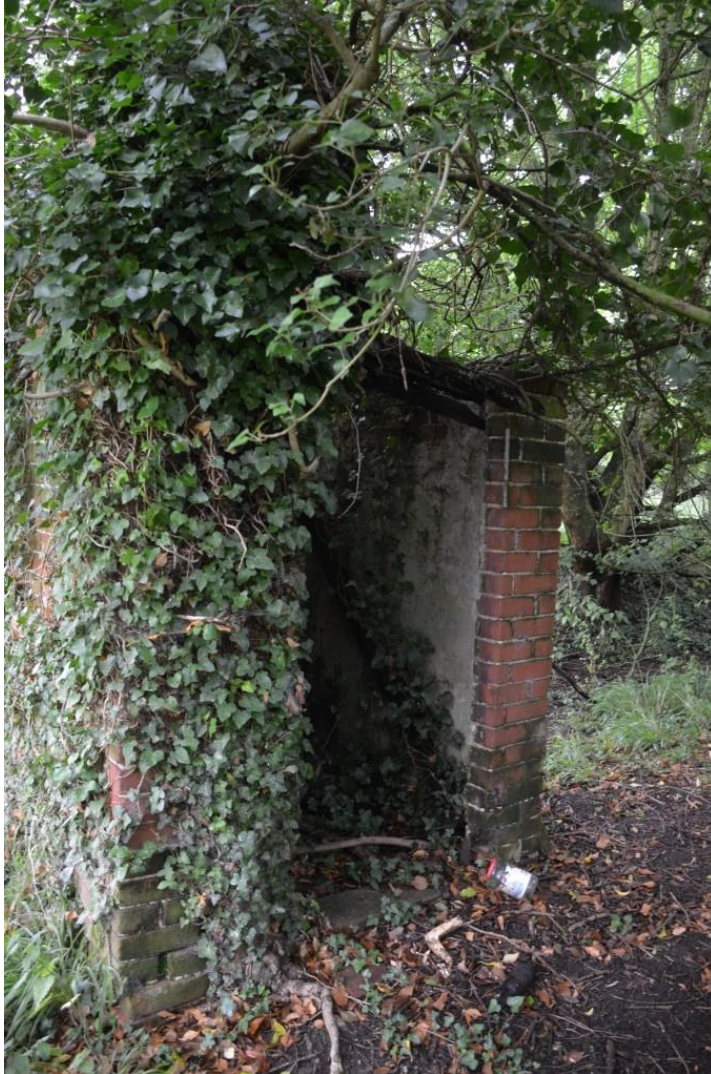
To the north-east of the house, a small, stand-alone brick-built privy survives in a ruinous state (Fig 48). This has been stripped of any fittings, but appears to be constructed in 20th century bricks.

Figure 48: Small former garden privy, now ruinous.
