Harrock Hall, Wrightington

Heritage Impact Assessment: Replacement of Modern Orangery

February 2021

Heritage Impact Statement: Replacement of Modern Orangery

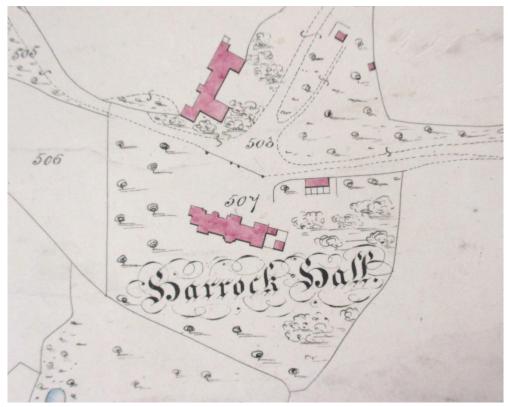
Figure 1: Detail from Tithe Map, 1841 (Lancashire Archives)

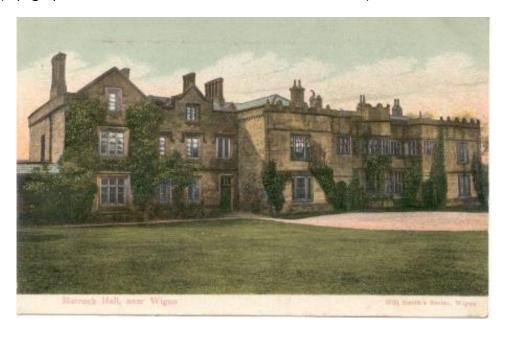
Fig.2: undated postcard, c.1900, with Boulton's gabled east wing to the left

In the 1860s the house was the seat of Elizabeth Boulton, who is said to have built a 'large addition' designed to 'harmonise in some measure with the original building' (Scottish Gardener 1866, p. 343-344). This was probably the gabled east wing shown on the tithe map and illustrated in a post card (see Fig.2). This is shown on the 1893-4 OS map (Fig.3) and was demolished in the late 20th century.

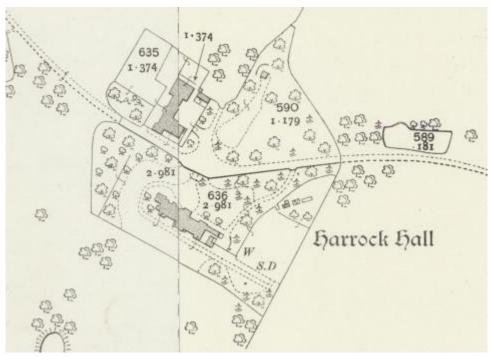
Figure 3: 1893-4 25 inch OS map (National Library Scotland)

This 1890s OS map records the heyday of the hall and the gardens, as soon after this it went into decline.

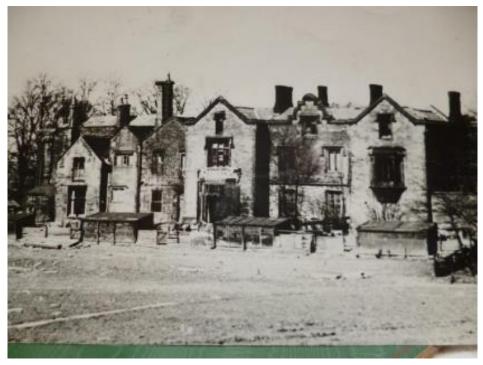
Figure 4: dilapidated south elevation, mid 20th century (client collection)

By 1911 Harrock Hall was described in the Victoria County History as being neglected. During the early 20th century the hall was tenanted as a farm house. An undated image (Fig.4) shows the gabled south elevation in a dilapidated state and small animal or poultry sheds on what had been the south gardens.

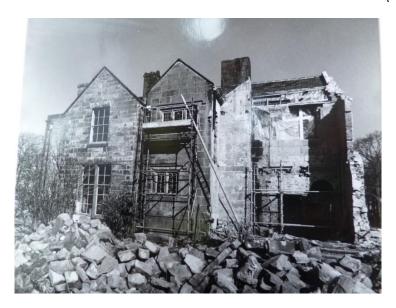
Figure 5: south elevation after clearance of Victorian east buildings, early 1980s (client collection)

In 1978, most of the mid 19th century east wing was demolished, leaving the core of the house in a fragile condition. The building was recorded by the RCHME at this time (photographs in Historic England Archive). In the early 1980s the hall was bought by Peter Moores, who demolished the remaining part of the east wing (Fig.5) and invested in repairs to the hall. He built a modern two storey flat-roofed addition immediately east of the hall range, partly hidden behind the rebuilt north frontage of the east wing (Fig.6). As part of this process a 19th century gabled wing to the north side of the hall was taken down, exposing the hall chimney stack (Figs.5 and 6). The exposed north elevation of the hall was renovated, and the ground floor mullioned and transomed window and north door to the hall were uncovered (Fig7).

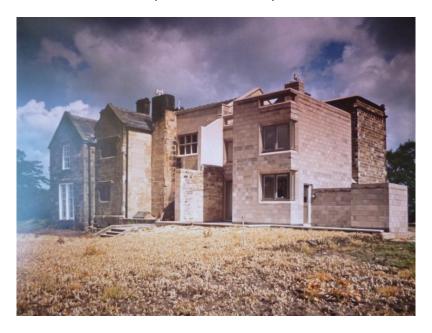
Figure 6: north elevation with early 1980s wing (client collection)

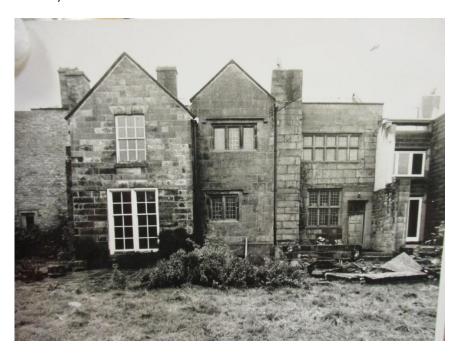
Figure 7: south elevation in c1990, before demolition of 1980s east wing (client collection)

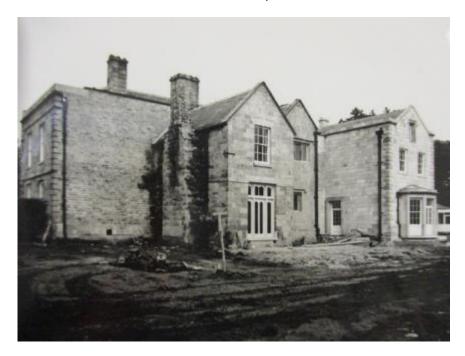
Figure 8: south elevation and new south-east wing in the 1990s (private collection)

In 1987, Harrock Hall was purchased by the present owner, Bill Ainscough, who undertook major renovations to the hall. The early 1980s two storey south-east flat-roofed addition was replaced with a gabled wing of more sympathetic design (Fig.8). The south doorway into the hall was blocked.

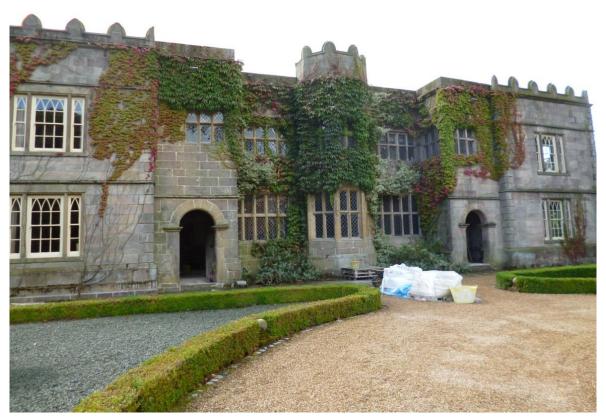
Figure 9: Principal north elevation of Harrock Hall, 2017

The symmetrical front elevation faces north onto a forecourt, the south elevation faces south over gardens. The central feature on the north front is the full-height canted bay window that lights the 'high end' of the hall. All windows are ovolo-

moulded and run in continuous bands, with the ground floor windows taller than those at first floor. Two projecting porches are at each end of the hall range, in the reentrant angles of the projecting east and west wings. The roof is hidden behind a parapet, with shaped crenellations to the bay window. The mullioned and transomed window to the right of the bay window lights a lobby, previously a parlour.

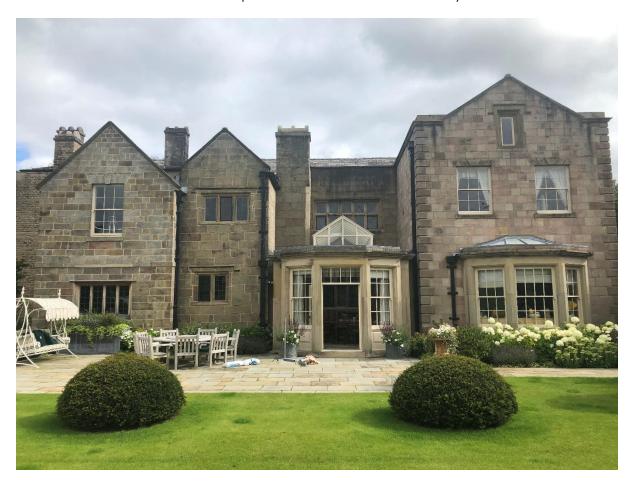
The south elevation is much altered; the current form of this elevation is the result of partial demolition and rebuilding in the late 20th century. The rear wall and mullioned and transomed window of the hall are partly hidden by the 2002 orangery, but are visible inside. The first floor mullioned window above dates from late 20th century remodelling.

To the left (west) of the orangery, a gabled 17th century projection contains the staircase, with offset mullioned windows. The gabled parlour wing projecting to the west of the staircase is faced in ashlar, but internally, remains of timber-framing (now hidden) are evidence that the stone cladding is a later alteration, probably 19th century; the external chimney stack is on the west wall (Fig.11). The ground floor mullioned window is a recent replacement for late 20th century French windows.

Fig. 10: south elevation (Seven Architecture)

To the east of the hall range, facing south, the gabled east wing is part of rebuilding by the present owner in the 1990s (Fig.10).

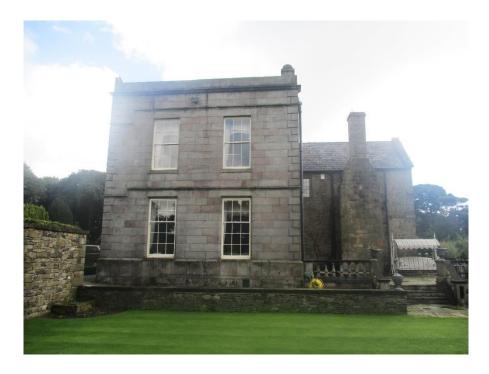
Figure 11: Georgian drawing room range (left) and late 16th century parlour (right)

The drawing room range to the west of the parlour wing was added in the late 18th or early 19th century; the north side of the east wing was re-fronted in matching style, probably at the same time (this was rebuilt in the 1990s). These end wings' proportions, character and design are typical of the late Georgian period, with ashlar masonry, chamfered quoins and sash windows; the shaped crenellations to the front parapets copy those on the hall bay window.

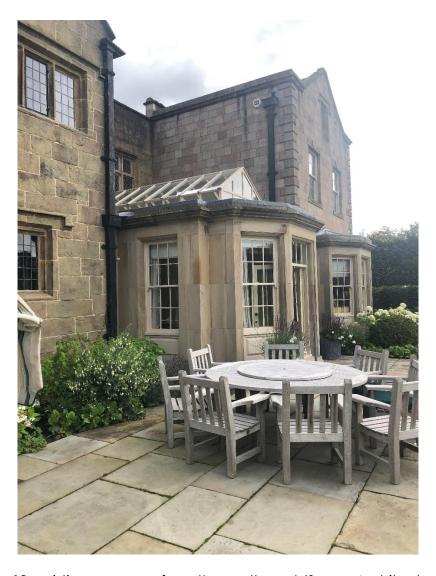
The orangery or garden room was added in 2002 by the present owner. It is faced in ashlar, with a moulded cornice to the flat roof. The south elevation has a canted bay with timber French doors and sash windows, with a sash to the west side. The room is top- lit by a large glazed lantern.

Fig. 12: existing orangery from the south-east (Seven Architecture)

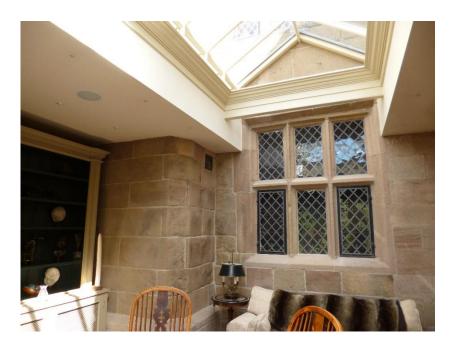
Inside, the fair-faced stone external walls, chimney stack and mullioned and transomed window of the hall are clearly visible (Fig.13). An internal doorway connects the east side of the room to the kitchen in the 1990s east wing, this is a reset early 19th century gothic revival feature (Fig.14); there is no link into the hall to the north or west. The plan (Fig.15) shows how it relates to the adjoining parts of the house.

Fig. 13: orangery interior with exposed rear wall of hall, from the south, 2017

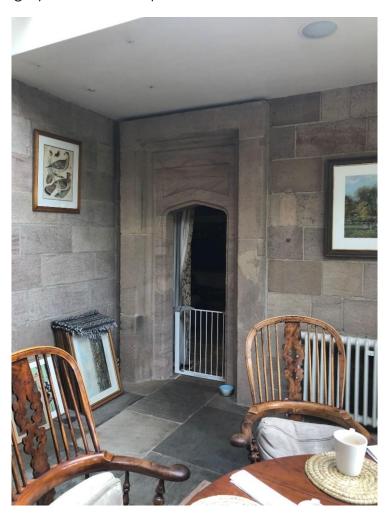
Fig. 14: re-set 19th century doorway between the orangery and the 1990s east wing, from the west (Seven Architecture)

Altering the re-set stone doorway on the 1990s east wing has a neutral impact and causes no harm.

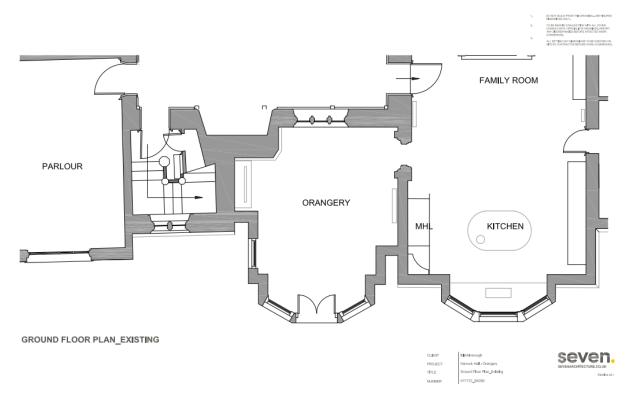
Fig. 15: existing plan (Seven Architecture)

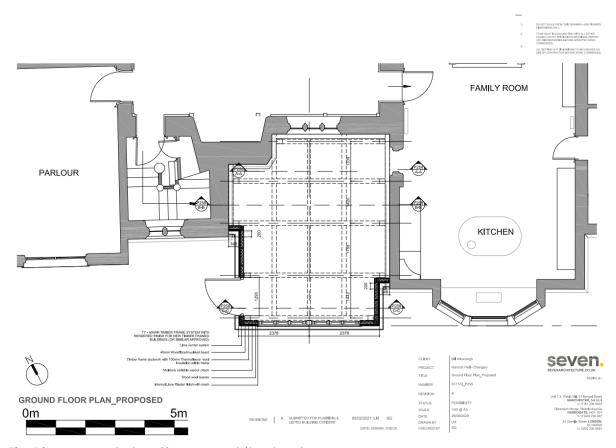
The new structure will occupy the same footprint, with a plain south gable wall instead of the existing canted bay window.

The proposed structure will be built using a green oak frame on a stone plinth. The roof comprises traditional collar trusses supporting an insulated pitched roof. The line of the roof has been designed to minimise impact on the hall mullioned and transomed ground floor window, with the ridge just below the sill of the first floor window. The roof will be laid with natural slates with rooflights to each bay; lead flashings will be used to protect the junction with the existing stone wall of the hall.

Fig. 18: proposal plan (Seven Architecture)

The proposed south gable end will have an oak mullioned window, to complement the character of this part of the hall (Fig.19). The elevations will be faced with a lime-based buff-coloured render, above the plinth. On the west return a part-glazed door into the garden is proposed. Inside, all walls remain fair-faced as existing, with minor modification to the re-set doorway into the kitchen to the east.
