## Ecological Survey: Bats

**Client:** The PCC of Holy Trinity Church

**Location:** Holy Trinity Church, High Street, Queenborough, Kent, ME11 5EP

**Project:** Quinquennial repairs to include new rainwater goods and drainage, roof repairs, repairs to the interior of the belfry and external masonry repairs to the western tower, chancel and other areas of the building

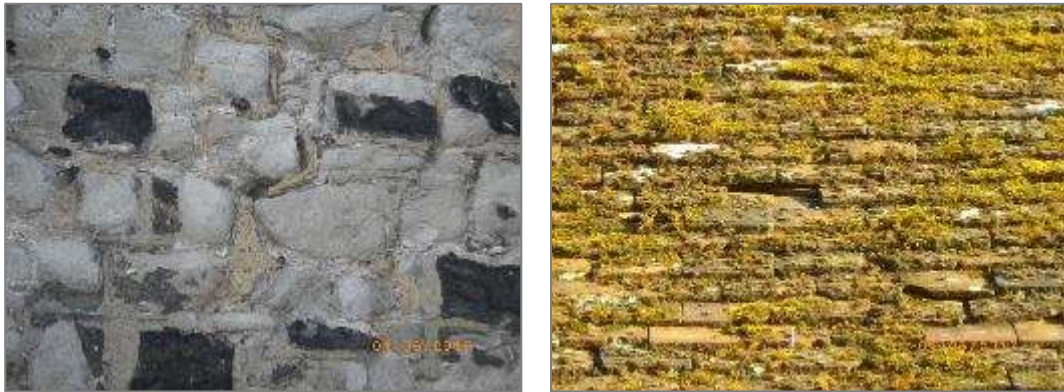
- 3.5 The grade II\* listed church is constructed of stone with several buttresses to the north and south. The church consists of a western tower, adjoining nave and chancel, southwest porch and north vestry. There are numerous cavities within the stone walls (particularly upon the western tower) where mortar has degraded, these were being used by a variety of bird species for nesting activities.

- 3.6 The gabled roof is pitched north to south and clad in traditional clay tiles which have naturally raised edges. There are a few missing and slipped flat tiles on the northern roof pitch of the nave. The ridge tiles are in good condition and are tight fitting. A single dormer is located within each roof pitch of the nave, these have tile hung cheeks, however the tiles are relatively tight fitting. The roofs are lined with traditional bitumen felt and the eaves are open, however they have been closed off with a

plastic/steel mesh in most area. However there are a few openings present along the northern elevation of the nave and chancel.

*Cavities within external masonry and missing roof tiles on the northern roof pitch of the nave*

- 5.1 In order to prevent disturbance to nesting birds during the works, the installation of scaffolding and the start of works should ideally start prior to March 2018 as the active bird nesting period runs from March to August (inclusive). The ongoing disturbance of the works at the site should in turn deter nesting birds. However, if this is not feasible, the stone cavities within the proposed work areas should be accessed between September 2017 and February 2018 by an ecologist and contractor to inspect the crevices and block them using a suitable material.

- 5.2 Stone masons must inspect cavities and crevices within masonry prior to raking out and repointing. If a bat or active birds nest is found during the works, all work must immediately stop and Mountfield Ecology be contacted for further advice.

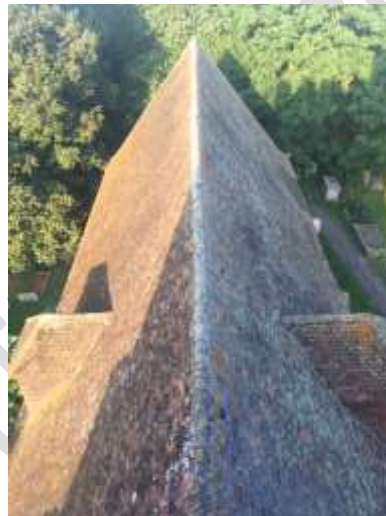
*Aerial view of the nave and chancel roofs*

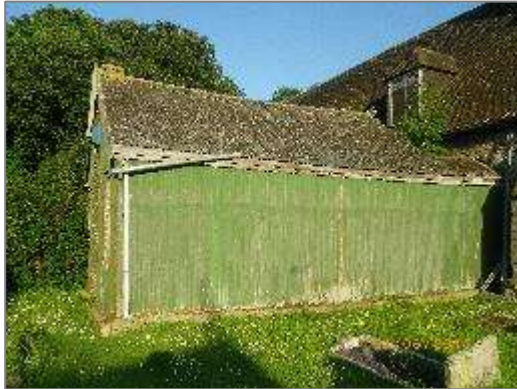
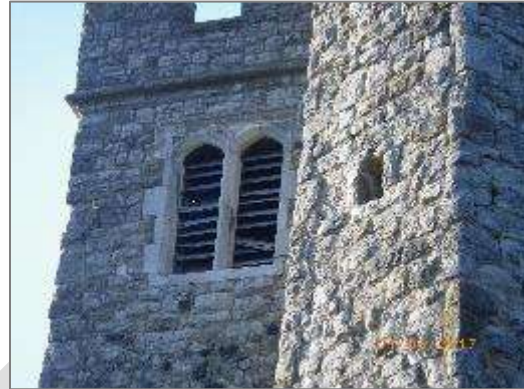
- 3.7 The vestry is attached to the northern elevation of the nave via a narrow passageway. It is constructed with corrugated fibre cement panels upon the walls and roof. The remains of a brick chimney are to the northern elevation. Timber barge boards are slightly raised from the surface of the corrugated sheeting. Numerous crevices have been previously filled with expanding foam. The vestry has an inaccessible roof void.
- 3.8 The southwest porch is open and the main entrance door is tight fitting. The internal roof area is lined with timber sarking, a small inaccessible void is present. The western tower is accessed via a stairway turret leading to the ringing chamber, belfry and

tower roof where there is a castellated parapet. The belfry has timber louvered openings, some of the boards are in poor condition. The openings have been covered over by a narrow gauge wire mesh and the frame associated with this is tight fitting. One opening also has internal timber shutters. The doorway leading onto the roof is tight fitting at the top and sides, with a narrow crevice at the base of the door.

*North vestry (left) and broken louvers on western tower (right)*

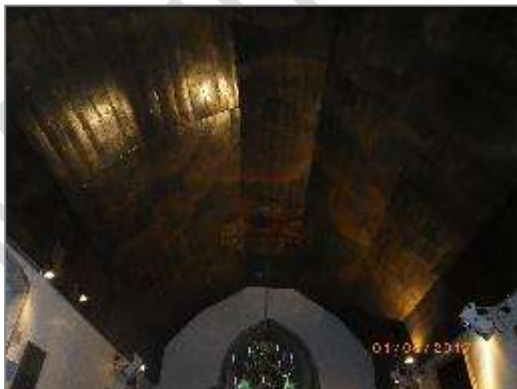
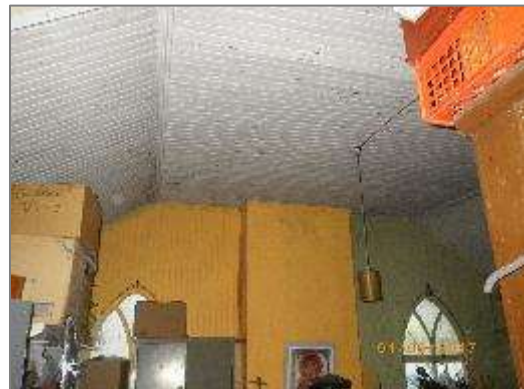
- 3.9 The main internal area of the church has a decorative painted ceiling upon the timber sarking. A small hatch provides access to the roof void via the southern dormer, however the void above the sarking is narrow and likely to be inaccessible from this hatch (in turn this area was not accessed).

*Internal roof of the nave and chancel (left) and the vestry (right)*
