**Lochay Substation, Lochay Power Station
Killin, Stirling
Cultural Heritage Desk Study**

*SHE Transmission Project No: PT000321 – Lochay 132/11Kv
Transformer Replacement
AOC Project No: 24477
September 2018*

Cultural Heritage Desk Study

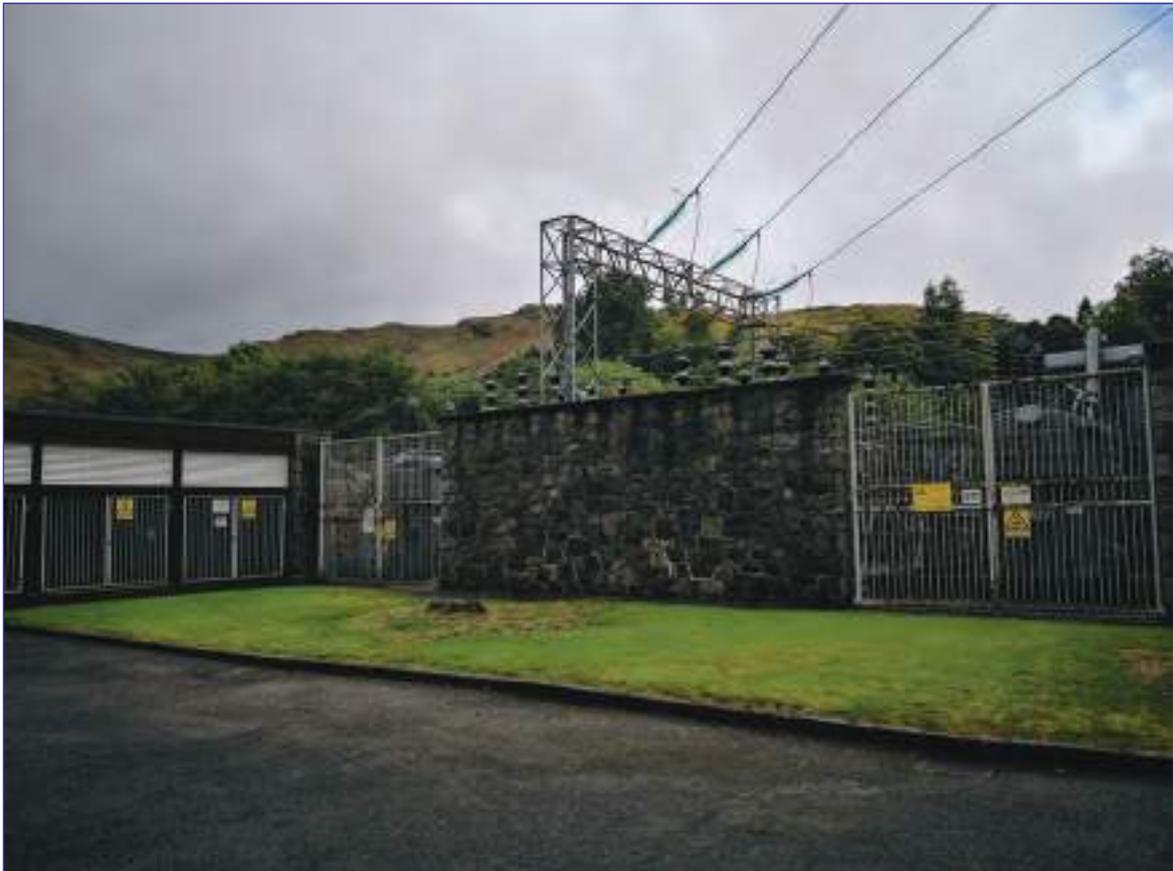
Plate 1: West facing view of existing substation (Option 1)

The existing substation is located at the western end of the power station complex and stands within a stone walled complex with further equipment installed within a low range of steel gated structures to its immediate southeast (Plate 1). The substation could not be entered on safety grounds however it was observed that it is

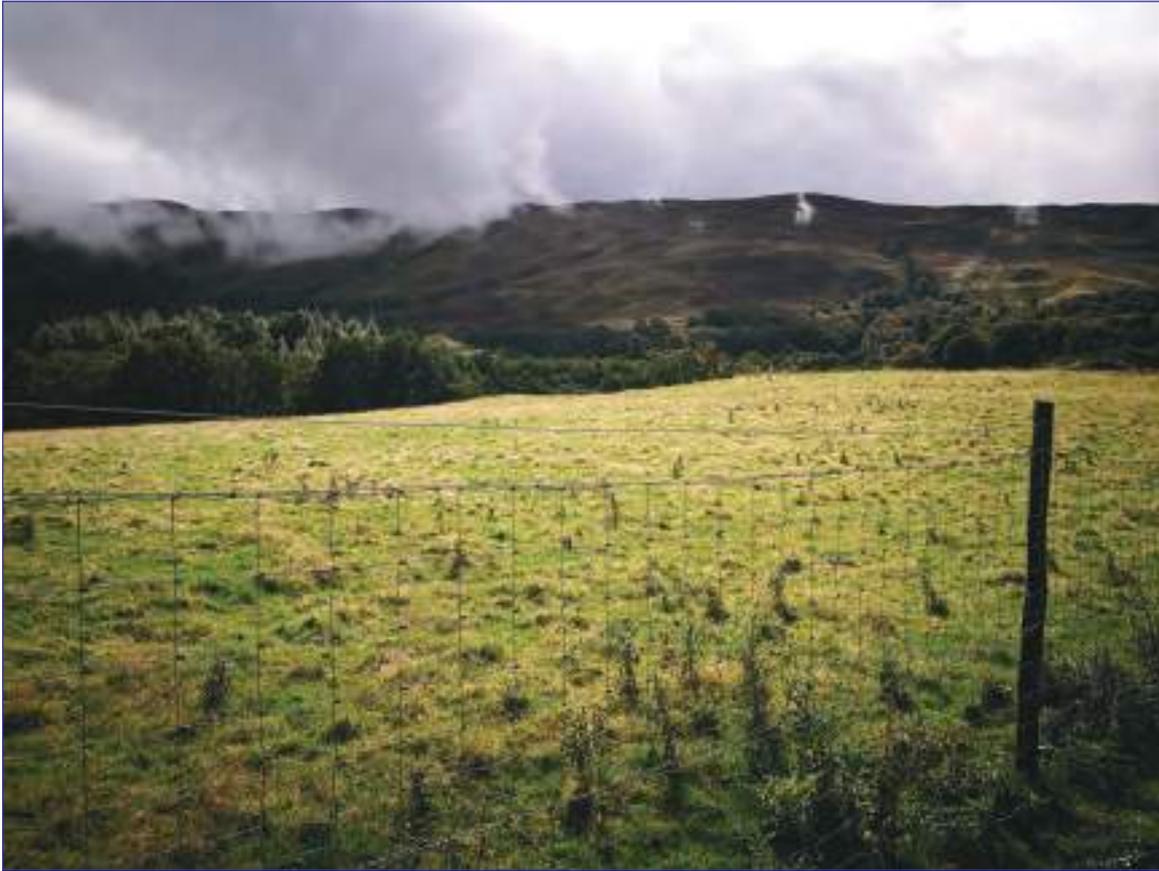
Plate 9: Southeast facing view across Option 4 showing the possible mound (Site 56) in the middle distance (centre)

- 1.5 Although a possible artificial mound was identified to the east of the modern road within the Option 4 area during the walkover survey, the only upstanding remains identified within Options 1-3 were modern and in all probability associated with the power station. The land surrounding the power station has clearly been landscaped, with trees planted within both the Option 2 and the Option 3 areas. Earthmoving within Option 2 appears to have been limited, although within Option 3 it may have been more extensive. Ground within Option 1 has clearly been extensively disturbed by the construction of the existing substation in 1958 and any surviving remains will be buried, and in all probability severely truncated. The Option 4 area is an improved pasture field, outwith the SSE ownership boundary with no obvious signs of ground disturbance although an overhead line tower stands within it.

discounted. Given the presence of a possible artificial mound there is considered to be an elevated potential for archaeological remains to be present along the ridgeline within Option 4.

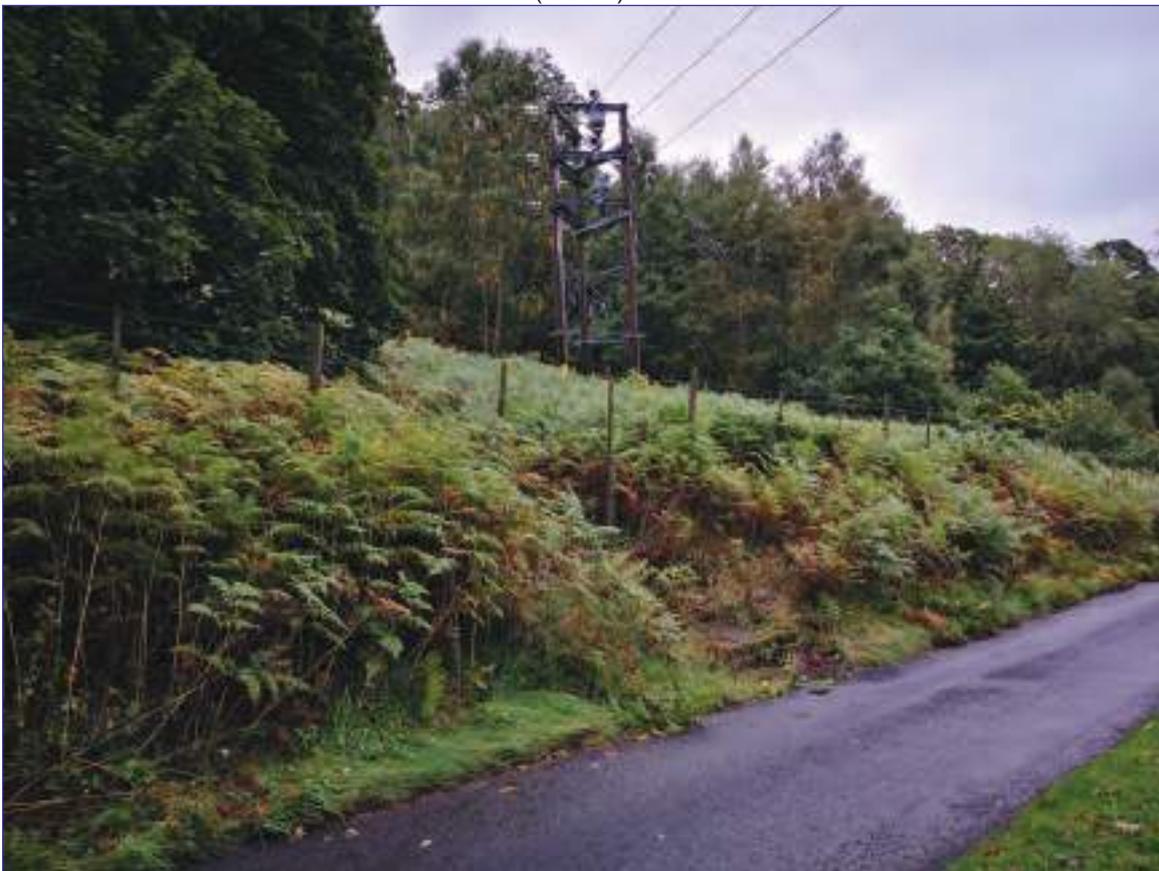
Plate 10: Northeast facing view towards the recorded site of a township (Site 13) to the north of Option 1

5.9.2 The site of the former crofting township (Site 13), that is recorded immediately north of Option 2 was also examined from the public road. The site was found to be heavily overgrown with trees and bracken, within which no upstanding remains could be identified (Plate 10). However, Site 13 could not be accessed directly due to the presence of a deer fence and it is possible, indeed perhaps likely, that upstanding remains may survive within the dense undergrowth. It was noted that Site 13 was located on a rising hillslope.
