STRUCTURAL REPORT

ON: VERONICA, LOOE
STRUCTURAL APPRAISAL OF PROPOSED SCHEME

FOR: MR F. TALIA

DATE: JULY 2021

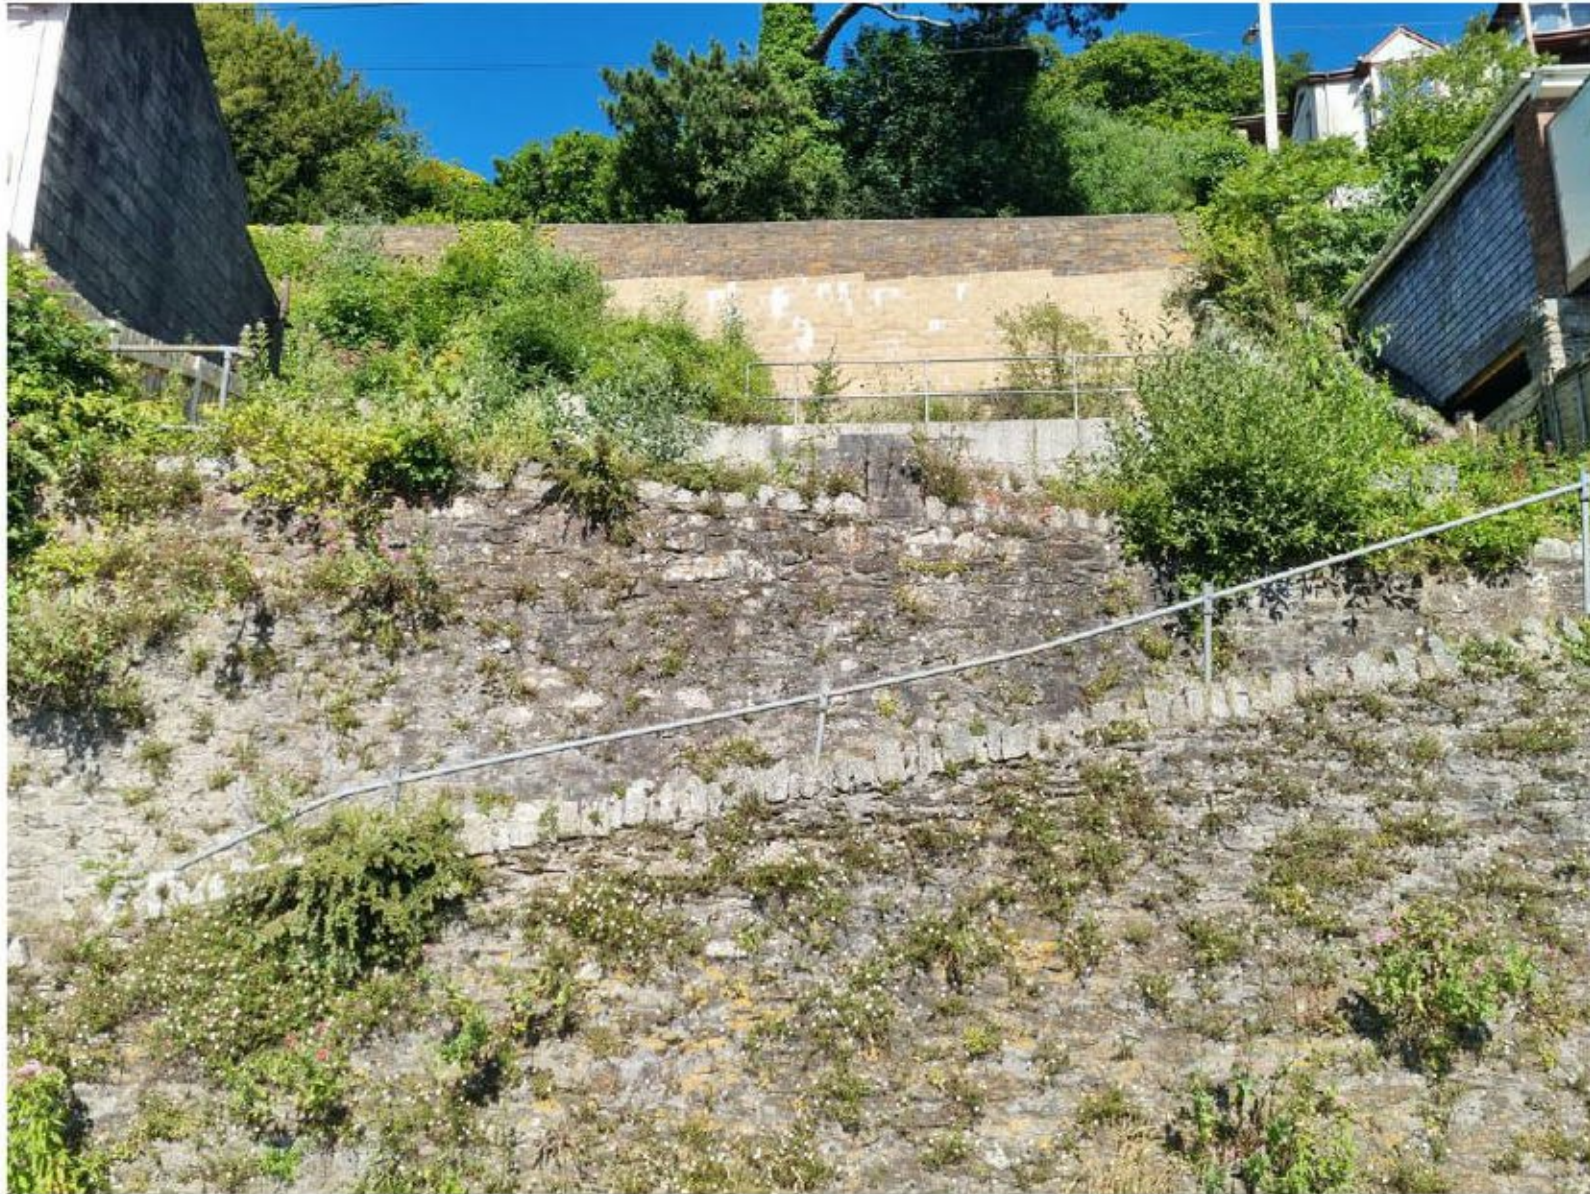
Figure 1 - Vegetation on stone facing walls.

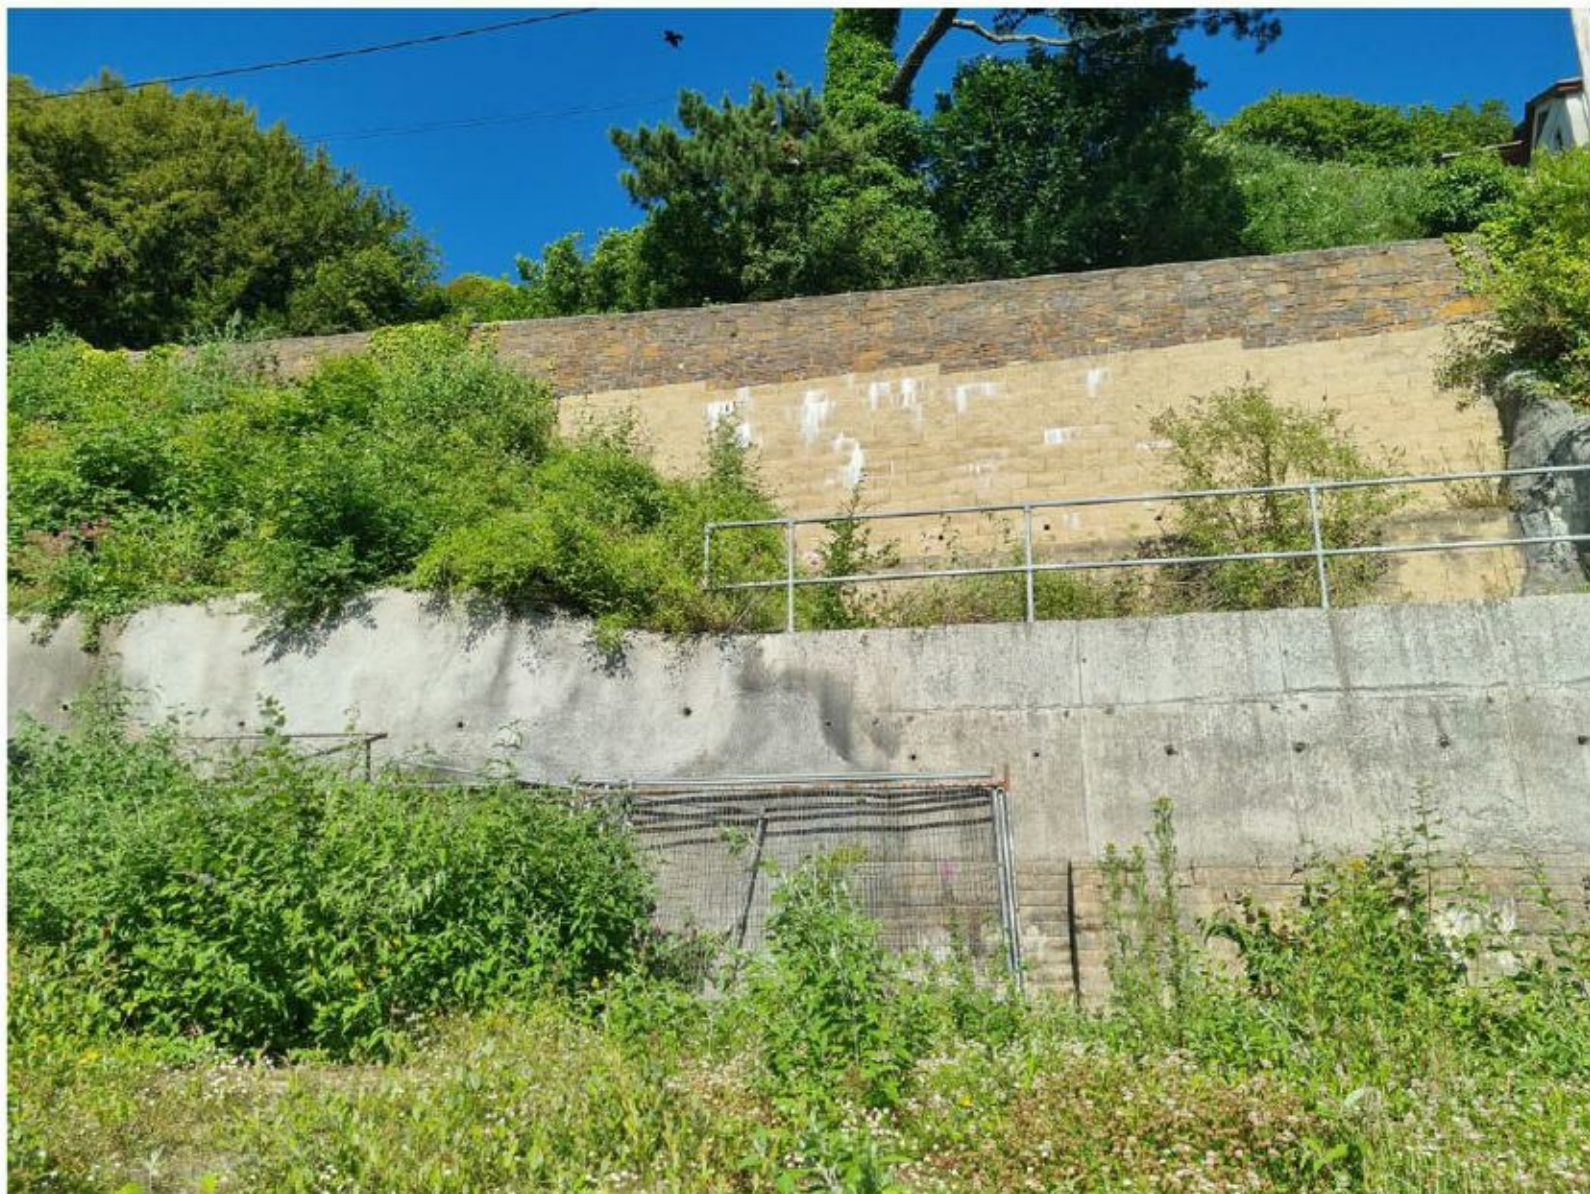
Figure 2 - Highway retaining walls to rear of site.x

- 4.1 The highway retaining structure at the rear of the site will be retained and the proposed scheme will be designed not to affect the support system to the wall.
- 4.2 To allow for a reduction in site level, without undermining to the highway structure, a piled raft foundation is proposed. The excavations will be carefully monitored on site to ensure these are limited. A piled foundation will be created where made ground is present.
- 4.3 At the front of the site, any potential loading onto the existing stone facing walls will be designed
