Heritage Statement

Ref: Proposed Greenhouse at Mansion Farm, Knowle Hill, ME17 1ES

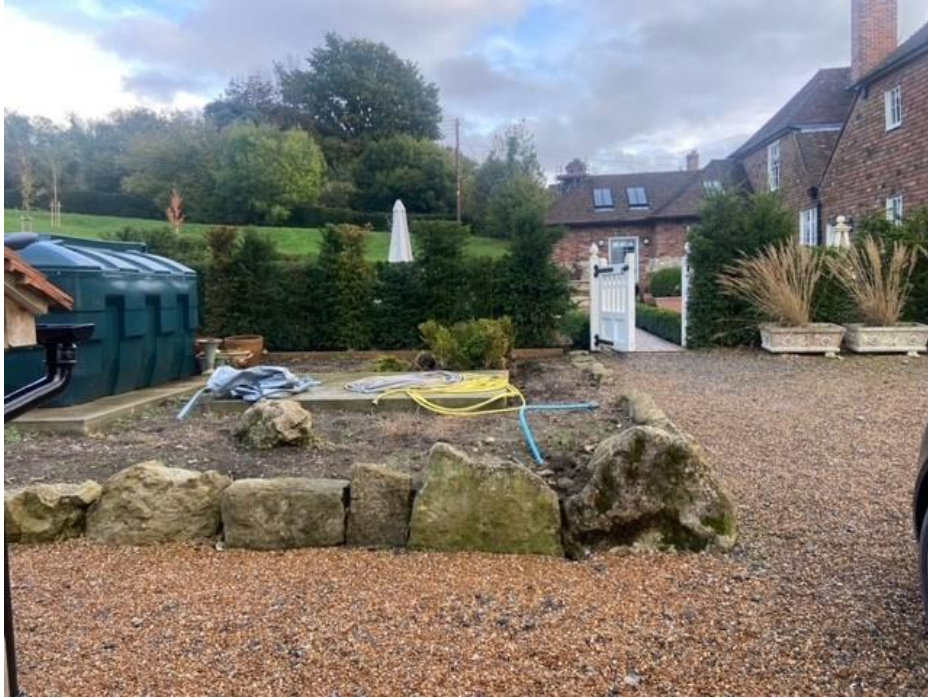
Proposed greenhouse location looking east, showing existing concrete slab and courtyard garden beyond

between the garden and the existing garage that was built with permission granted under 16/503778/FULL and 16/503779/LBC. An existing concrete pad will be utilised as far as possible to provide a raft foundation for the greenhouse, thus minimising the need for excavation during the building works.

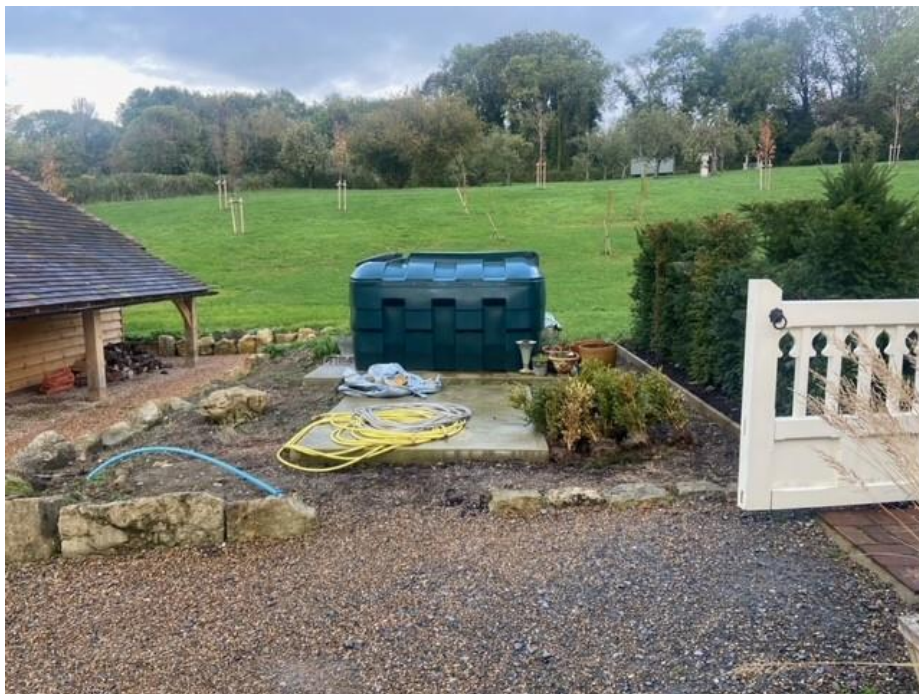
Proposed greenhouse location between courtyard garden and existing garage, looking north

The greenhouse is sensitively located to the north-west of the dwelling house, creating a sense of containment with existing buildings in this area. The proposed greenhouse will sit adjacent to the courtyard garden and will fill the space
