Heritage Impact Assessment

Replace & Upgrade to Existing Porch

Bethlehem Chapel House, Llanfair Caereinion SY21 0HT

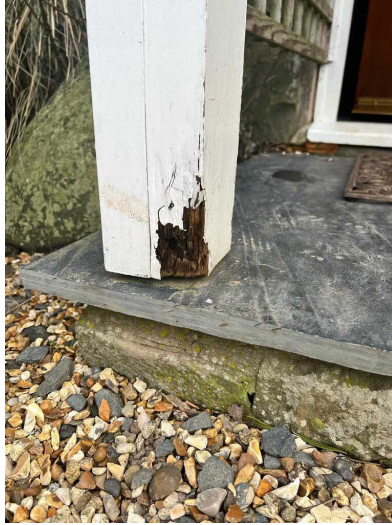
Image d.

The current porch is a small side entrance constructed with wooden posts, rose trellis and a slate roof, as shown in the below image. The posts have been repaired several times; each post has perished from the bottom and had repairs, the porch trellis is frail, if leaned on, it would fall over (unable to grow roses due to weight).

Decay at the bottom of the left post (image d) with a temporary repair made, right post repaired at the bottom from decay (image e).

Improve the functionality, repair the current porch damage and the appearance
Remove the rotted elements (both uprights)

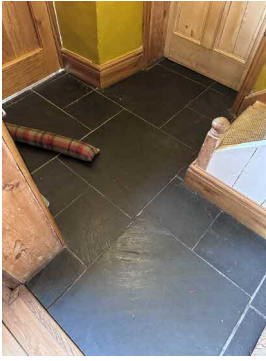
Inside the front door, is a small hallway. The hallway is approximately a 4ft sq area where the stairs, snug, office, under stairs area and front door meet. This area is where shoes and coats are put on, however as a central point of doors it becomes highly congested resulting in a safety risk for anyone with mobility issues. This

Image g. Actual Hall layout taken from the snug

Image h. Actual Hall layout taken from the reception room

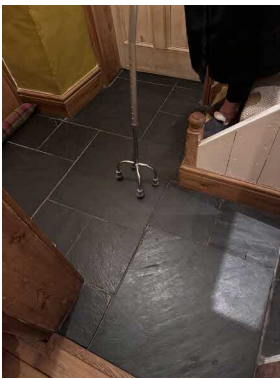
Image i. Hall layout is a health & safety risk

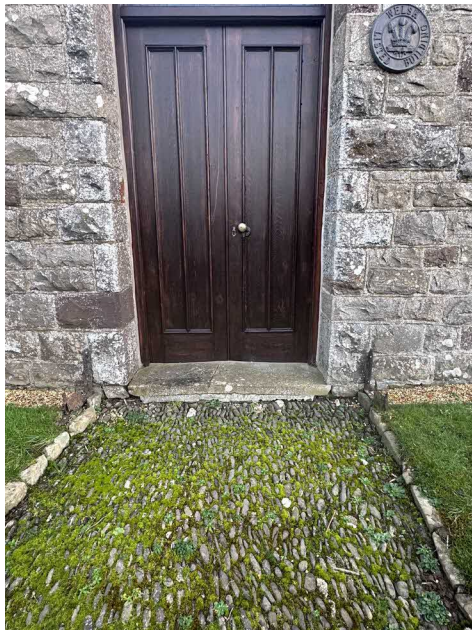
Image j. Step to Chapel Entrance is York stone, reclaimed York stone has been selected for the Ministers House step and floor

All materials used will be selected carefully, the stones for the porch wall will be welsh hand selected stones for shape; the porch frame will be green oak left to naturally age; the glass used will be oak framed glazing matching the windows in the ministers house; the porch floor will be reclaimed old York stone, this is in keeping with the Chapel Porch, where York stone has been used as the step in front of the Chapel door but also the 3 steps leading up to the cobbled path.
