MR I BURGESS

OLD GWERNYFED, VELINDRE, BRECON,

PROPOSED EAST ELEVATION

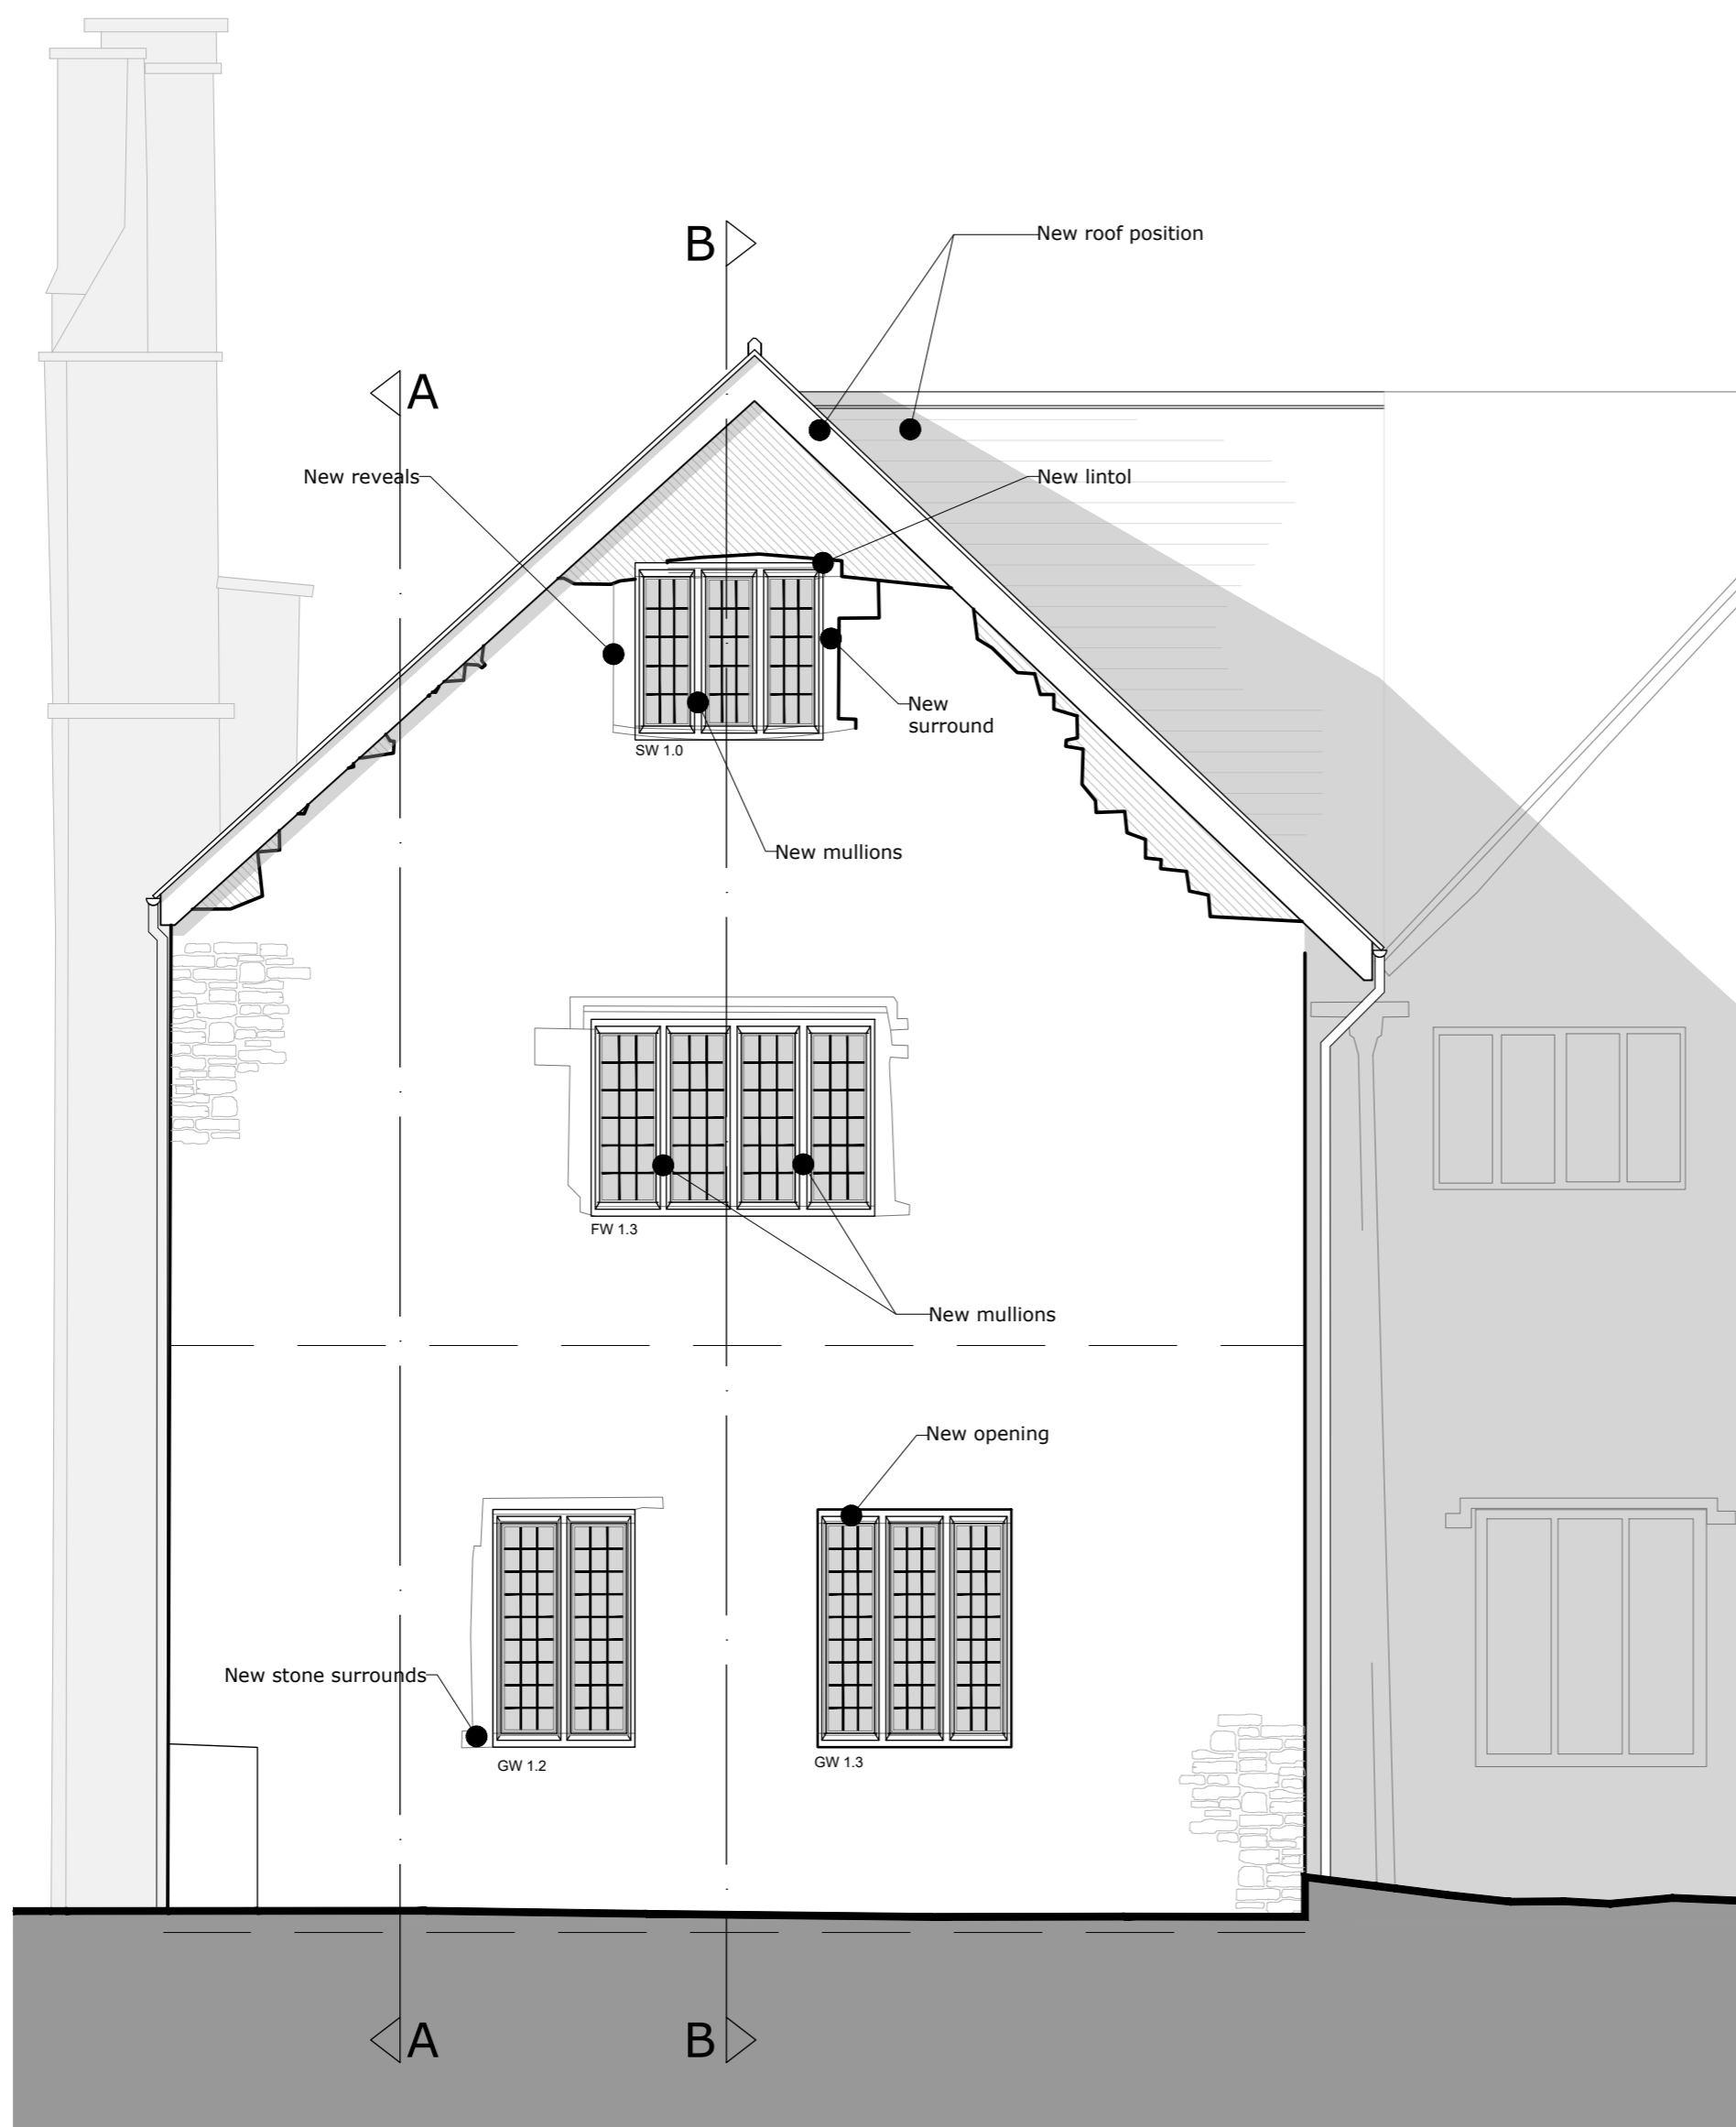
PROPOSED PART EAST ELEVATION

Drawing to be read in conjunction with Stonemason Charles Shaw Stone by Stone Report

Carefully remove infill to all window openings assess condition of mullion windows, repair damage to profiles where essential and stitch cracks, indent stone as necessary and replace mullions where required. Apply lime shelter coat to stone surround.

New windows to be set behind existing.

Where stonework has failed bonding, rebuild in matching stonework or grout in gravity lime fill, if small area.
