# MOSSLEY

Stuart Baxter  
Kerr Baxter and Associates  
Conc: Sauchiehall Street and Rose Street

Further to my recent inspection of the above property I would like to submit the following report concerning the condition of the existing facades.

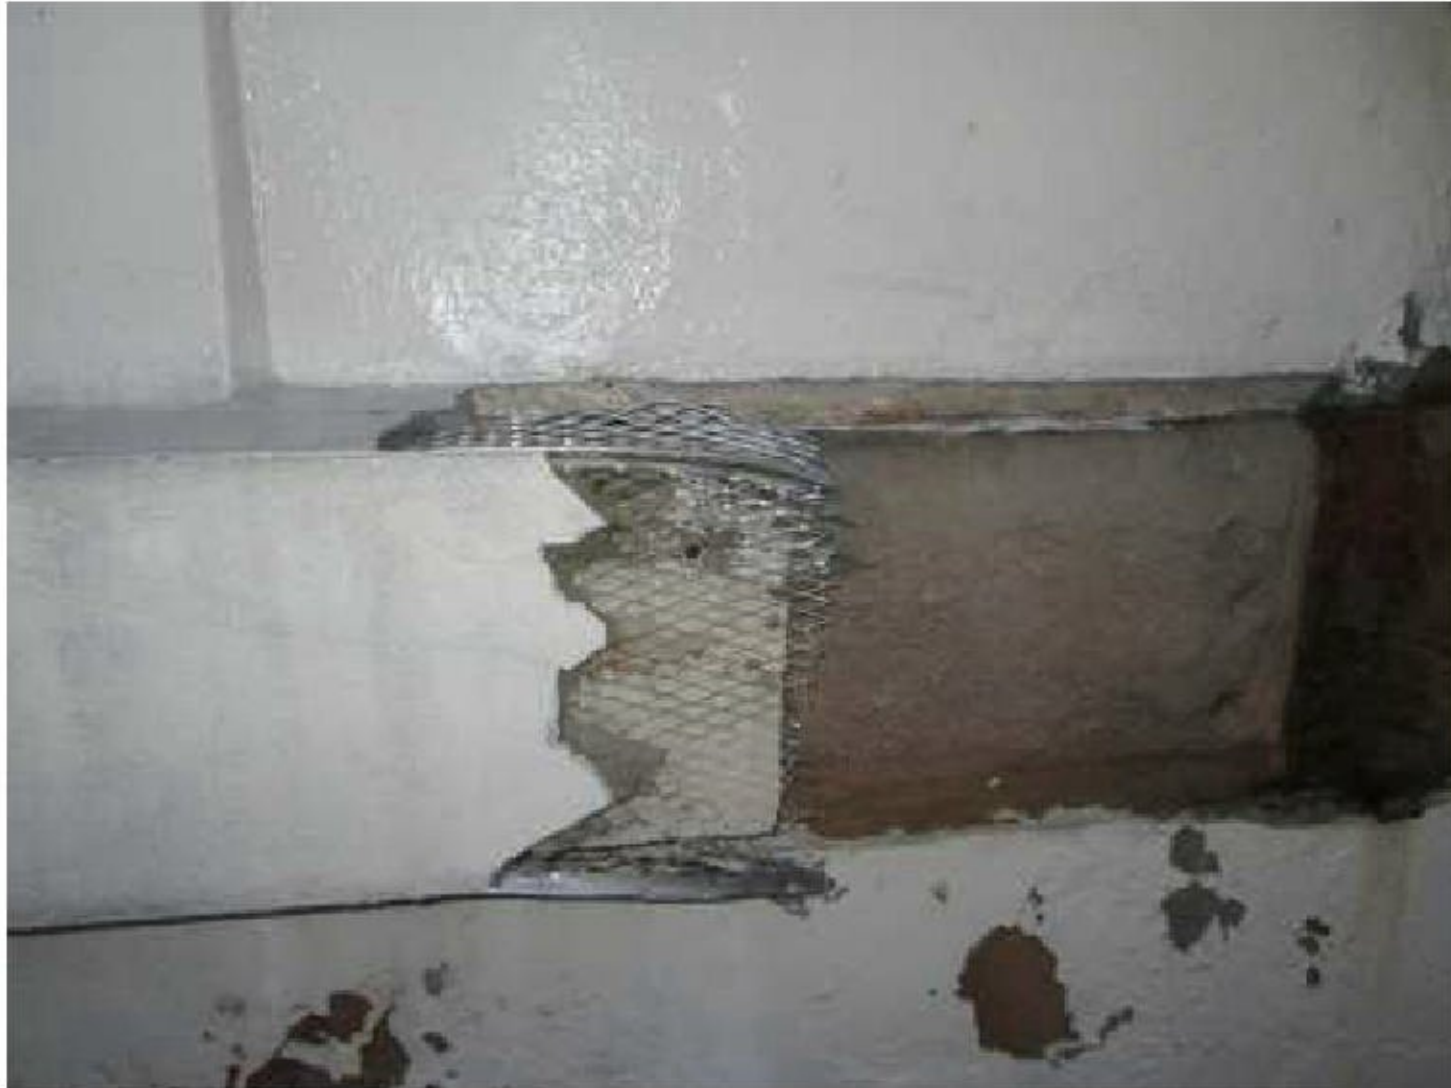
The existing projecting cill course appears to have been formed using some sort of fibreboard, overlaid with galvanised stop beads and mesh, and I would recommend testing this board for the presence of asbestos, prior to undertaking any further works.

Fibreboard and Mesh

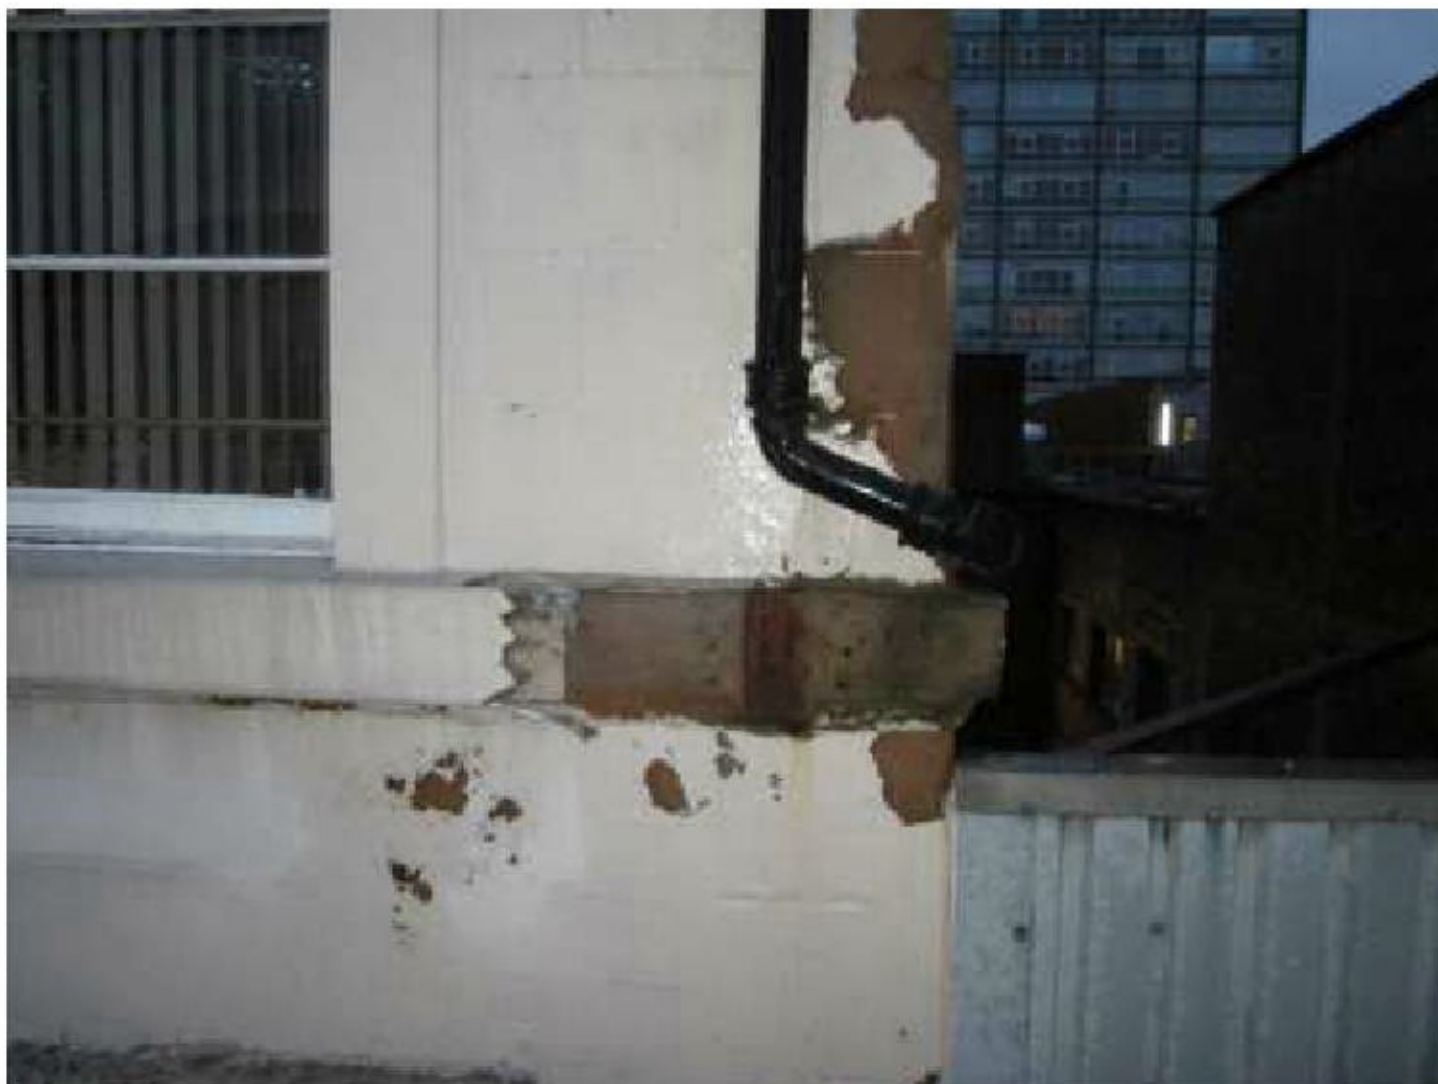
Cill Course

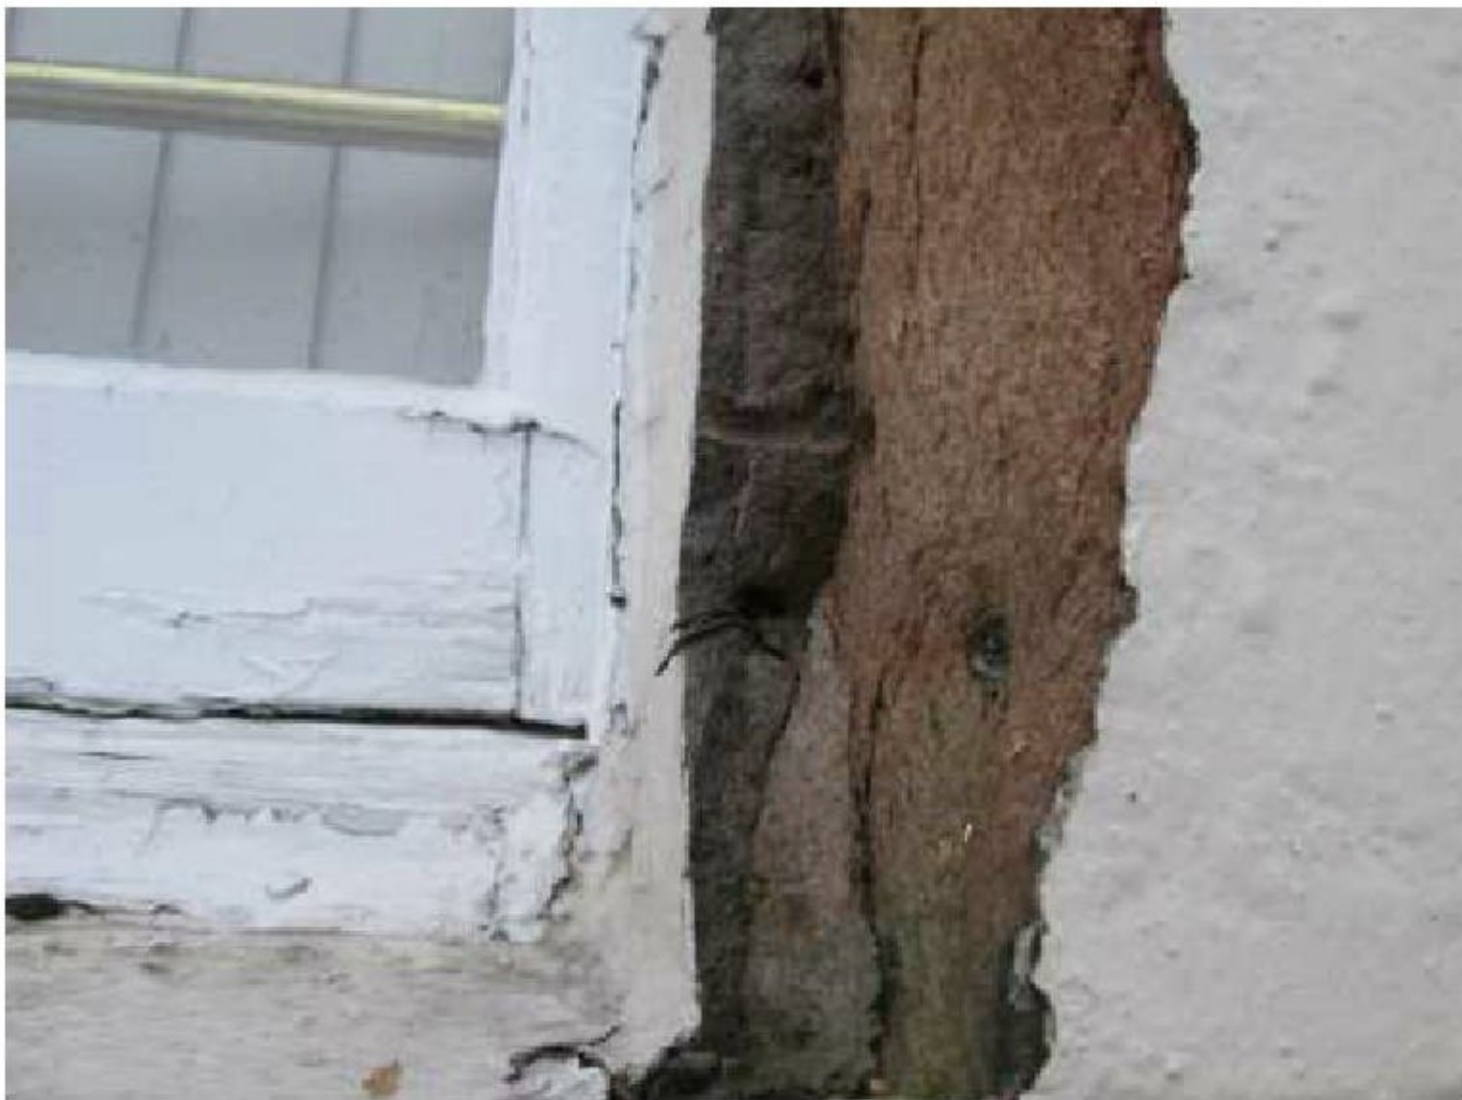
Existing Render
